Colquitz River Watershed

Proper Functioning Condition Assessment

Appendices

July 2009

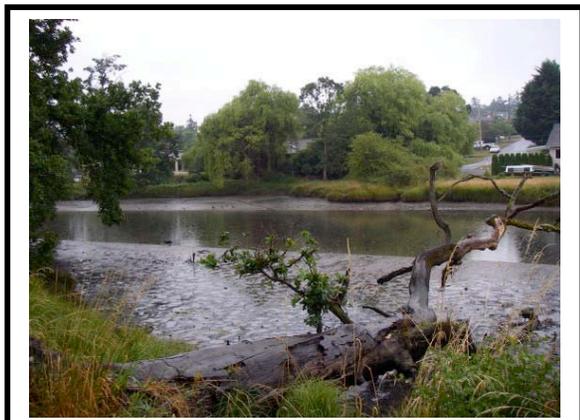
Colquitz River Reach 1, Photo 1, 2007-07-17. Facing upstream from Portage Inlet. The left hand bank consists mostly of residential lawns and little vegetation capable of handling high flows.

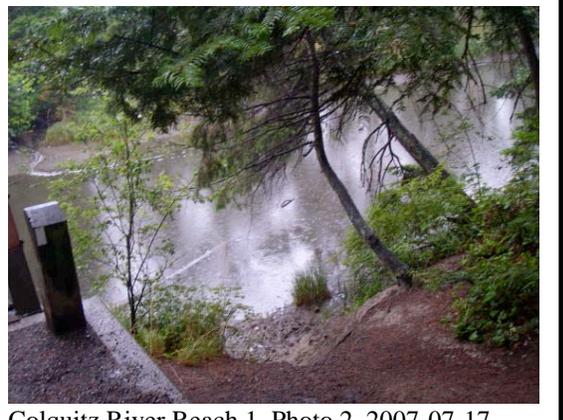
Colquitz River Reach 1, Photo 2, 2007-07-17. Facing the pedestrian bridge crossing closest to the Inlet. Noted erosion occurring adjacent to the bridge. In addition, residential stormwater drainage is entering the creek (top-left in picture).

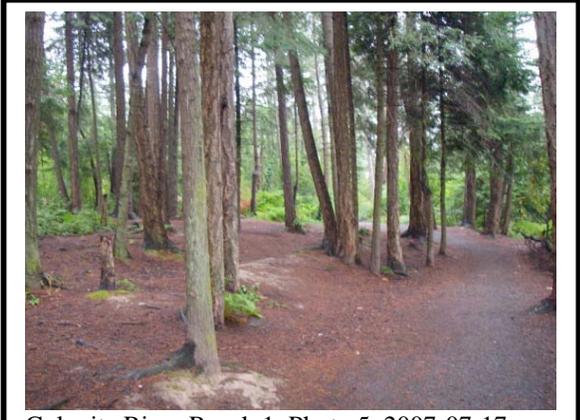
Colquitz River Reach 1, Photo 5, 2007-07-17. Large amount of off-path trampling is noted above; Area is at risk for considerable top-soil erosion leading to further reduced vegetation.

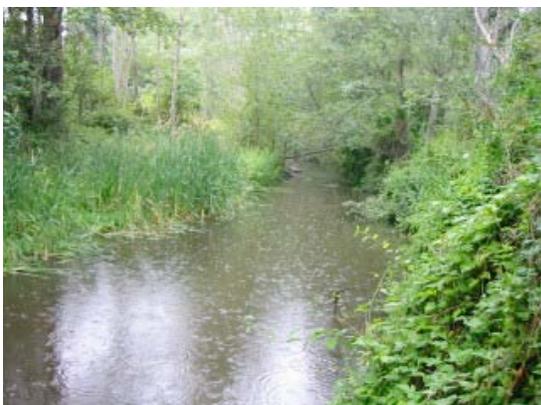
Colquitz River Reach 4, Photo 4, 2007-07-18.
Facing upstream. Large amounts of reed canary
grass (left) and Himalayan blackberries (right)
noted.

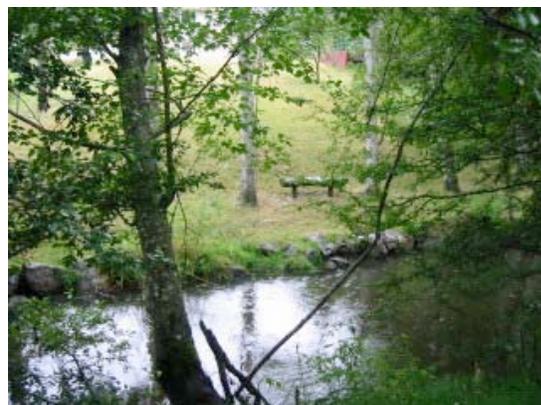
Colquitz River Reach 5, Photo 1, 2007-07-18.
Facing East towards residential property
consisting of grass that is mowed right to the
bank. Banks are armoured with blast rock.

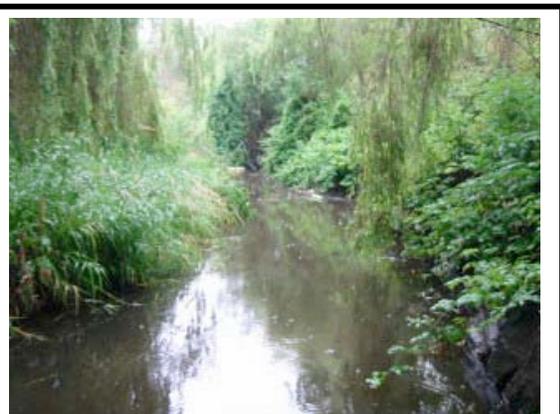
Colquitz River Reach 7, Photo 2, 2007-07-18.
Facing upstream. Noted large amount of invasive species present.

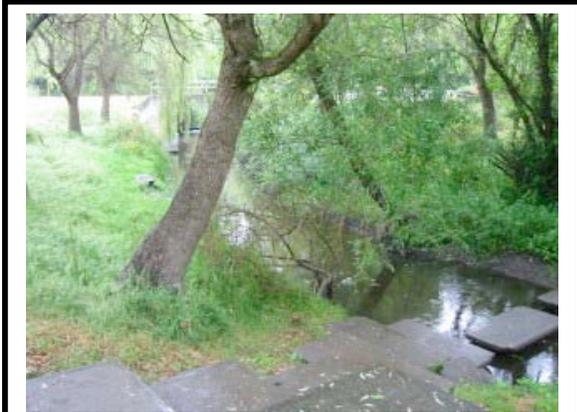
Colquitz River Reach 7, Photo 3, 2007-07-18.
Due to the concrete path and trampling, some streambank erosion has occurred on the right bank. Large Willow trees alongside channel are preventing riparian plant growth.

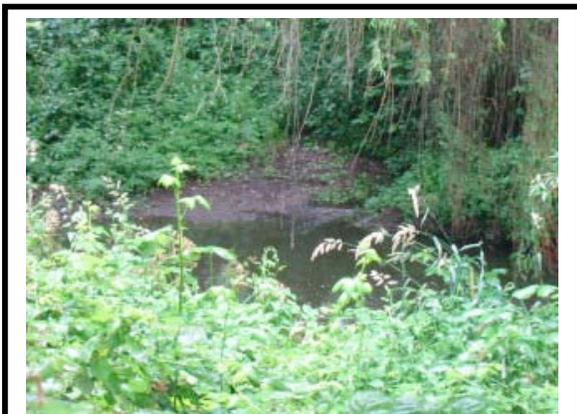
Colquitz River Reach 7, Photo 5, 2007-07-18.
Hyacinth Park. Channel forms into a ditch. As seen above streambank erosion is occurring.

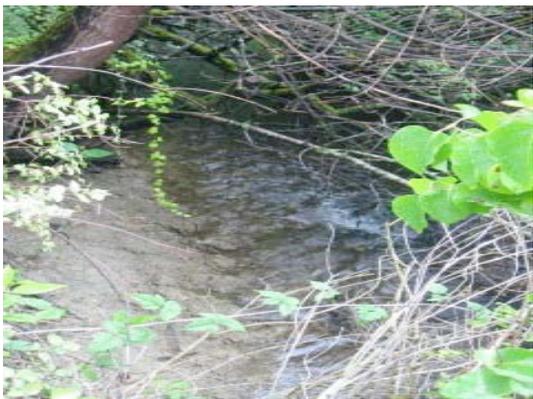
Colquitz River Reach 9, Photo 3, 2007-07-23.
Streambank erosion and invasive species noted.

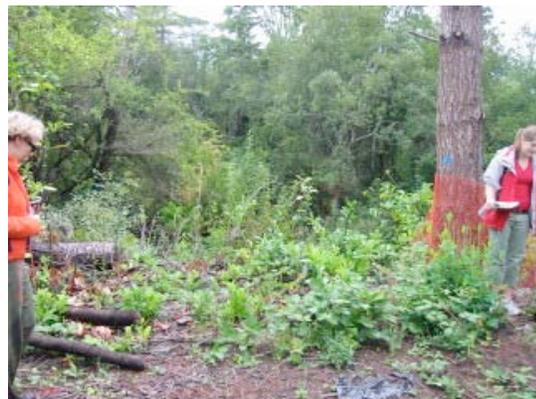
Colquitz River Reach 9, Photo 4, 2007-07-23.
Clearing of the property (corner of Grange and Gerda Road) and deposition of material is preventing vegetation growth and is accelerating bank erosion.

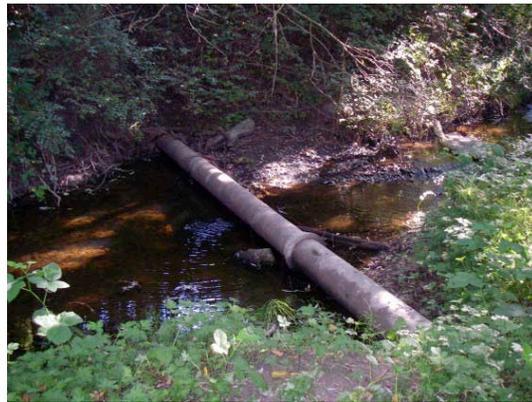
Swan Creek Reach 1, Photo 4, 2007-08-06.
Facing upstream. Noted pipeline crossing was
either installed in the creek bed itself or
surrounding material has eroded and exposed the
pipe.

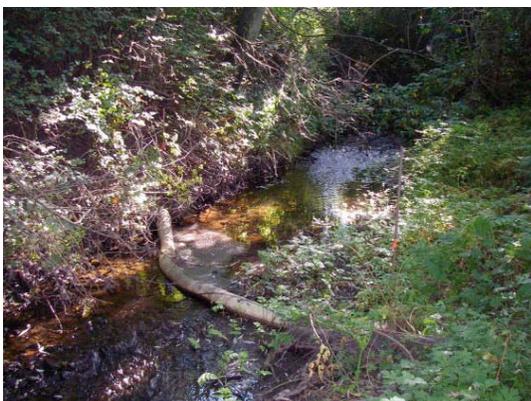
Swan Creek Reach 1, Photo 5, 2007-08-06.
Facing upstream. An aging spill boom was noted
still in place.

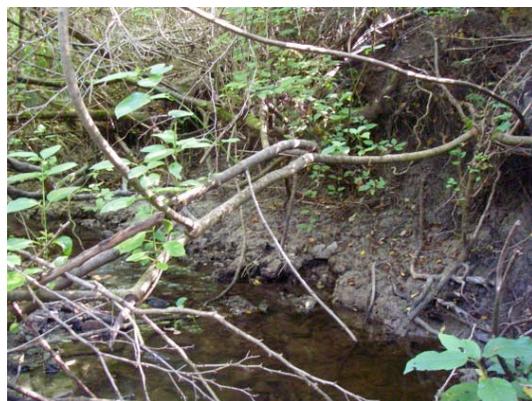
Swan Creek Reach 2, Photo 1, 2007-08-06.
Banks are eroding and downcutting.

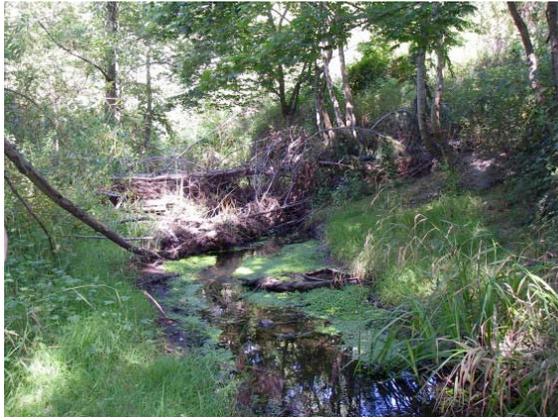
Swan Creek Reach 4, Photo 2, 2007-08-06. Facing downstream. Large amount of debris has been piled up from prior year storms.

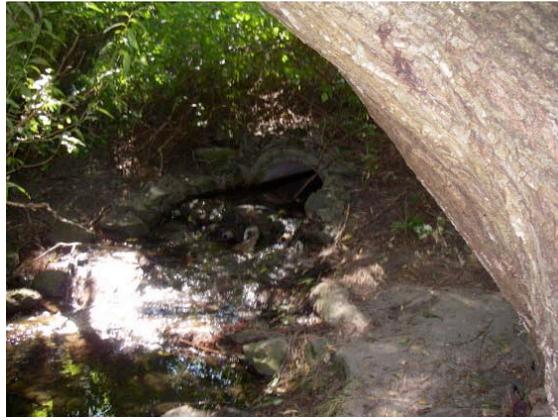
Swan Creek Reach 4, Photo 3, 2007-08-06. Facing upstream. A culvert is discharging nearby stormwater into the creek.

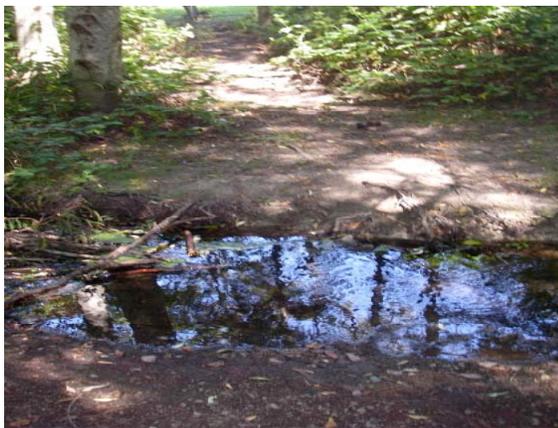
Swan Creek Reach 4, Photo 5, 2007-08-06. Streambed and riparian vegetation have been trampled.

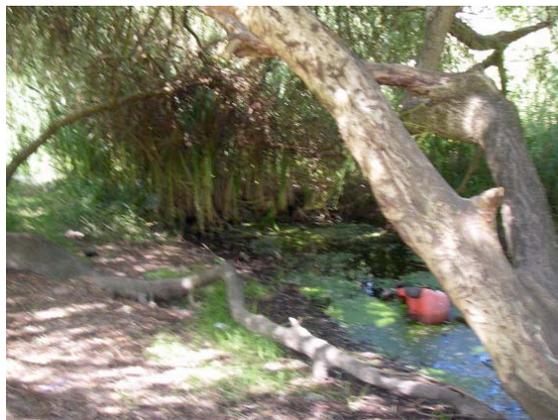
Swan Creek Reach 4, Photo 6, 2007-08-06. Facing downstream under large willow tree. Trash has been dumped in the channel and along the banks.

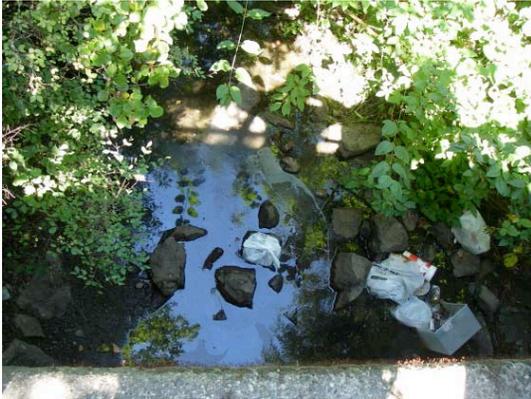
Swan Creek Reach 7, Photo 3, 2007-08-06. Ralph Street Culvert Crossing. Facing downstream. Garbage noted in channel.

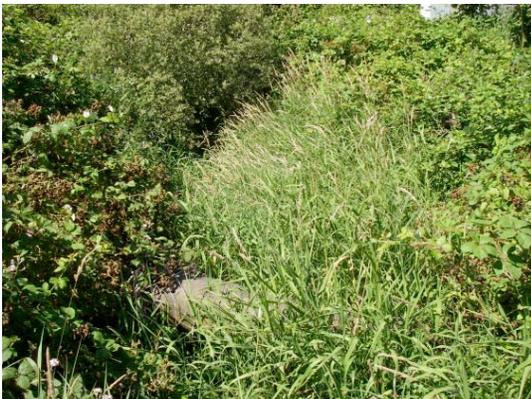
Swan Creek Reach 7, Photo 5, 2007-08-06. Kent Road pedestrian bridge facing downstream. Noted elevated pipe crossing parallel to the bridge. Area is inundated with invasive species.

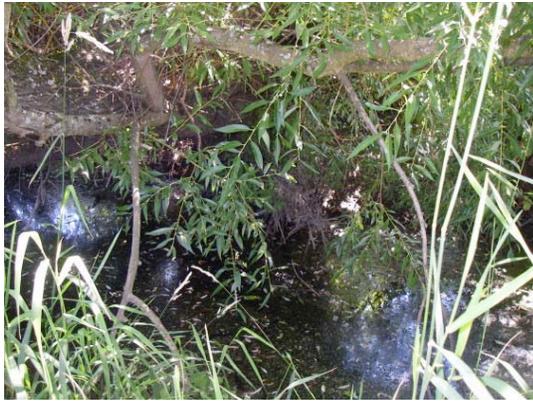
Swan Creek Reach 8, Photo 2, 2007-08-06.
Allotment gardens. Banks are steepened and bare in spots.

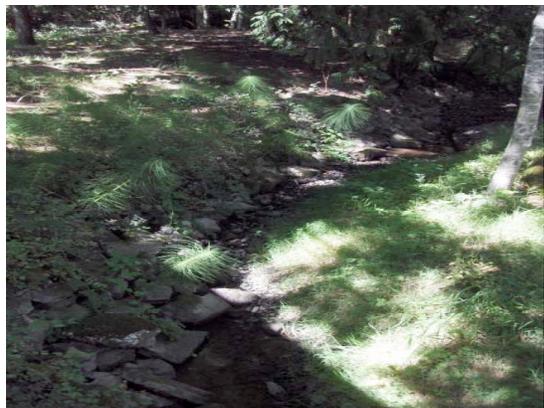
Viaduct Creek Reach 5, Photo 1, 2007-08-16.
Property of 478 Viaduct Avenue, facing upstream. Stream banks are armoured with rip-rap and contain little riparian vegetation.

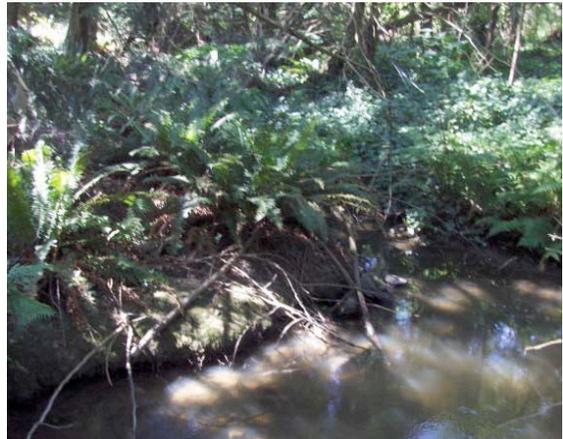
Viaduct Creek Reach 6, Photo 1, 2007-08-16.
Standing on pedestrian bridge, facing upstream.
Erosion is undercutting the bank.

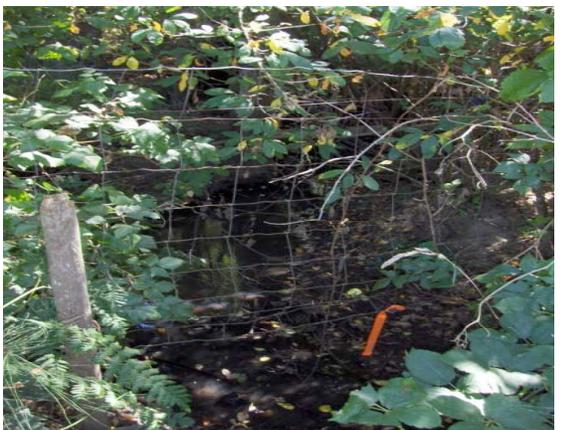
Viaduct Creek Reach 6, Photo 4, 2007-08-16.
Facing downstream, property line of 458 Viaduct
Ave. Channel has eroded.

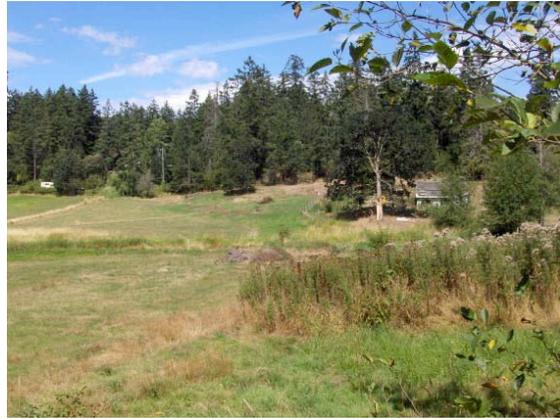
Viaduct Creek Reach 7, Photo 3, 2007-08-16.
Property of 458 Viaduct Ave. As seen in the background, channel has been ditched.

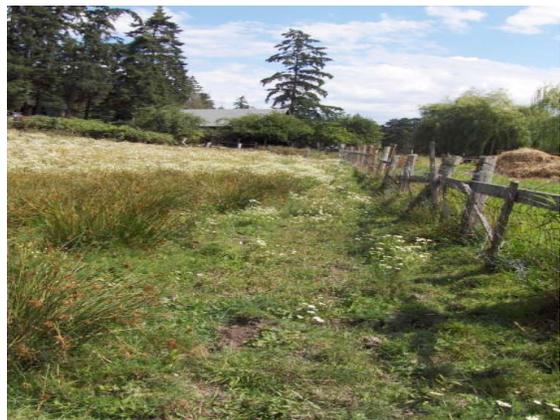
Viaduct Creek Reach 8, Photo 2, 2007-08-16.
Facing downstream towards property of 424 Viaduct Avenue. Area dries up in the summer and is grazed/trampled by cattle.

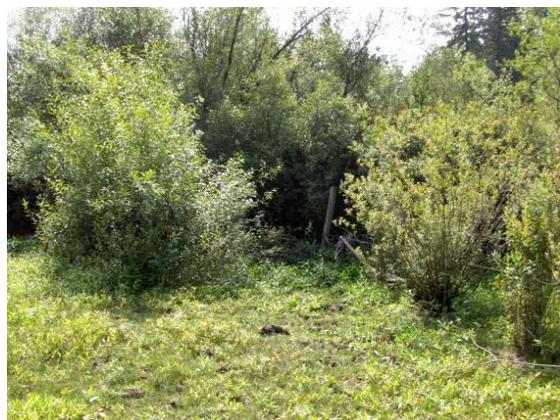
Viaduct Creek Reach 8, Photo 4, 2007-08-16.
Facing upstream on the property of 414 Viaduct Avenue. Area is trampled by horses.

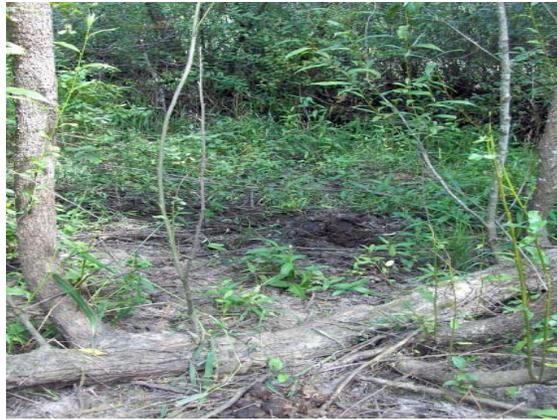
Viaduct Creek Reach 8, Photo 5, 2007-08-16. Property of 414 Viaduct Avenue. Channel is apparent and is completely dry. Noted horse manure in the dry channel bed.

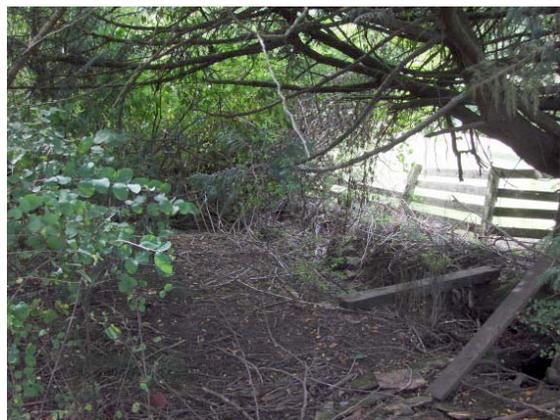
Viaduct Creek Reach 9, Photo 2, 2007-08-16. Facing upstream on the property of 414 Viaduct Avenue. Creek has seriously down-cut from large flows.

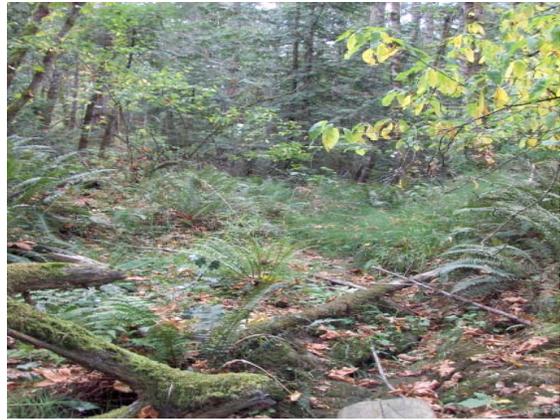
Viaduct Creek Reach 10, Photo 3, 2007-08-16. Facing upstream. Creek is well vegetated, has some erosion on the outside bends and has access to a developed floodplain.

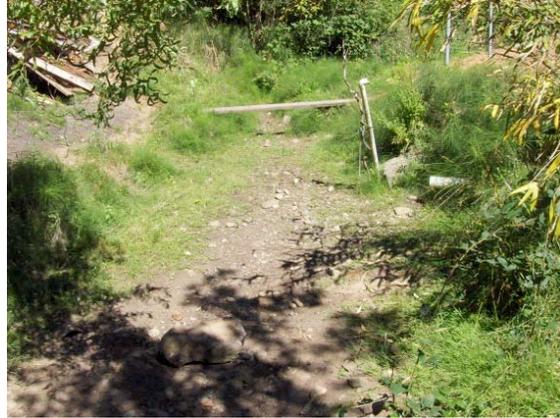
Viaduct Creek Reach 12, Photo 2, 2007-08-14. On property of 365 Viaduct Avenue, facing downstream. Creek-bed is completely dry and has limited riparian vegetation.

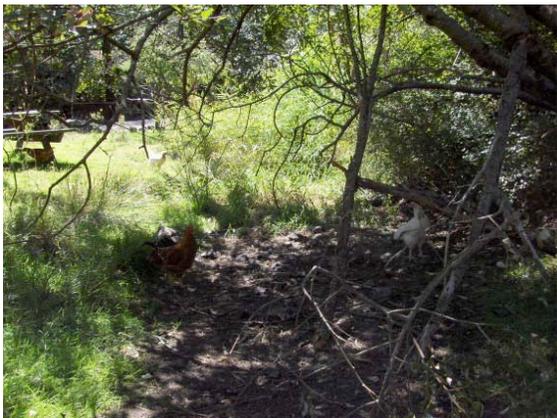
Viaduct Creek Reach 12, Photo 3, 2007-08-14. On property of 365 Viaduct Avenue, facing upstream. Noted chickens grazing in the channel. Channel is too straight and too wide.

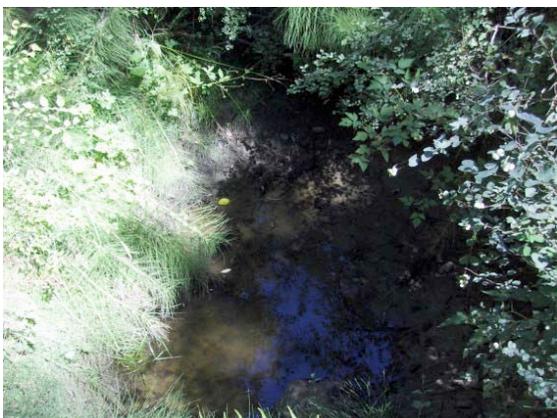
Viaduct Creek Reach 12, Photo 5, 2007-08-14. Facing upstream past property line. Some stream bank erosion noted. A working water pump was noted to the left.
