Capital Regional District

Notice of Meeting and Meeting Agenda Lyll Harbour Boot Cove Water Local Service Committee

Thursday, June 27, 2024

**MONEY LAKE DAM - 2022 DAM SAFETY REVIEW
SITE LOCATION PLAN**

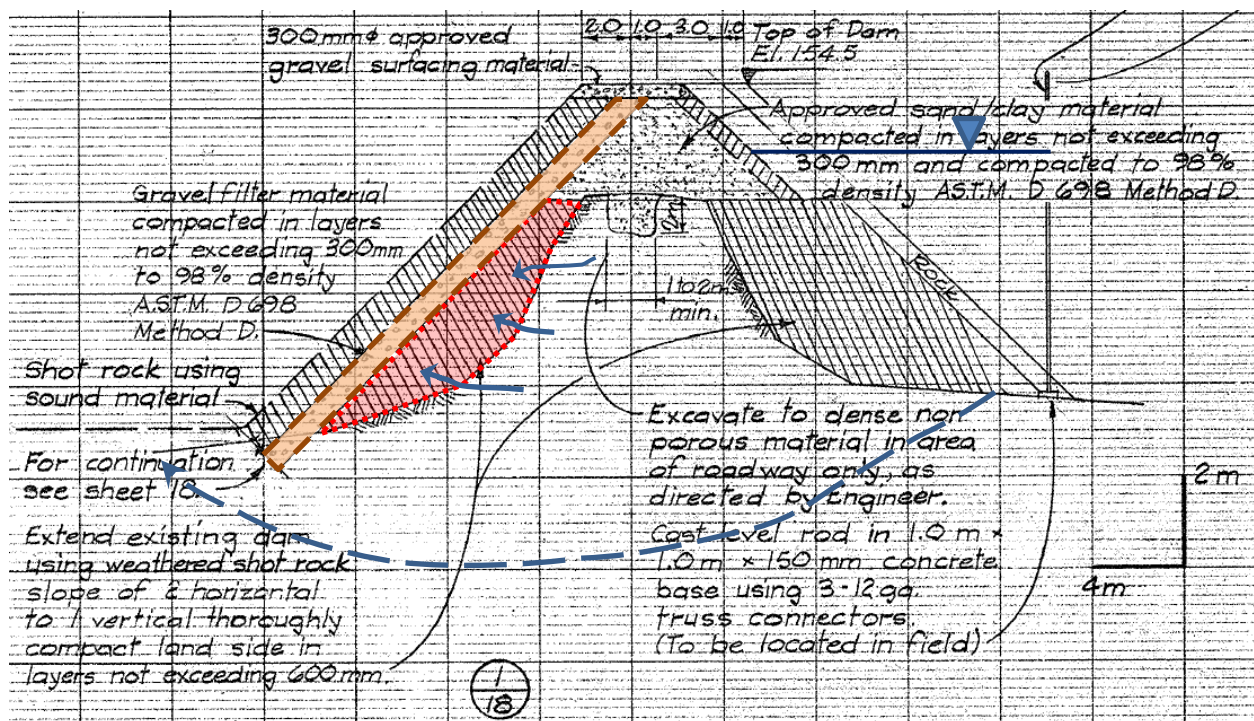
However, the available as-built information indicates the filter zone was not placed directly against the original dam fill, but rather was placed as an inclined layer against a zone of rockfill that was placed against the downstream face of the previous dam (see Figure 1 below). This means that fines from the pre-1979 embankment could be migrating into the unfiltered rockfill zone; however, this internal erosion would not necessarily be apparent. Additionally, there is no evidence that the new filter zone was extended to sufficient depth to filter seepage through natural channel deposits that remain under the central portion of the dam.

Figure 1: Illustrating unfiltered rockfill zone (red) upgradient of inclined filter (orange) as well as unfiltered foundation soils (From 1980 As-Built Drawing)

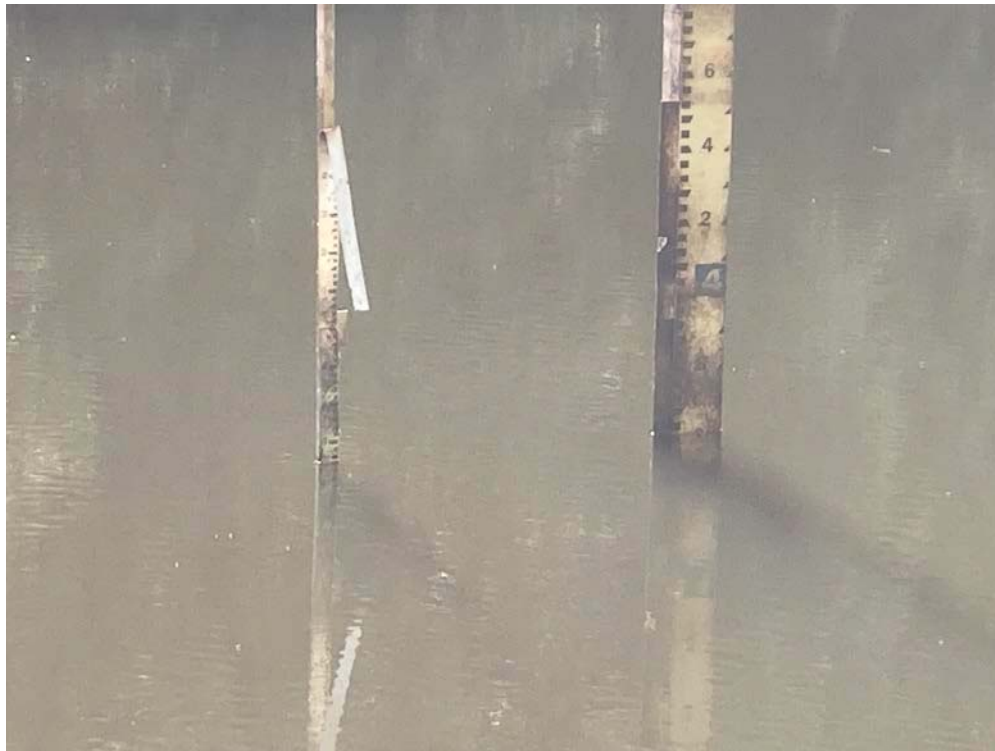
Photo 3: Staff gauges – difficult to read. (2022-08-31, JDM)

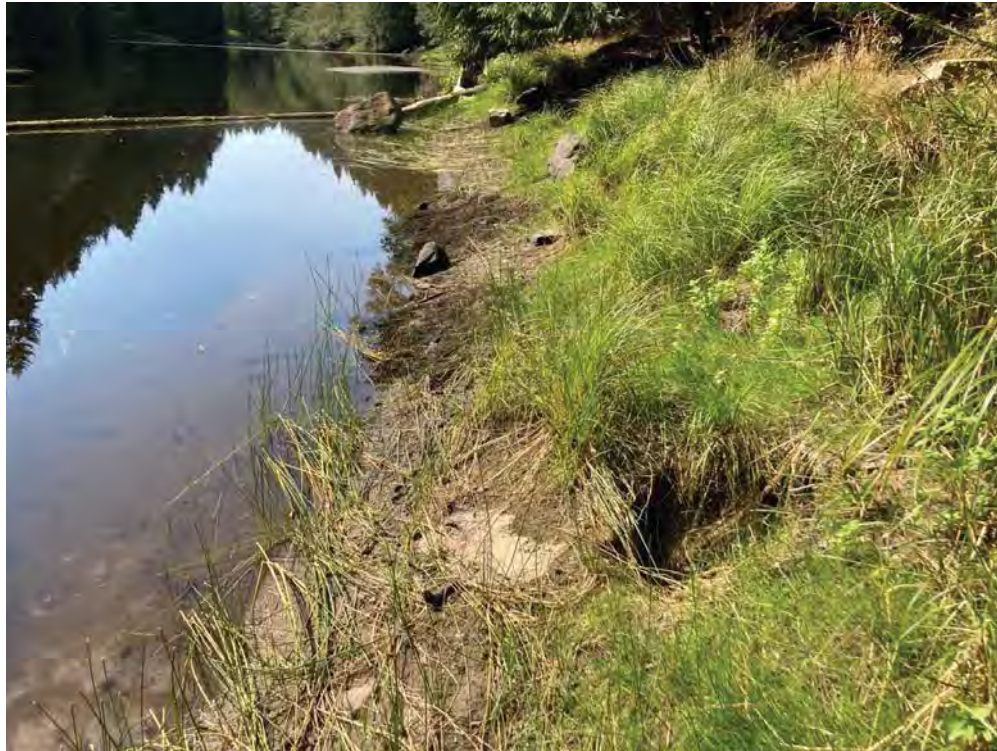
Photo 5: Sinkhole/depression upstream of left abutment. (2022-08-31, JDM).

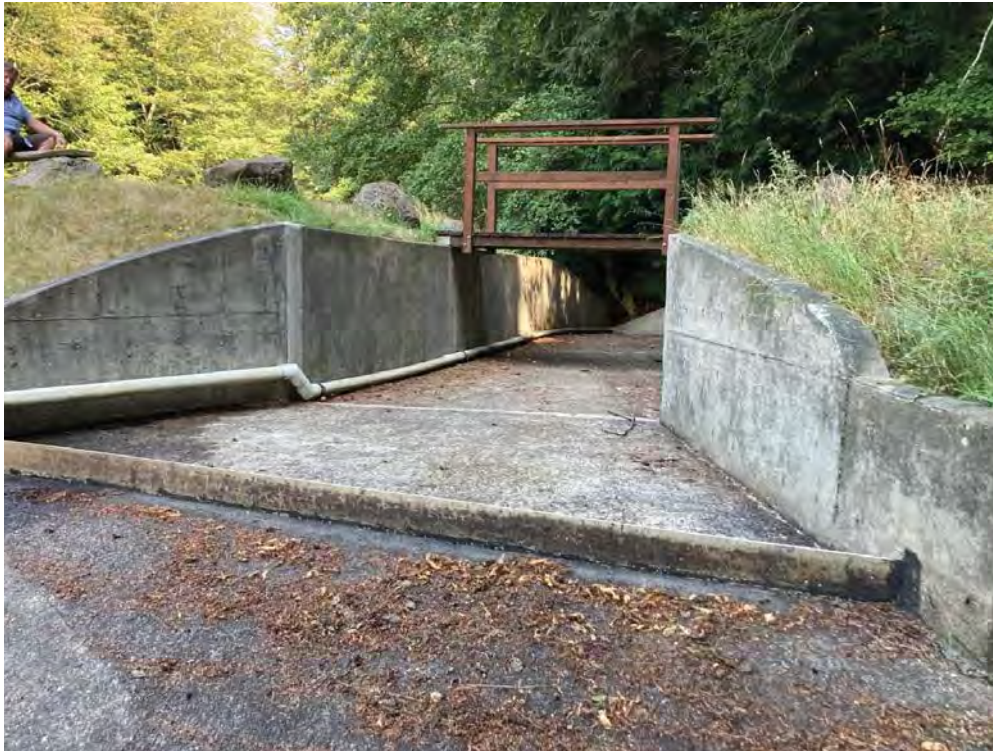
Photo 7: Looking north at entrance to spillway. Note seepage return pipe. (2022-08-31, JDM)

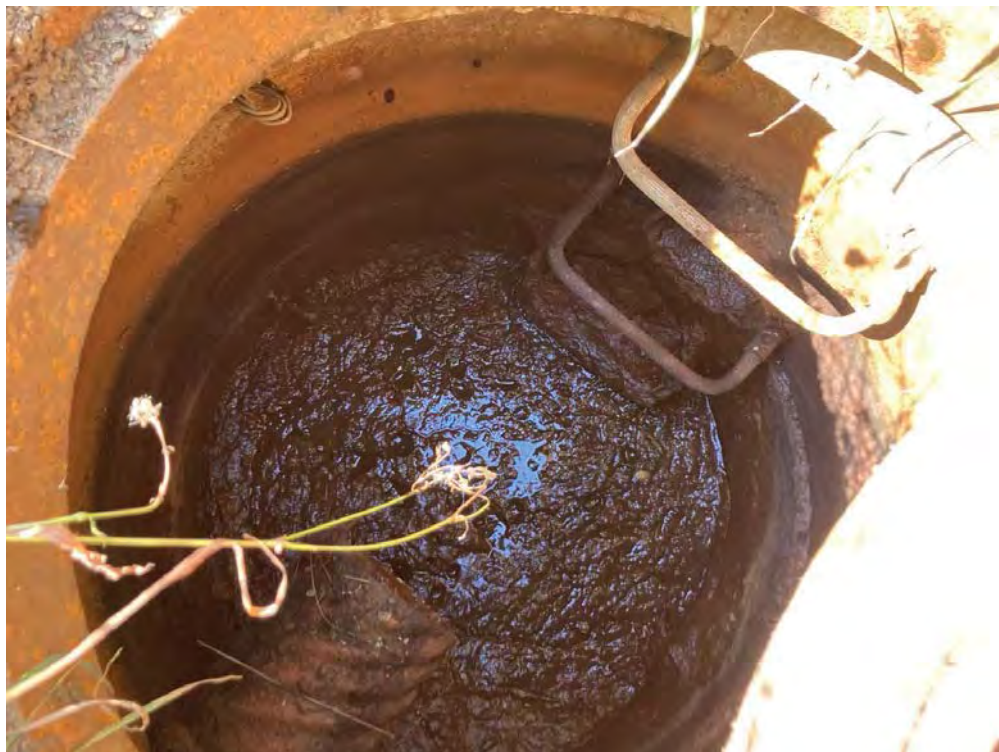
Photo 18: Interior of MH2 – approximately 250 mm of fine sediment. (2022-08-31, JDM).

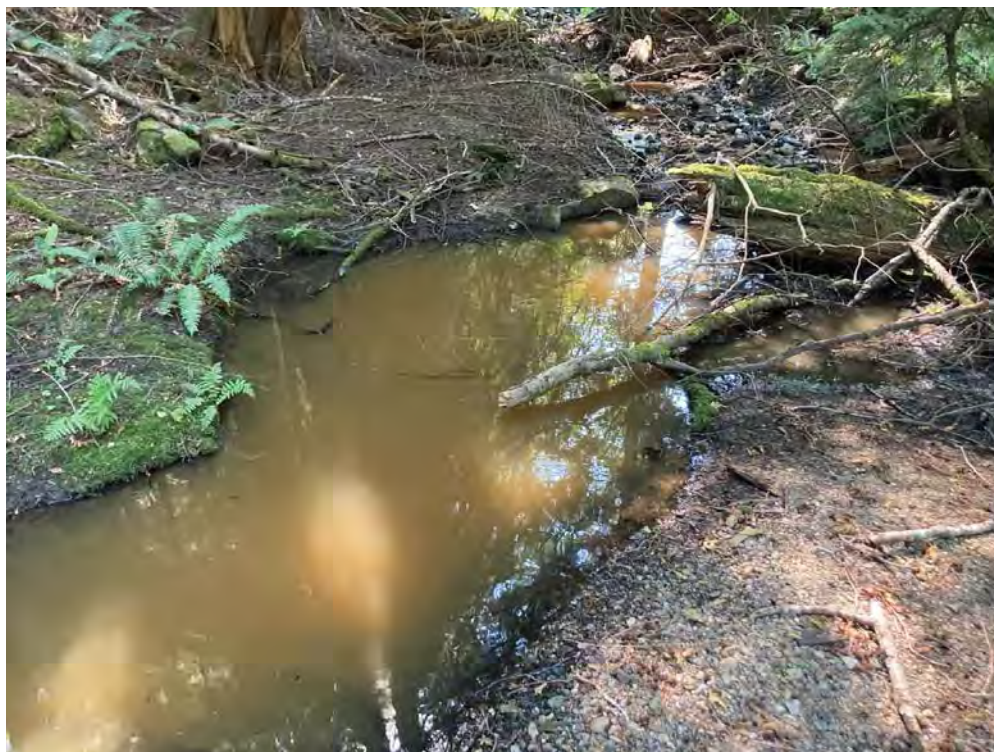
Photo 20: Unclear water pumped from MH1. (2022-08-31, JDM).
