**REPORT TO REGIONAL WATER SUPPLY COMMISSION
MEETING OF WEDNESDAY, JUNE 19, 2008**

SUBJECT WATER QUALITY TRENDS IN SOOKE RESERVOIR IN MAY 2008

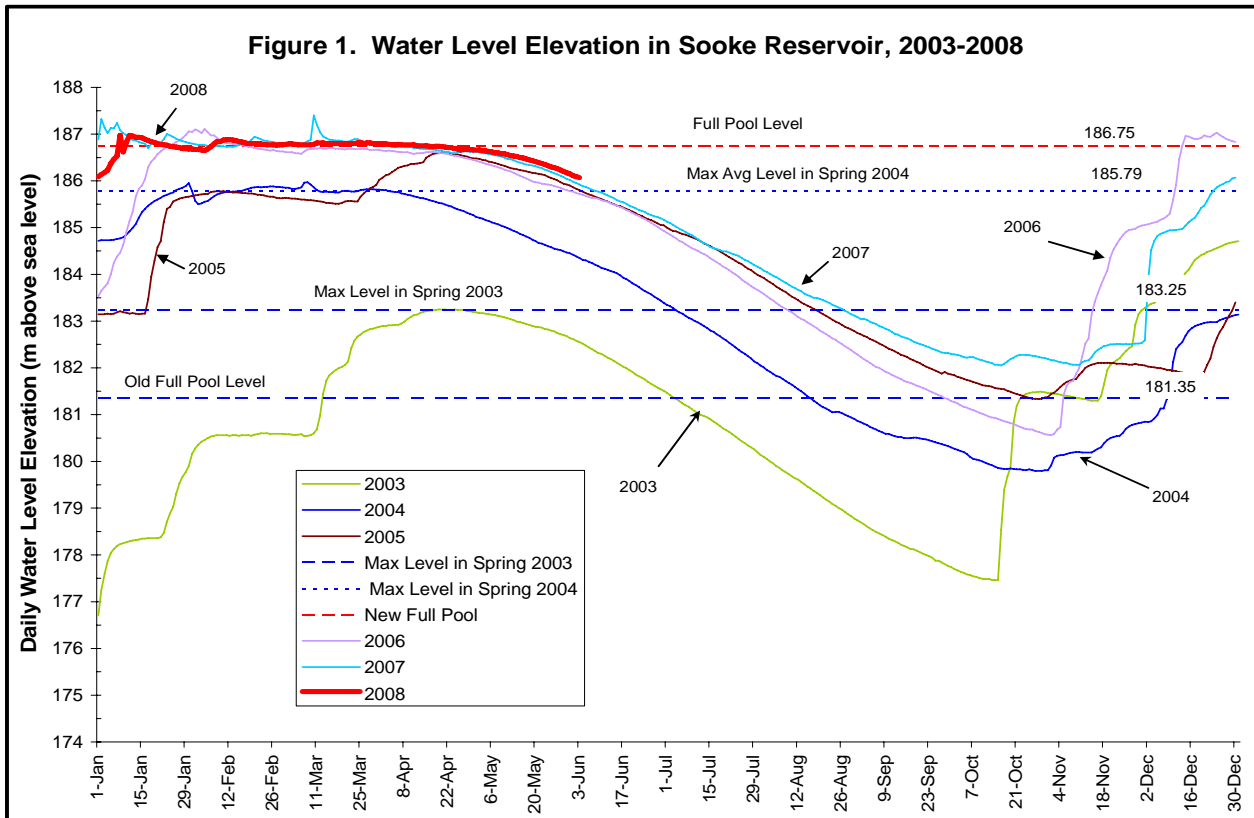
Water Levels. During May the water level in Sooke Reservoir declined gradually, following a similar pattern to that in 2007. By the end of May the water level was about 0.6 m below full pool level of 186.75 metres (186.15 m) (**Figure 1**).

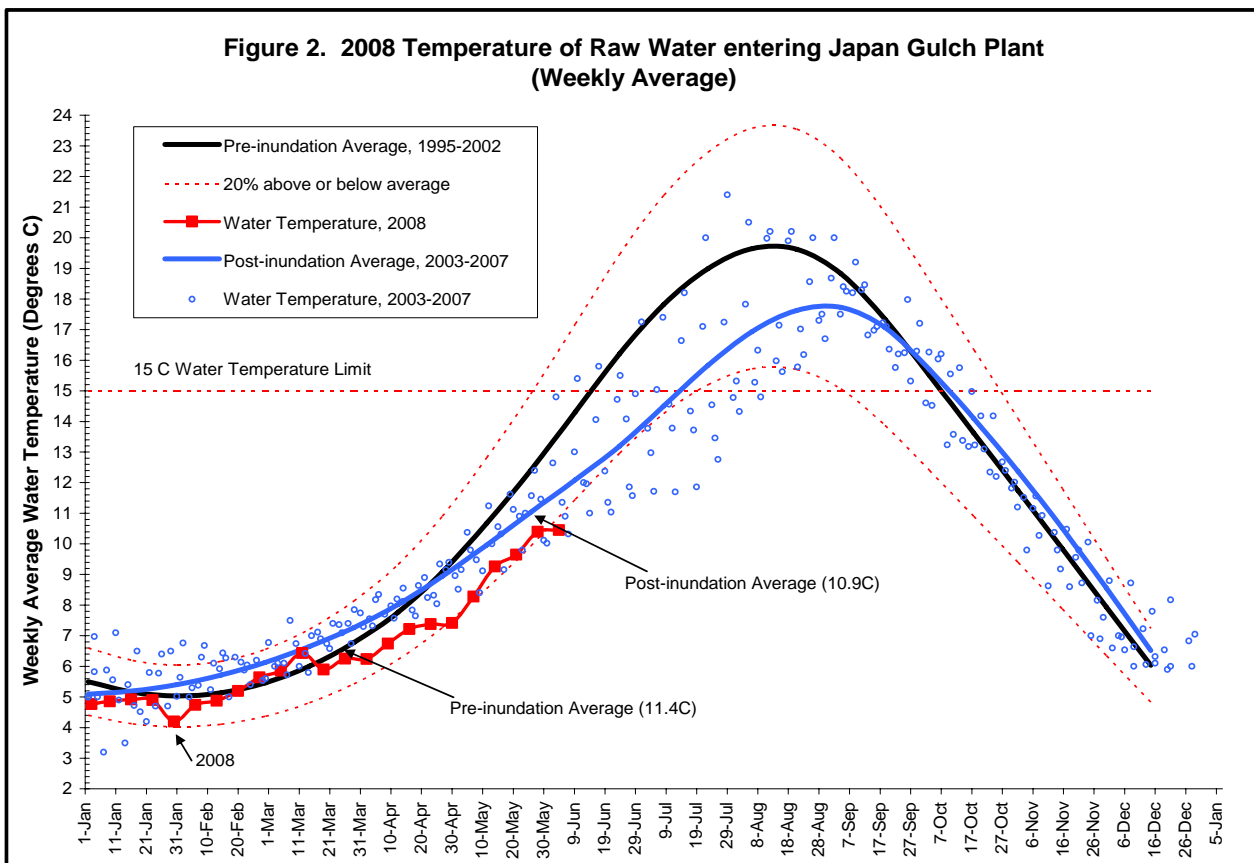
Water Temperature. During May, the weekly average temperature of the water entering the Japan Gulch Treatment Plant was cooler than the pre-inundation average by more than 1°C, averaging only 9.4°C versus 10.5°C (**Figure 2**). This drop in water temperature was due to colder than average temperatures in May and not due to the raising of the water level in the reservoir.

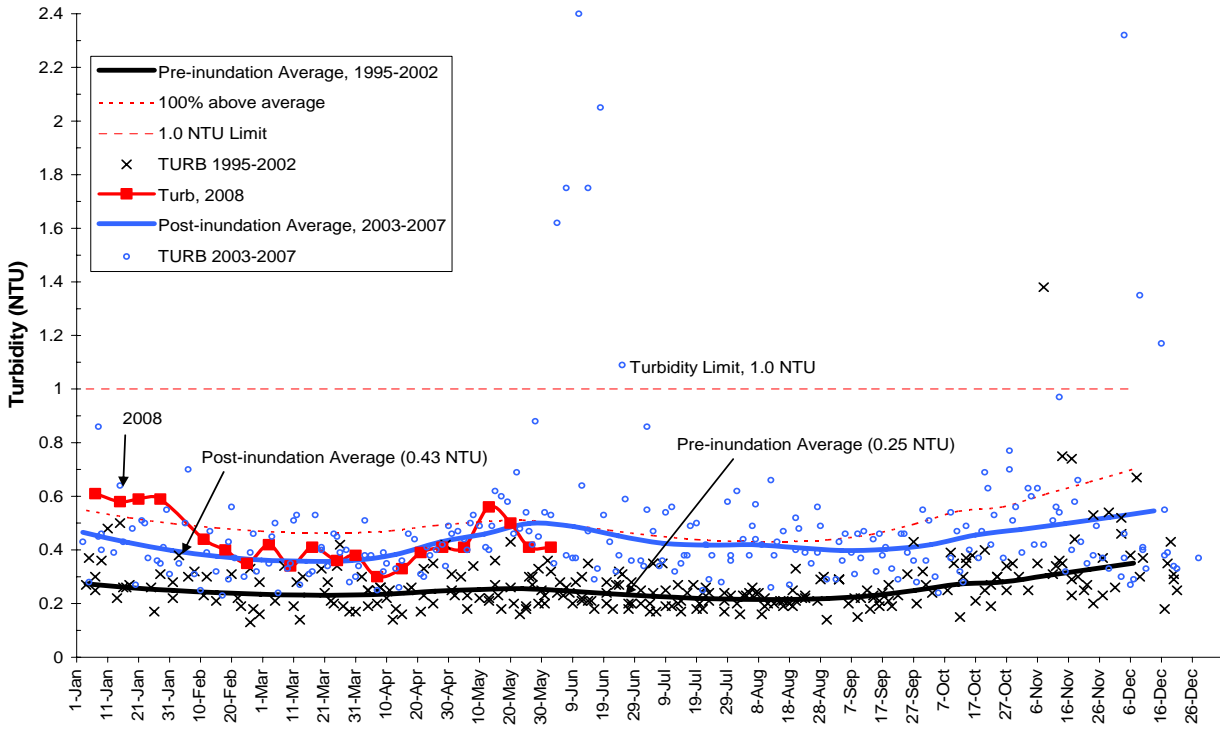
Figure 3. 2008 Turbidity in Sooke Reservoir
 North Basin, 1m depth (SOL-04-01)

Turbidity. During May, the turbidity of the water in Sooke Reservoir averaged 0.44 NTU. This value is consistent with the post-inundation average during that same time period and about 0.18 NTU above the pre-inundation average (**Figure 3**).

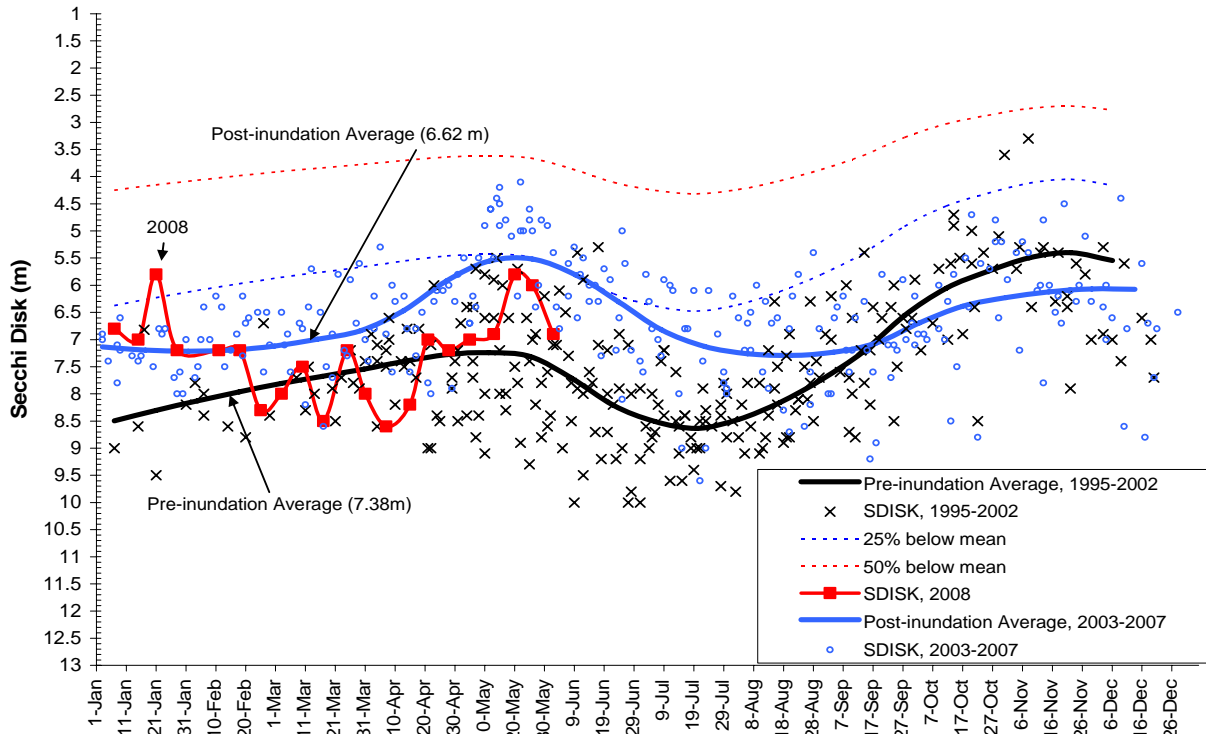
Figure 4. 2008 Water Transparency in Sooke Reservoir
 Intake tower, (SOL-00-01)

Water Transparency. In May 2008, the transparency of the water throughout Sooke Reservoir was better than the post-inundation average but slightly worse than the pre-inundation average (**Figure 4**).

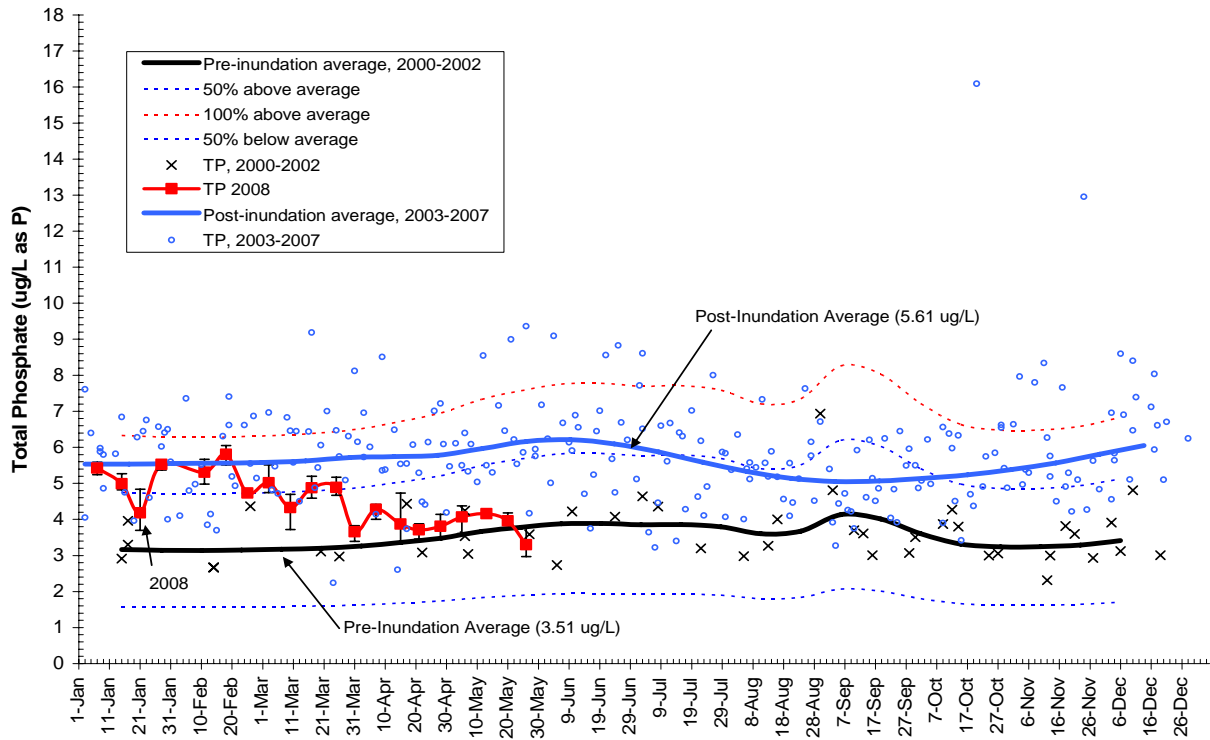
**Figure 5. 2008 Total Phosphorus for Sooke Reservoir
 South basin, 1 m depth (SOL-01-01)**

Phosphorus. During May, the total phosphorus concentrations continued to decline in both basins, approaching the pre-inundation average (**Figures 5 and 6**). (**Note:** In the charts, the bars on each data point indicate the range of data observed from triplicate samples.)

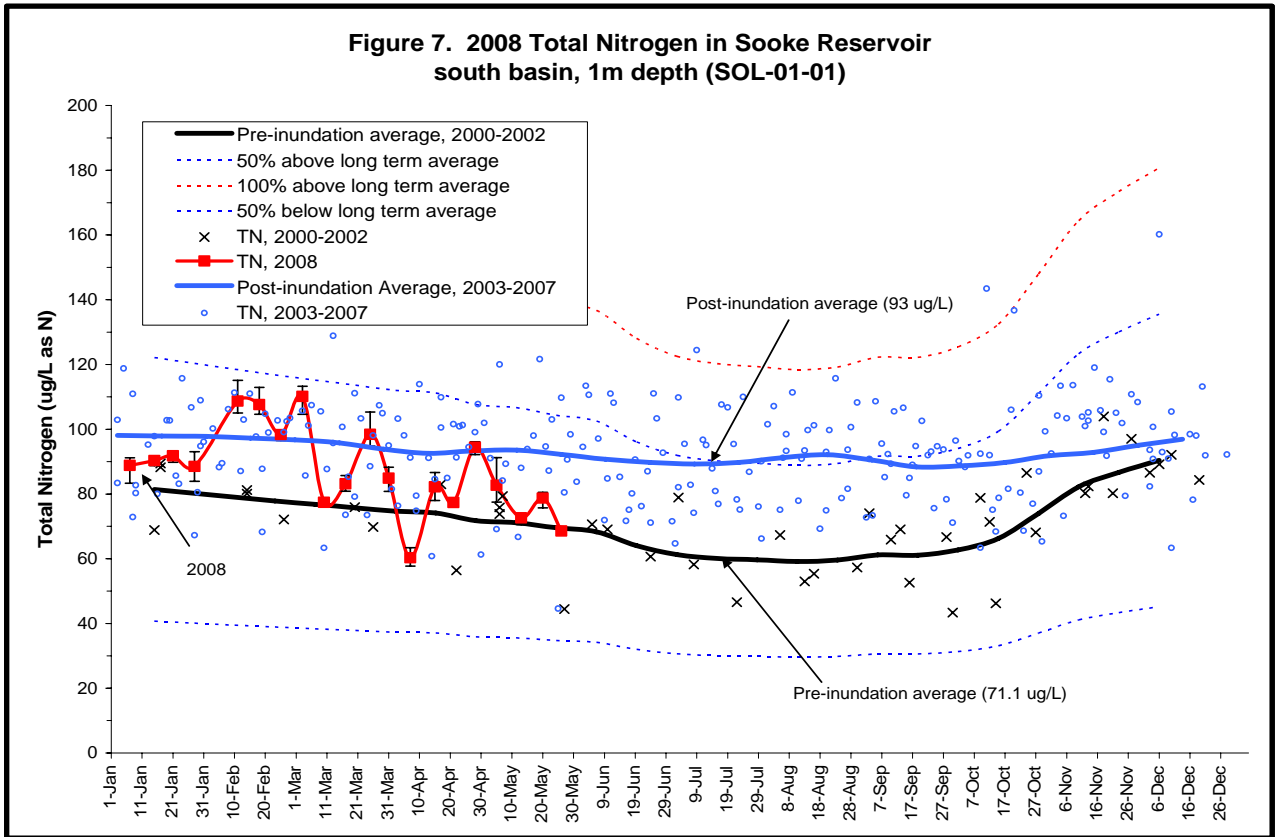
Nitrogen In May, the total nitrogen levels fluctuated in the south basin (**Figure 7**) and remained fairly steady in the north basin (**Figure 8**) of Sooke Reservoir. Generally, the total nitrogen concentrations drew closer to the pre-inundation averages in both basins.

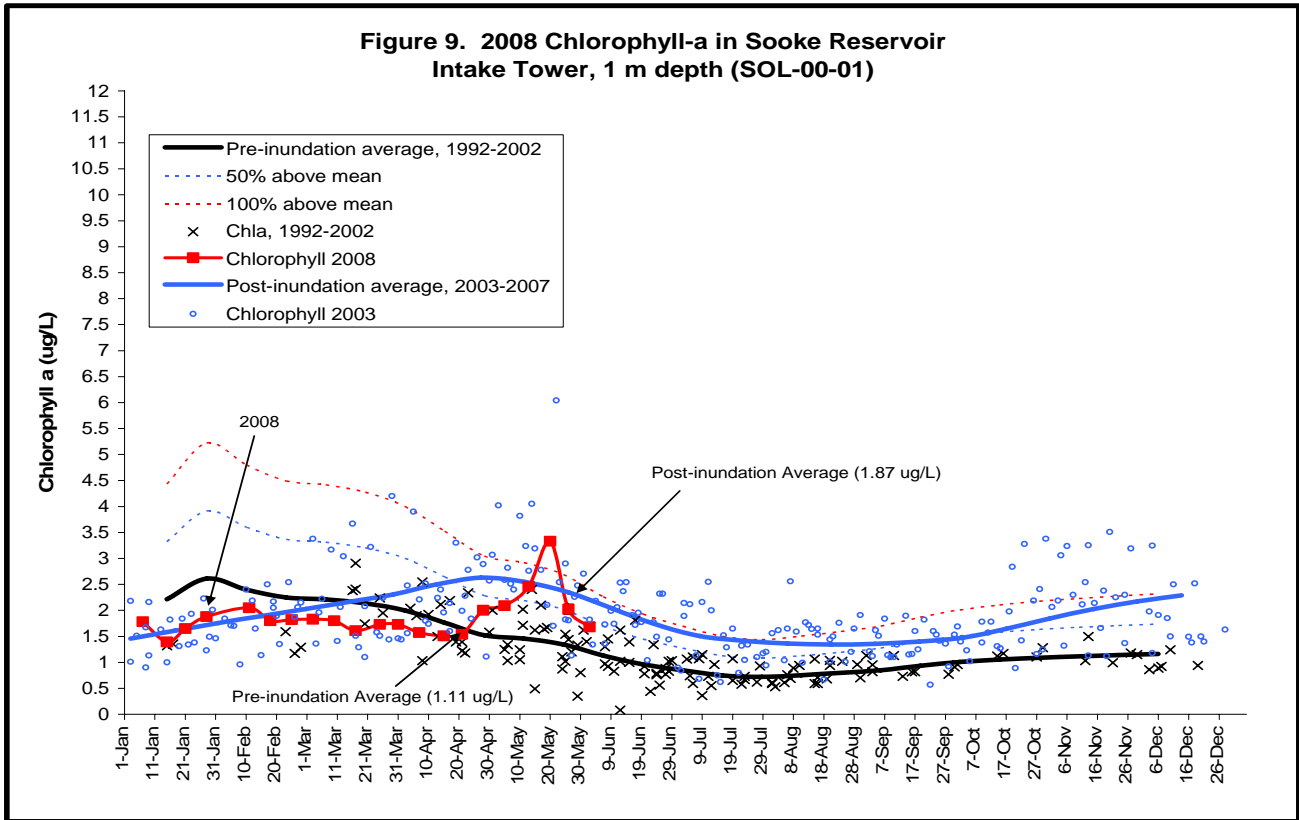
In May, chlorophyll-a concentrations continued to rise throughout the reservoir, peaking in mid- to late May and then returning to below post-inundation levels at the intake tower (**Figure 9**) and to pre-inundation averages in the north basin (**Figure 10**).
