**WHITEHEAD ENVIRONMENTAL
CONSULTANTS LTD.**

November 9, 2017
Our Project File: 090-3

ENVIRONMENTAL DUE-DILIGENCE REPORT:

**Capital Regional District Parks and Recreation Program Family Bike Park Project
at 160 Seaview Avenue, Salt Spring Island.**

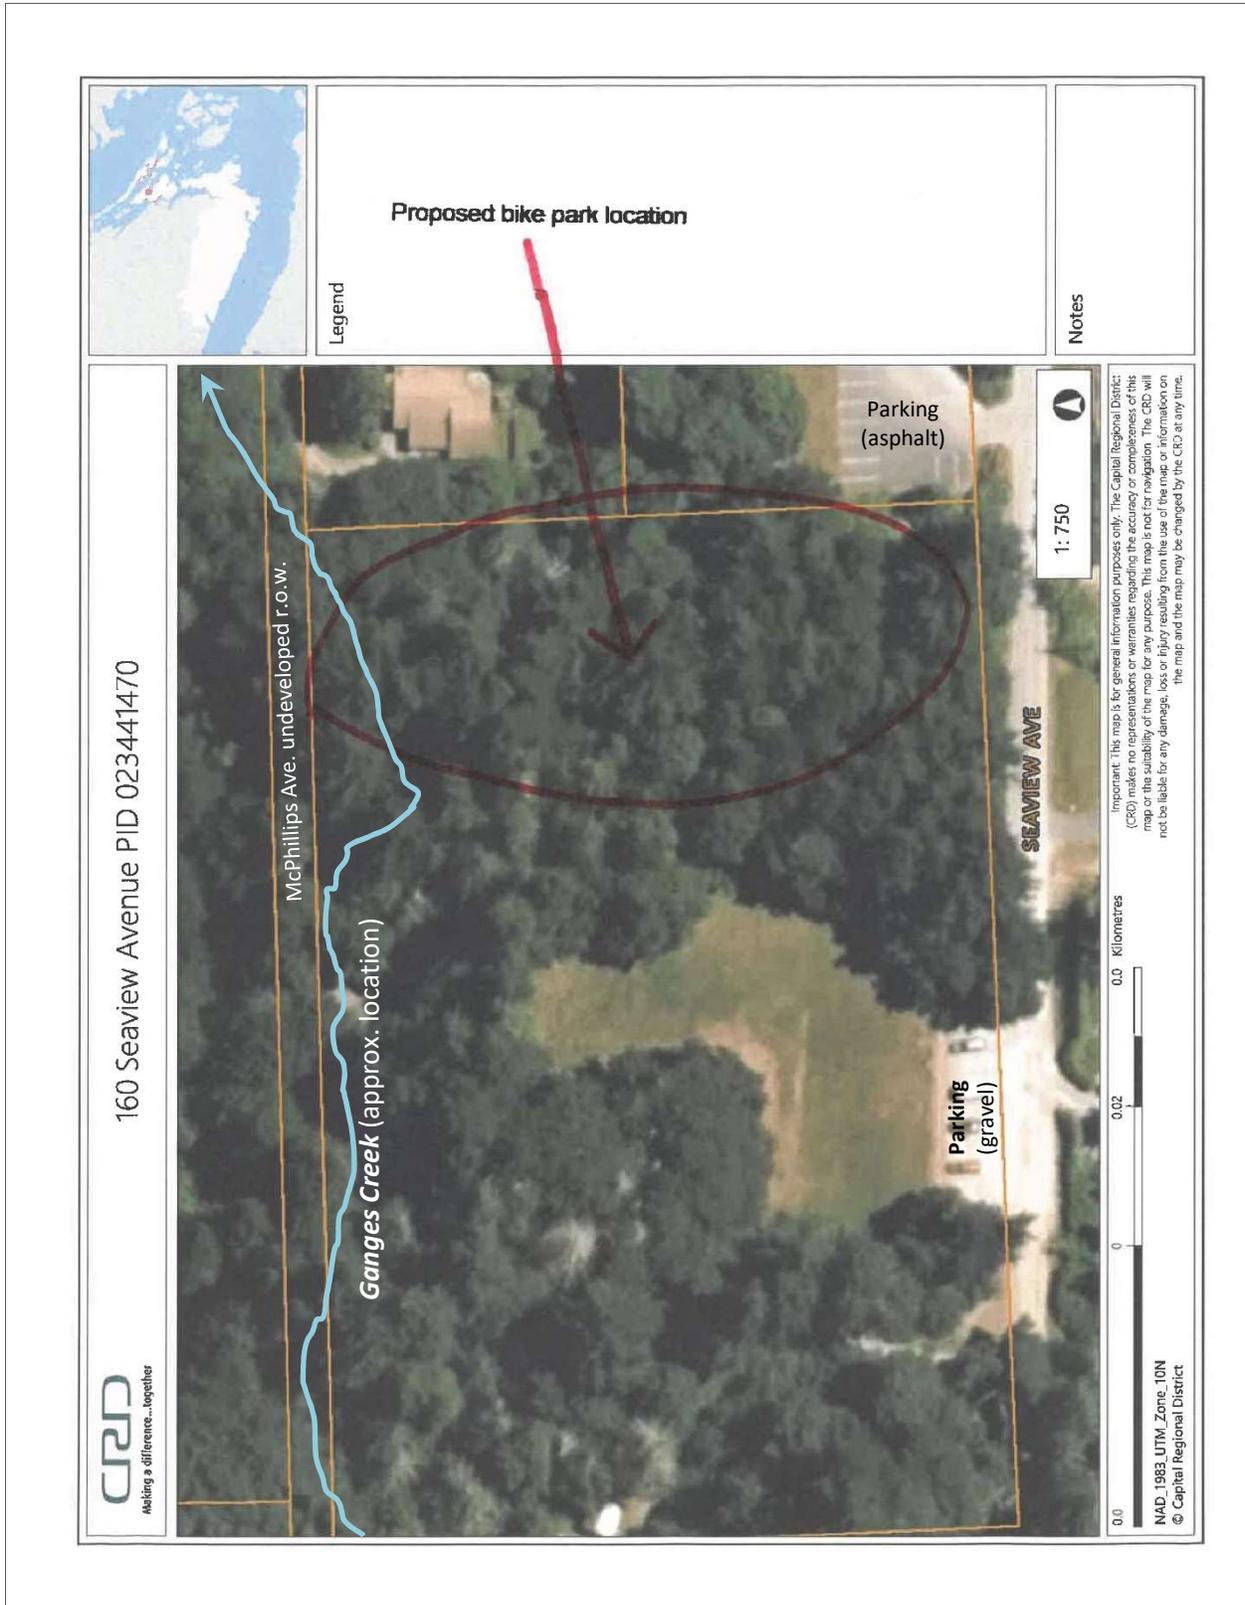
Figure 2. Location of the Proposed Bike Park at 160 Seaview Avenue (adapted from image provided by CRD staff.)

The study area is shown in Figure 2. The field reconnaissance was completed on October 19th 2017 during rainy weather. Deciduous vegetation was entering dormancy and, as a result, many of the smaller foot paths were hidden by recently fallen leaves. Bird and other wildlife activity was minimal due to the season and the rainy weather.

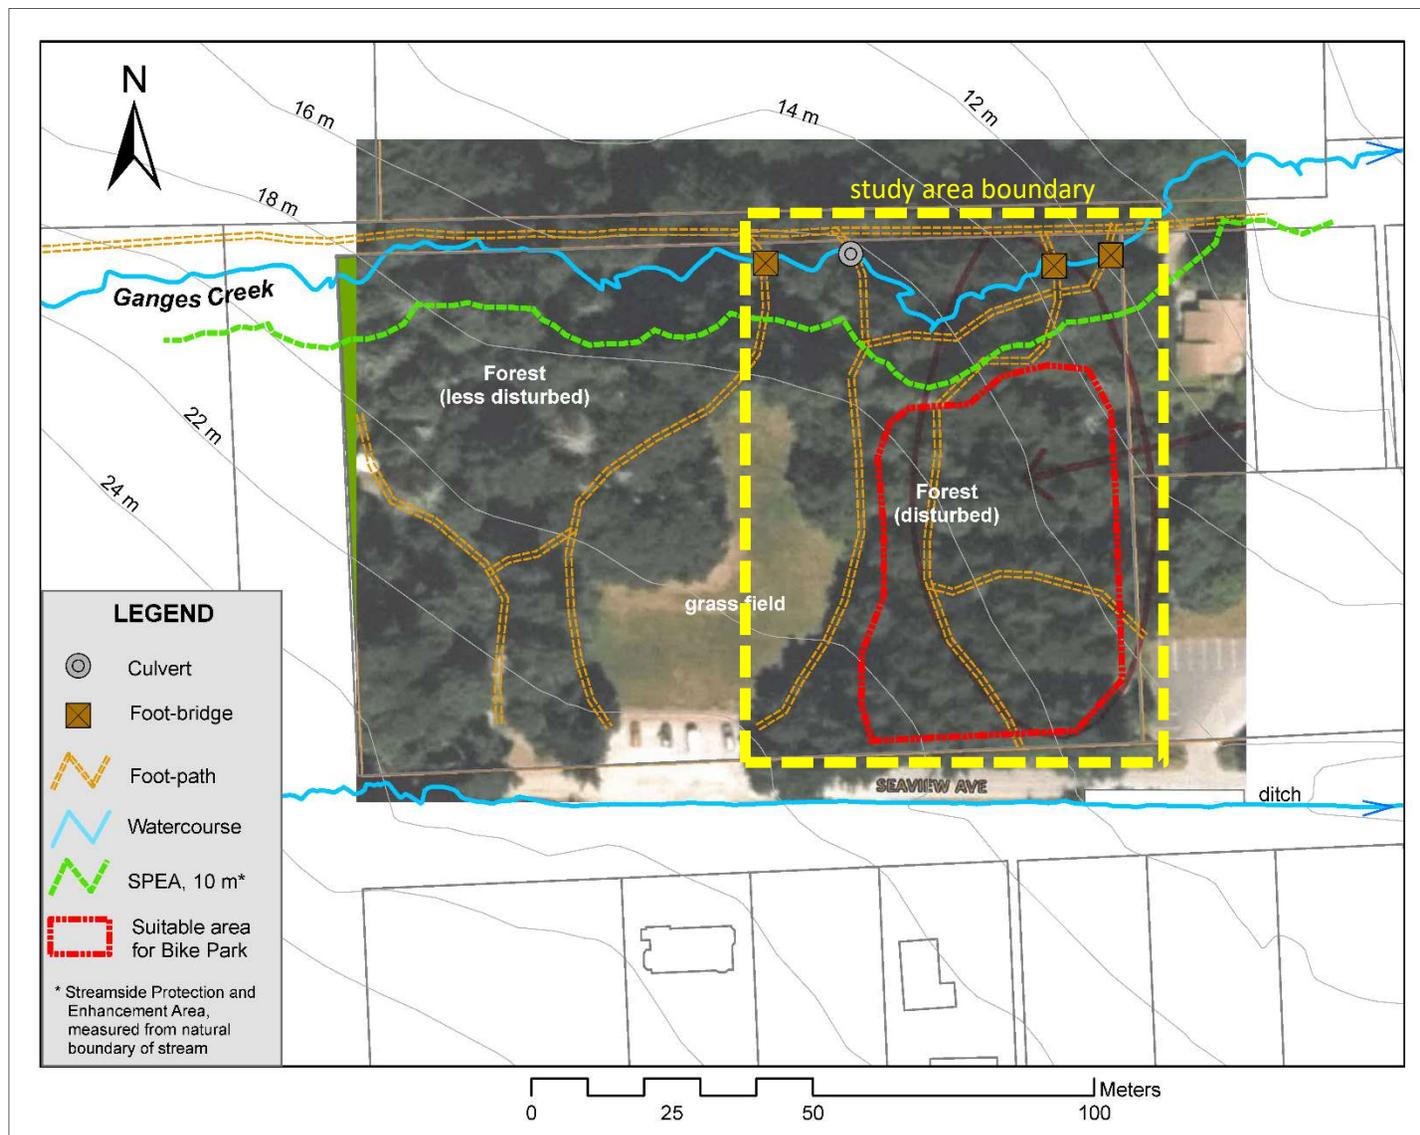
Figure 3. Biophysical Features and Recommended Stream Setback for the Proposed Bike Park at 160 Seaview Avenue.

Base map courtesy of the Islands Trust; air photo provided by CRD. All feature locations are approximate

The property is located in an area of gently sloping terrain that drains to the northeast, to Ganges Creek and Ganges Harbour (Figure 1). The upper part of the study area has an average gradient of approximately 8% increasing to 14% as the land descends towards the northeast corner of the subject lot. According to Islands Trust mapping, the elevation ranges from approximately 22 m to 12 m above sea level (Figure 3).

Accordingly, a riparian assessment of Ganges Creek in the project area was completed, employing the Method stipulated in the RAR. The completed assessment report is appended to this letter. The riparian assessment yielded a SPEA width of 10 m beside Ganges Creek at the project location (Figure 4). This width is, coincidentally, the same as the no-disturbance setback required under DPA 4.

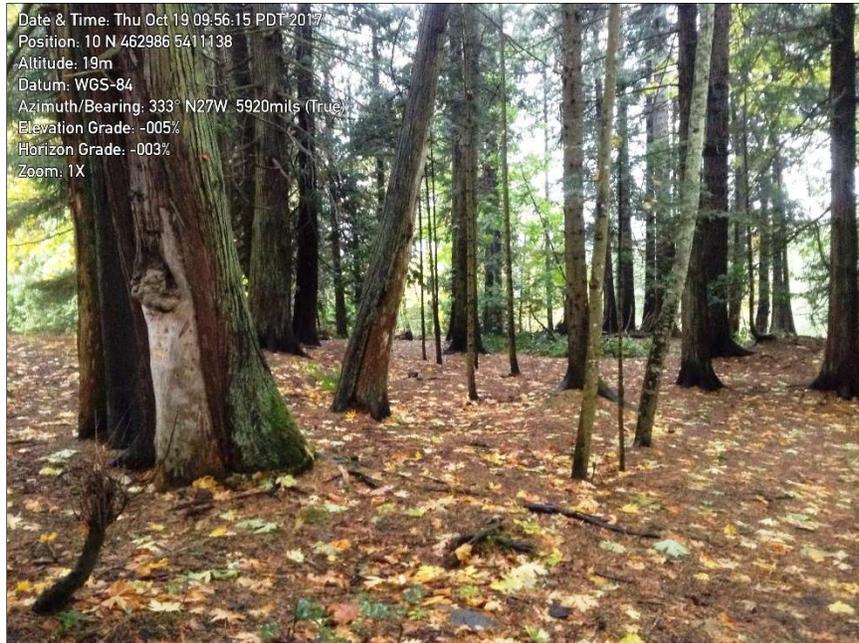
Photo 1. Proposed bike park area at 160 Seaview Avenue viewed to north from east of gravel parking area. Note absence of understory vegetation in much of this forest. 19-Oct-2017

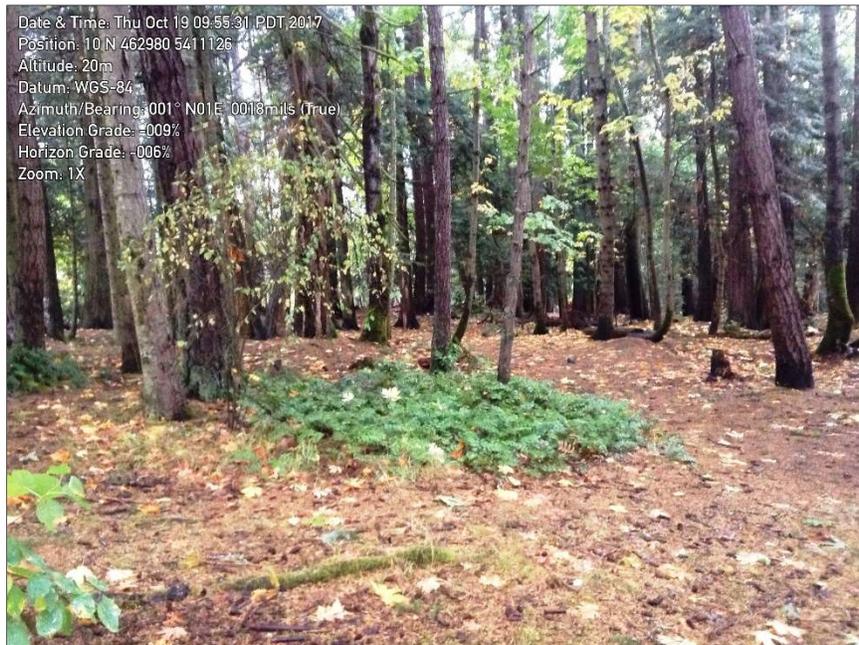
Photo 2. Proposed bike park area viewed to north from near edge of Seaview Avenue. Patch of understory vegetation is Oregon grape. 19-Oct-2017

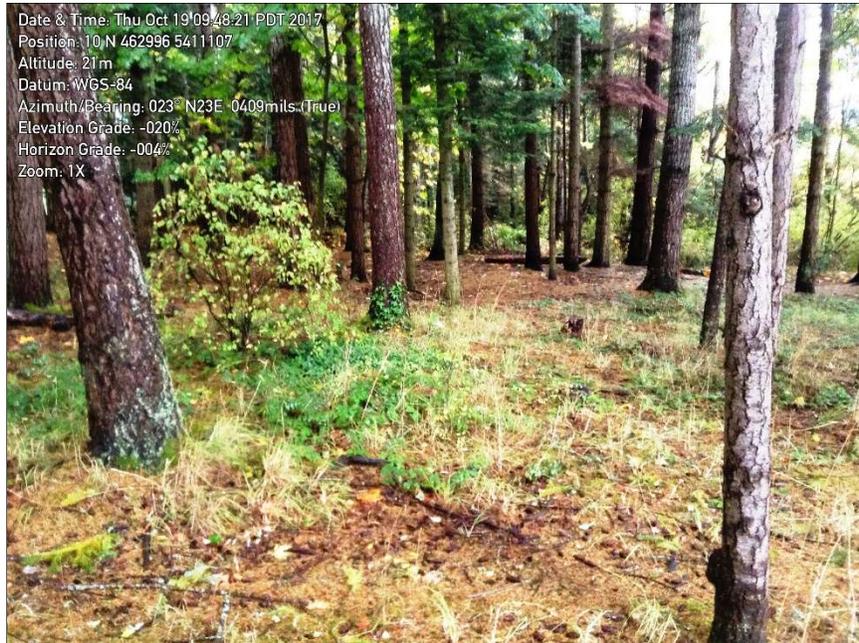
Photo 3. Denser ground vegetation southeast sector of proposed bike park area at 160 Seaview Avenue. 19-Oct-2017

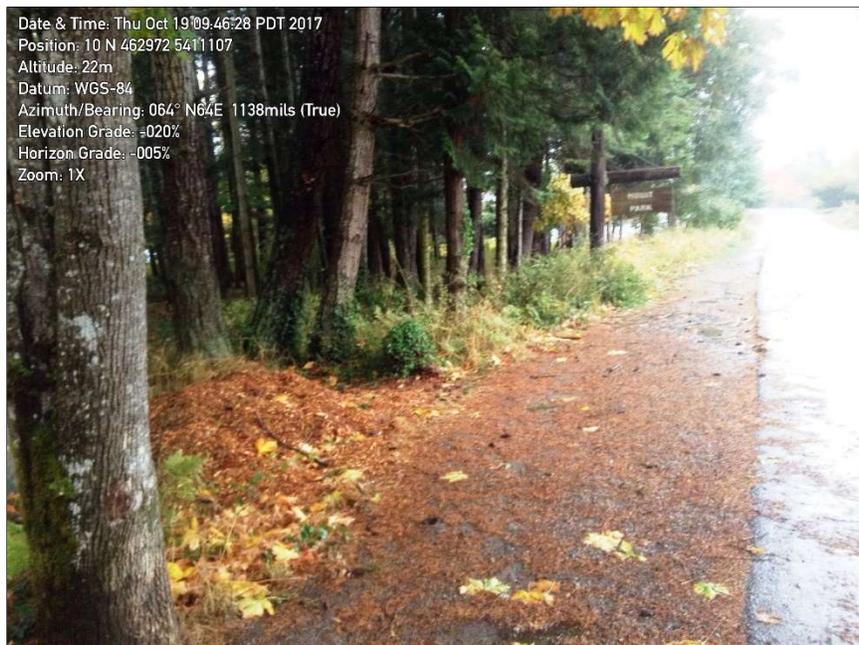
Photo 4. South edge of proposed bike park area viewed to east along Seaview Avenue. Note English ivy growing on tree trunks, and pile of wood-chips. 19-Oct-2017

Invasive plant species observed on the property were identified by reference to online information available from the Salt Spring Island Conservancy (SSC 2017) and the provincial government (Ralph et al. 2014), and are listed in Table 1. The most prominent invasive species were English ivy (Photo 16) and Himalayan blackberry. One plant of spurge laurel (Photo 18) was also observed. In general, the surface area affected by invasive plant species within the proposed bike park zone was limited to the outer edges, with the exception of English ivy in the east-central part of the study area.

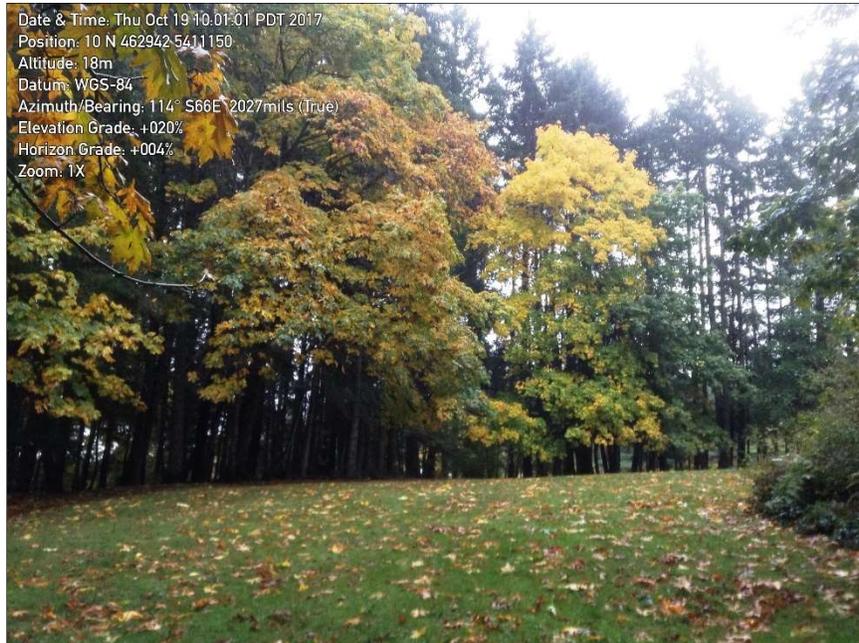
Photo 5. Eastern edge of proposed bike park area (in forest) viewed from north end of grassy field. 19-Oct-2017

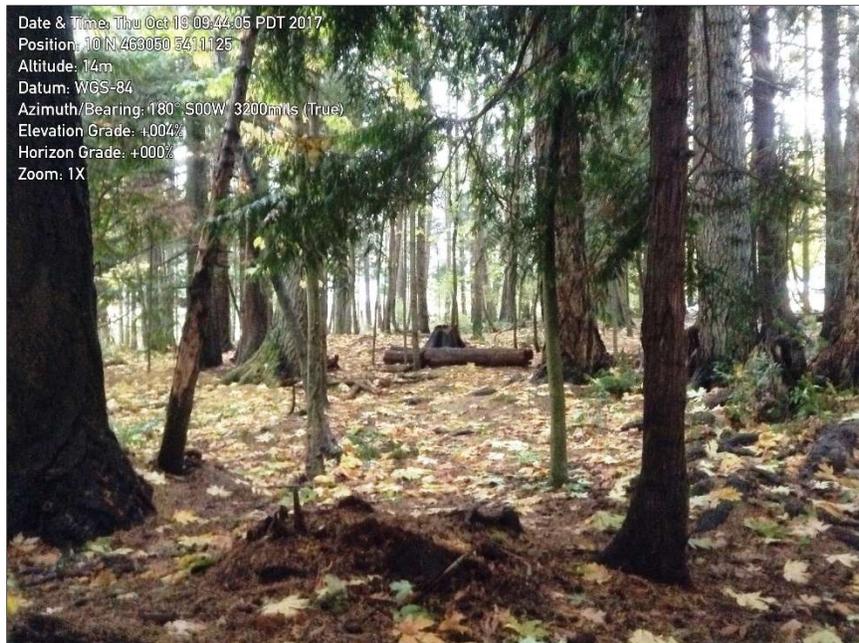
Photo 6. Northern sector of proposed bike park area viewed to south from near Ganges Creek. Note varied trunk diameters, and leaning dead tree. 19-Oct-2017

- d. Ensure that healthy trees are protected during the removal of any danger trees. This recommendation is especially important for the riparian corridor within 10 m of Ganges Creek, and also applies to other areas within the bike park.

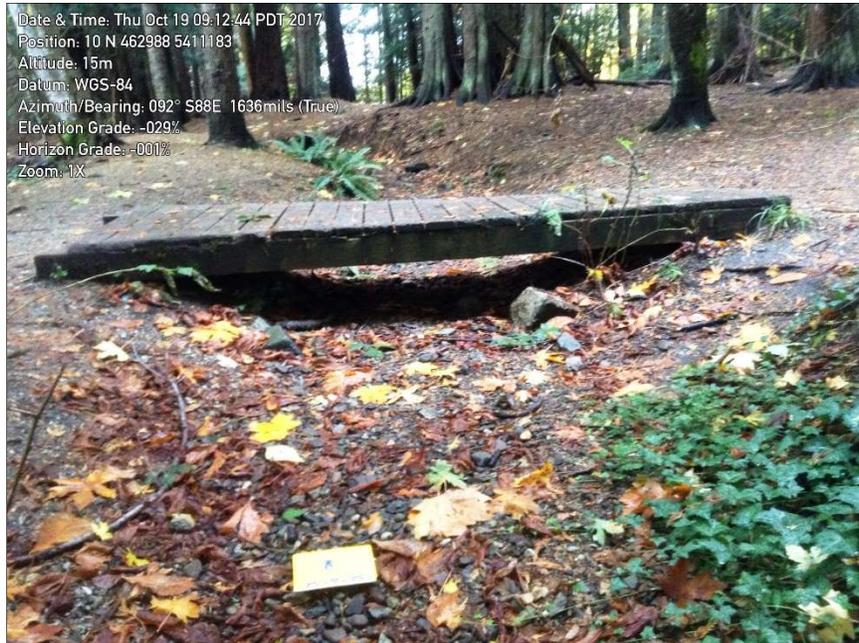
Photo 7. Dry channel of Ganges Creek on area of shallow gradient, viewed downstream toward uppermost foot bridge. Note sparse swordfern beside channel on left and English ivy on right. 19-Oct-2017

No areas of flowing or standing water were observed on the date of inspection, despite rainy weather. The channel of Ganges Creek was entirely dry; however, CRD staff indicated that water depth in the channel can increase to approximately 0.3 m in places during periods of peak flow (Kirk Harris, personal communication). Also, a permanent spring, which likely contributes significant water to the creek during the summer months, is reported to exist on Ganges Creek in the adjacent lot to the north, approximately opposite the upper end of McPhillips Avenue (Kathy Reimer, Personal communication); this spring is outside of the bike park project area.

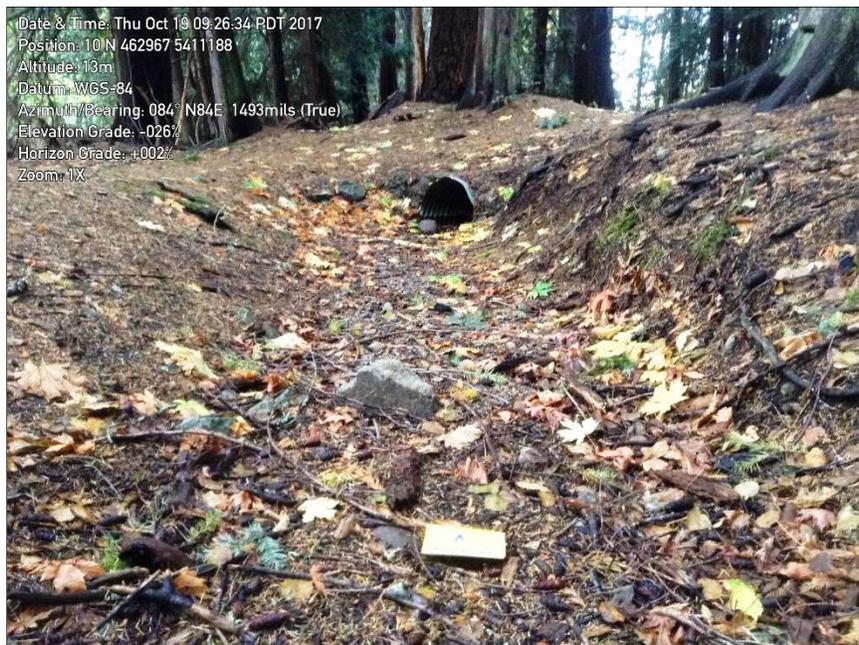
Photo 8. Dry channel of Ganges Creek viewed downstream toward culvert. Culvert was reportedly installed to protect an archaeological site (midden, see text). Note absence of riparian ground vegetation. 19-Oct-2017

Existing development in the study area, which is forested, is limited to a network of unsurfaced pathways, one culvert and three wooden foot-bridges across the channel of Ganges Creek. The 36-inch diameter metal culvert is reported to have been installed to protect a midden discovered at the time the channel was being excavated (Kathy Reimer, personal communication). The remains of old concrete platforms (slabs on grade) were also observed in the area; these are reported to have been built when the area was a former provincial park. There are two parking areas along Seaview Avenue: one to the east beside the community lands parcel, and the other to the west of the proposed bike park opposite a small grassy area within the subject lot. Wooden fencing was present along much of the east property boundary, and wire fencing in variable states of repair was present along the north boundary.

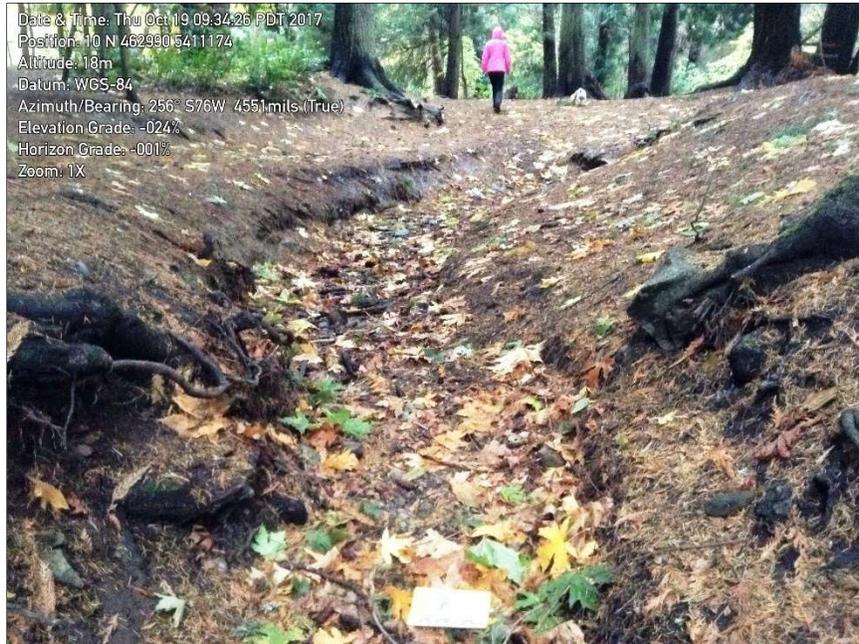
Photo 9. Dry channel of Ganges Creek viewed upstream toward culvert outlet (arrow). Proposed bike park area is to left of photo. The RAR assessment yielded a no-disturbance setback (streamside protection and enhancement area 10 m wide on either side of the stream channel – see text). 19-Oct-2017

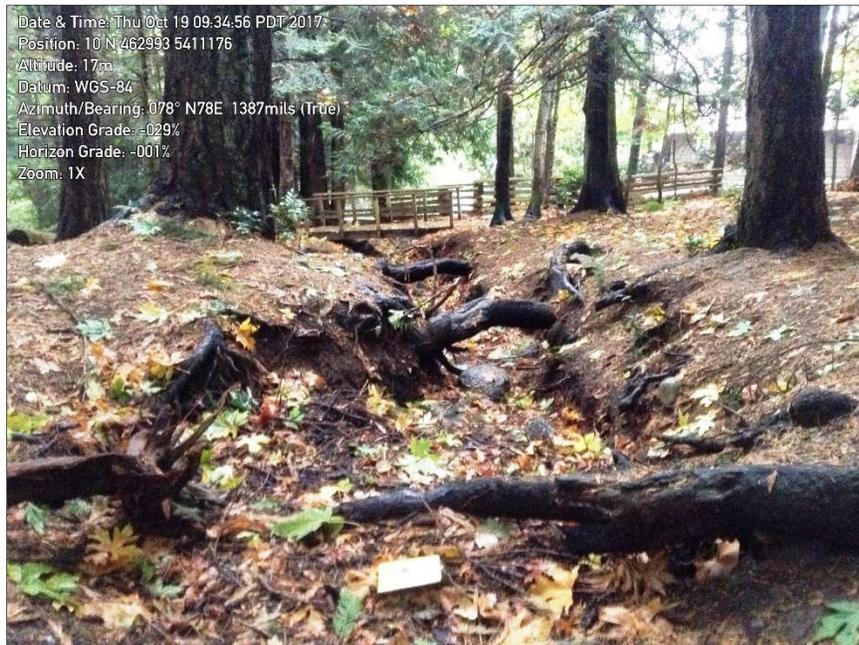
Photo 10. Dry channel of Ganges Creek viewed downstream toward second foot bridge. Note exposed large roots of Douglas-fir trees; these roots were exposed (and protected) when the channel was excavated many years ago. Proposed bike park area is to right of photo. The RAR assessment yielded a no-disturbance setback (streamside protection and enhancement area 10 m wide on either side of the stream channel – see text). 19-Oct-2017

- e. When designing features of the bike park, ensure that the root systems and trunks of local trees are protected. To this end, seek the advice of a professional arborist to ensure that the bike course remains sufficiently far away from the trunks to prevent direct damage to exposed roots, and to prevent localized soil erosion and/or compaction that may adversely affect the roots and health of the trees. Excavation that exposes roots should be avoided, and placement of fill should be limited. Where it may be desirable for bike park features to be very close to trees, it is preferable that the course is elevated on a constructed platform.

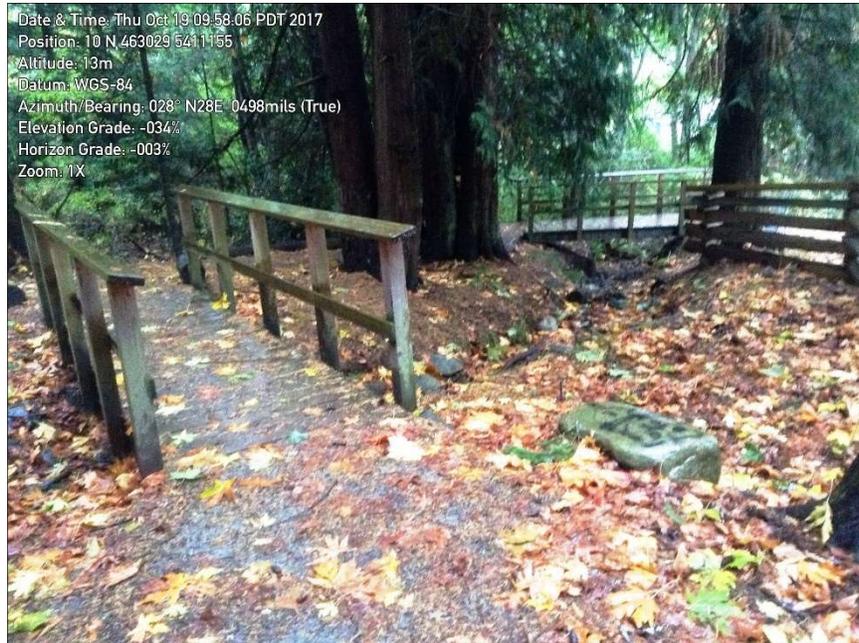
Photo 11. Second (left) and third foot-bridges Ganges Creek in northeast corner of study area, viewed downstream. Third foot-bridge leads to trailhead at McPhillips Road. 19-Oct-2017.

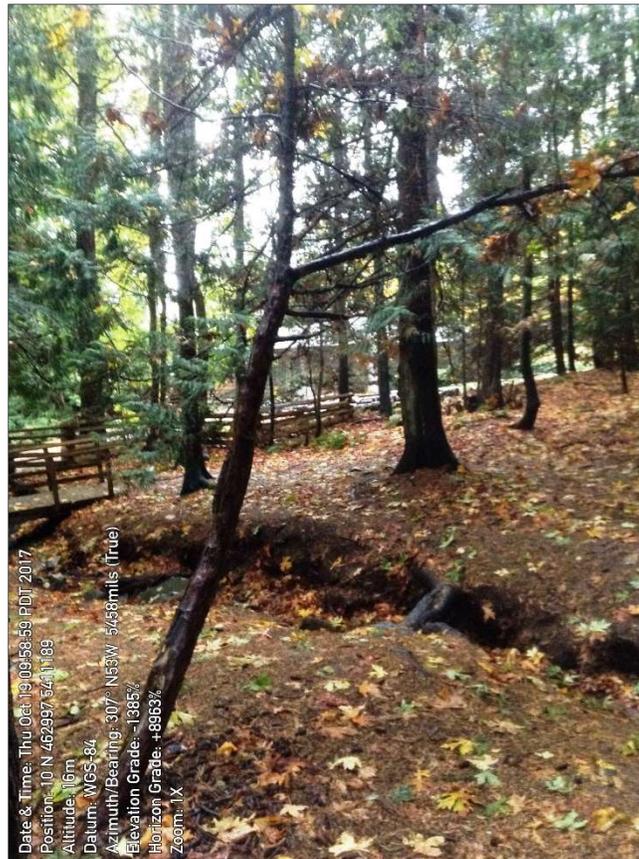
Photo 12. Wooden fence line along east side of subject lot viewed across Ganges Creek from trail along north property line. Small tree in foreground is a yew. 19-Oct-2017

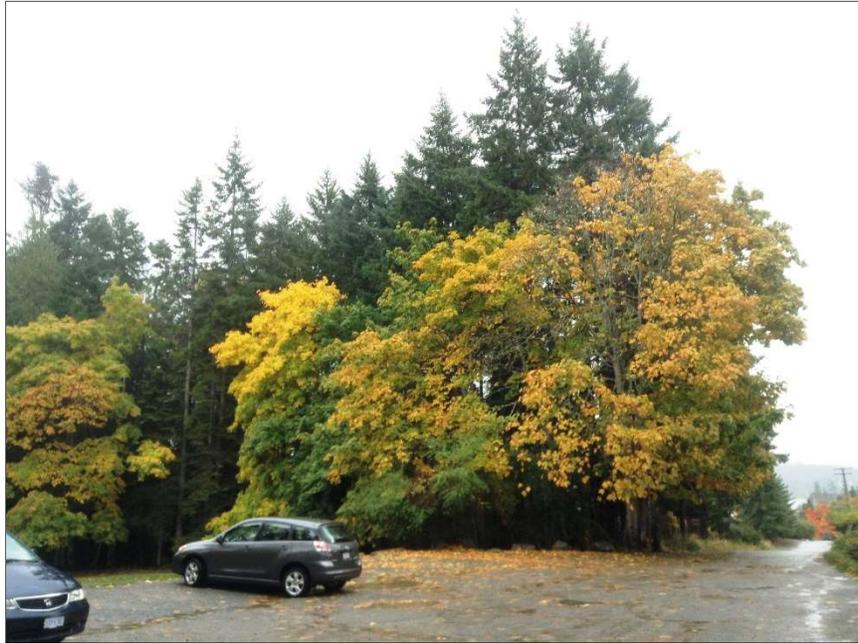
Photo 13. Southwest part of proposed bike park (in forest) viewed from parking area beside grassy field. Seaview Avenue is on right. Dominant conifers are Douglas-fir, while bigleaf maple are visible in foreground. 19-Oct-2017

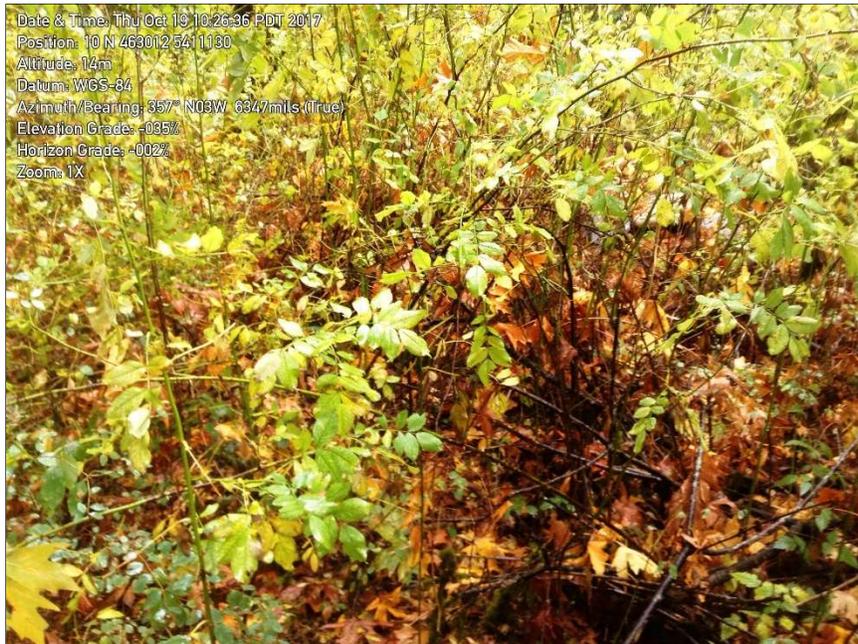
Photo 14. Thicket of Nootka rose in understory of open forest on east side of study area. 19-Oct-2017

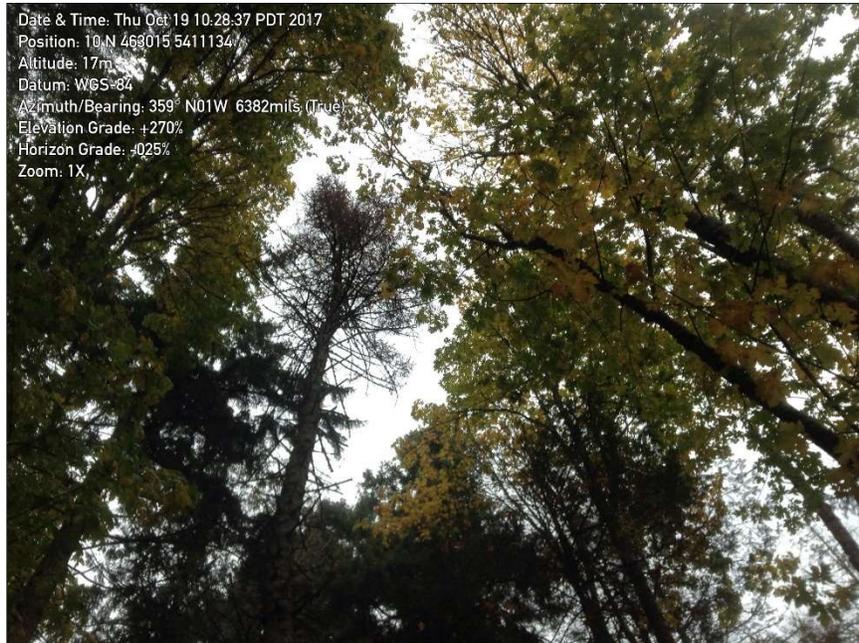
Photo 15. Standing dead tree (grand fir) in northeastern sector of study area. 19-Oct-2017

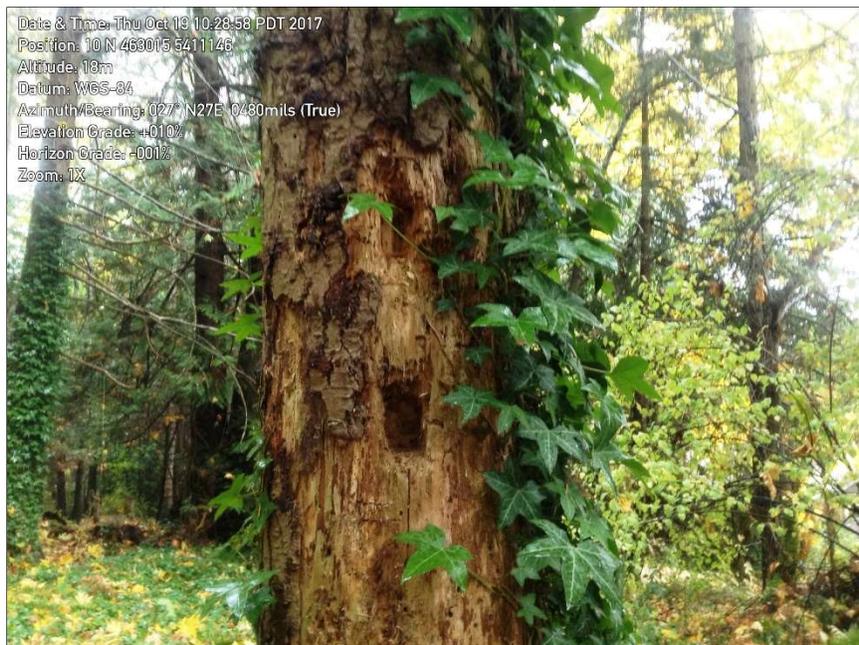
Photo 16. Cavity created by feeding Pileated Woodpecker in standing dead tree (grand fir) in northeastern sector of study area. Note English ivy on trunk. 19-Oct-2017.

Three bird species only were observed during the reconnaissance: Pileated Woodpecker, Steller's Jay and Common Raven. A possible long-abandoned Bushtit nest (Photo 17) was found in the southeast corner of the lot; no other bird nests were observed. Some of the grand fir snags contained cavities that may be used for nesting or roosting by bats, smaller birds (e.g., Chickadees, Red-breasted Nuthatch and others) and, to a lesser extent, by larger species such as woodpeckers and owls (Photo 16). No hawk, owl or heron nests were found in the trees on the property.

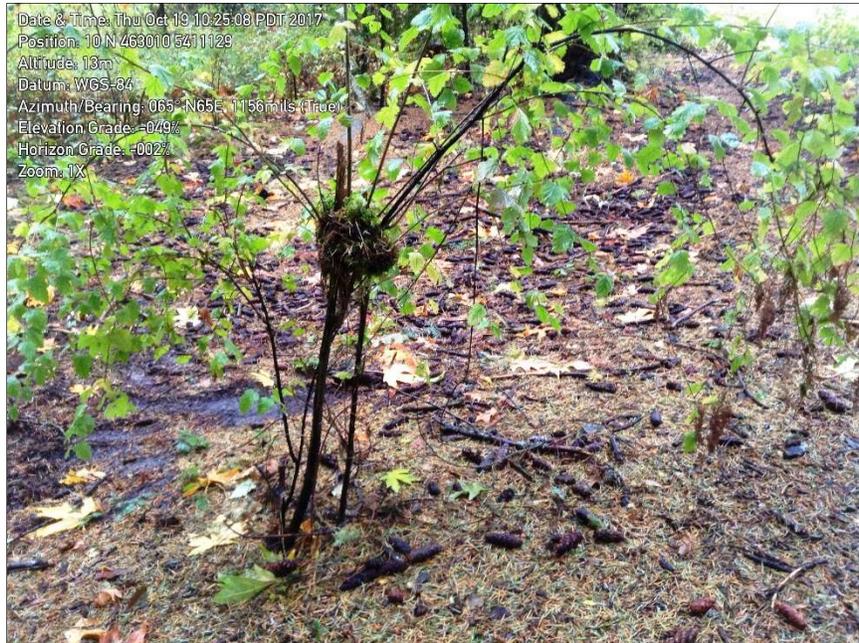
Photo 17. Bird nest (long abandoned) in oceanspray shrub in southeast sector of study area. 19-Oct-2017

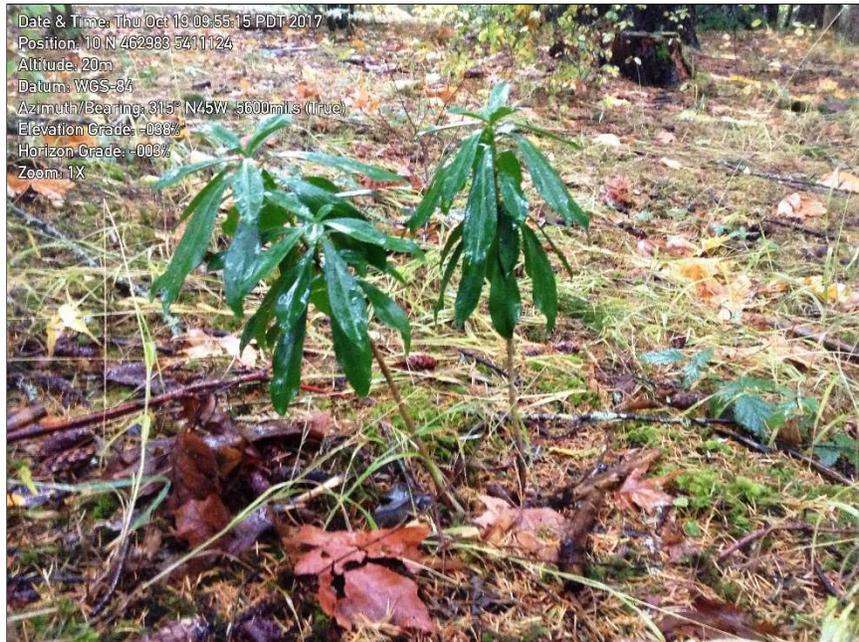
Photo 18. Spurge laurel plant (toxic invasive species) in southern part of study area. 19-Oct-2017
