Capital Regional District

Notice of Meeting and Meeting Agenda Lyll Harbour Boot Cove Water Local Service Committee

Thursday, June 27, 2024

**MONEY LAKE DAM - 2022 DAM SAFETY REVIEW
SITE LOCATION PLAN**

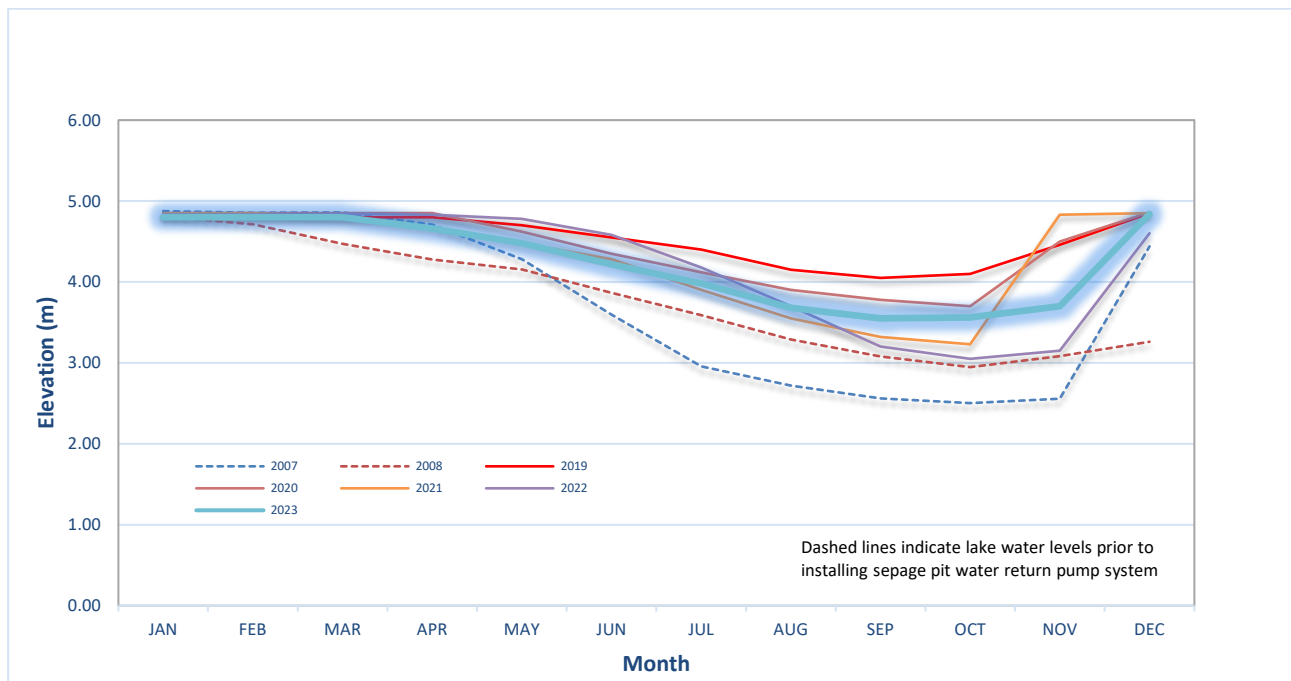
Figure 2: Money Lake Monthly Water Level

Referring to Figure 2 below, Money Lake monthly water levels are highlighted for 2023. It is important to note that water supply levels in Money Lake, prior to 2008, were historically lower during the summer period. An upgrade to mitigate the low water levels involved the installation of a groundwater seepage spring recirculation pumping system. Excess water from the seepage spring is pumped back to Money Lake to keep the Lake as full as possible. The groundwater seepage spring water level is not monitored; however, the seepage spring weekly flow rate is monitored to confirm production rate. The seepage spring typically provides 100% of the winter water system demand for the community. Money Lake water is used periodically to supplement seepage spring flows, typically during the summer dry period.

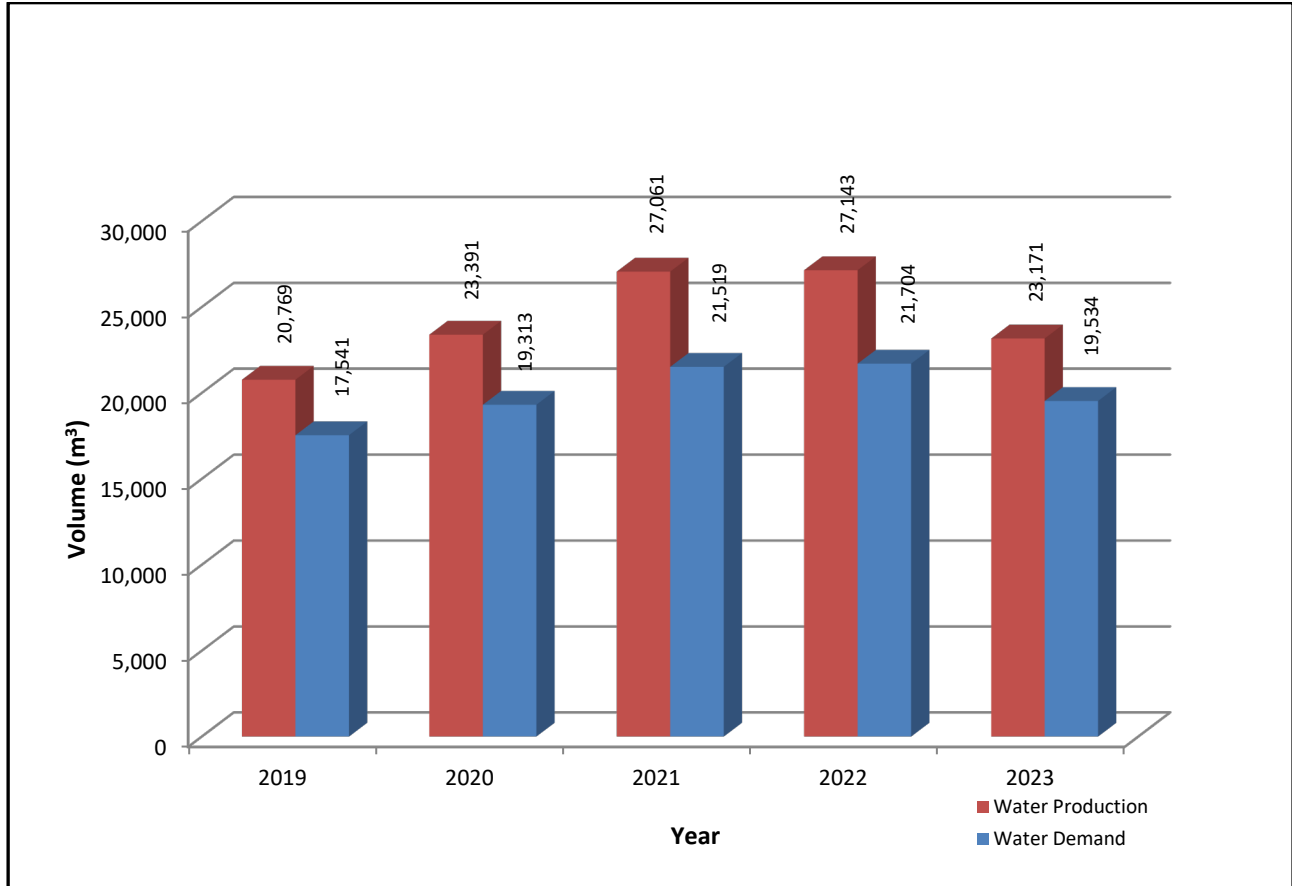
Figure 3: Lyall Harbour/Boot Cove Water System Annual Water Production and Demand

Referring to Figure 3, 23,171 cubic meters of water was extracted (water production) from the seepage spring and Money Lake Reservoir in 2023; a 15% decrease from the previous year and a 7% decrease from the five-year average. Water demand (customer water billing) for the service totaled 19,534 cubic meters of water; 10% decrease from the previous year and an 1% increase from the five-year average.

The difference between annual water production and annual customer demand is referred to as non-revenue water and can include water system leaks, water system maintenance and operational use (e.g. water main flushing, filter system backwashing), potential unauthorized use and fire-fighting use.

The 2023 non-revenue water (3,637 cubic meters) represents about 16% of the total water production for the service area. However, almost 14% of the non-revenue water can be attributed to operational use which includes water main flushing to keep chlorine residuals at acceptable levels at the extremities of the water system and water treatment filtration system backwashing activities. Therefore, the non-revenue water associated with system losses is approximately 2% which is considered acceptable for small water systems.

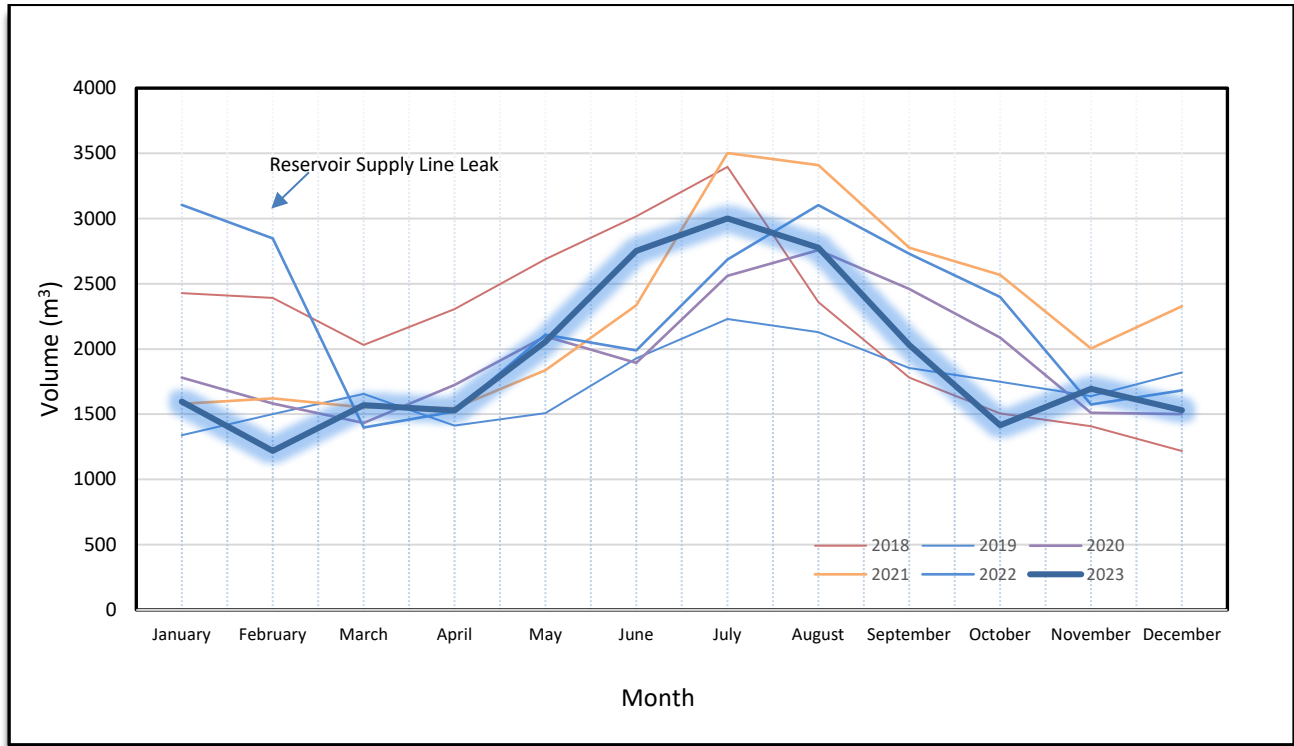
Figure 4: Lyall Harbour/Boot Cove Water Service Monthly Water Production

Figure 4 illustrates the monthly water production for 2023 along with the historical water production information. The monthly water production trends are typical for small water systems such as the Lyall Harbour/Boot Cove water system.

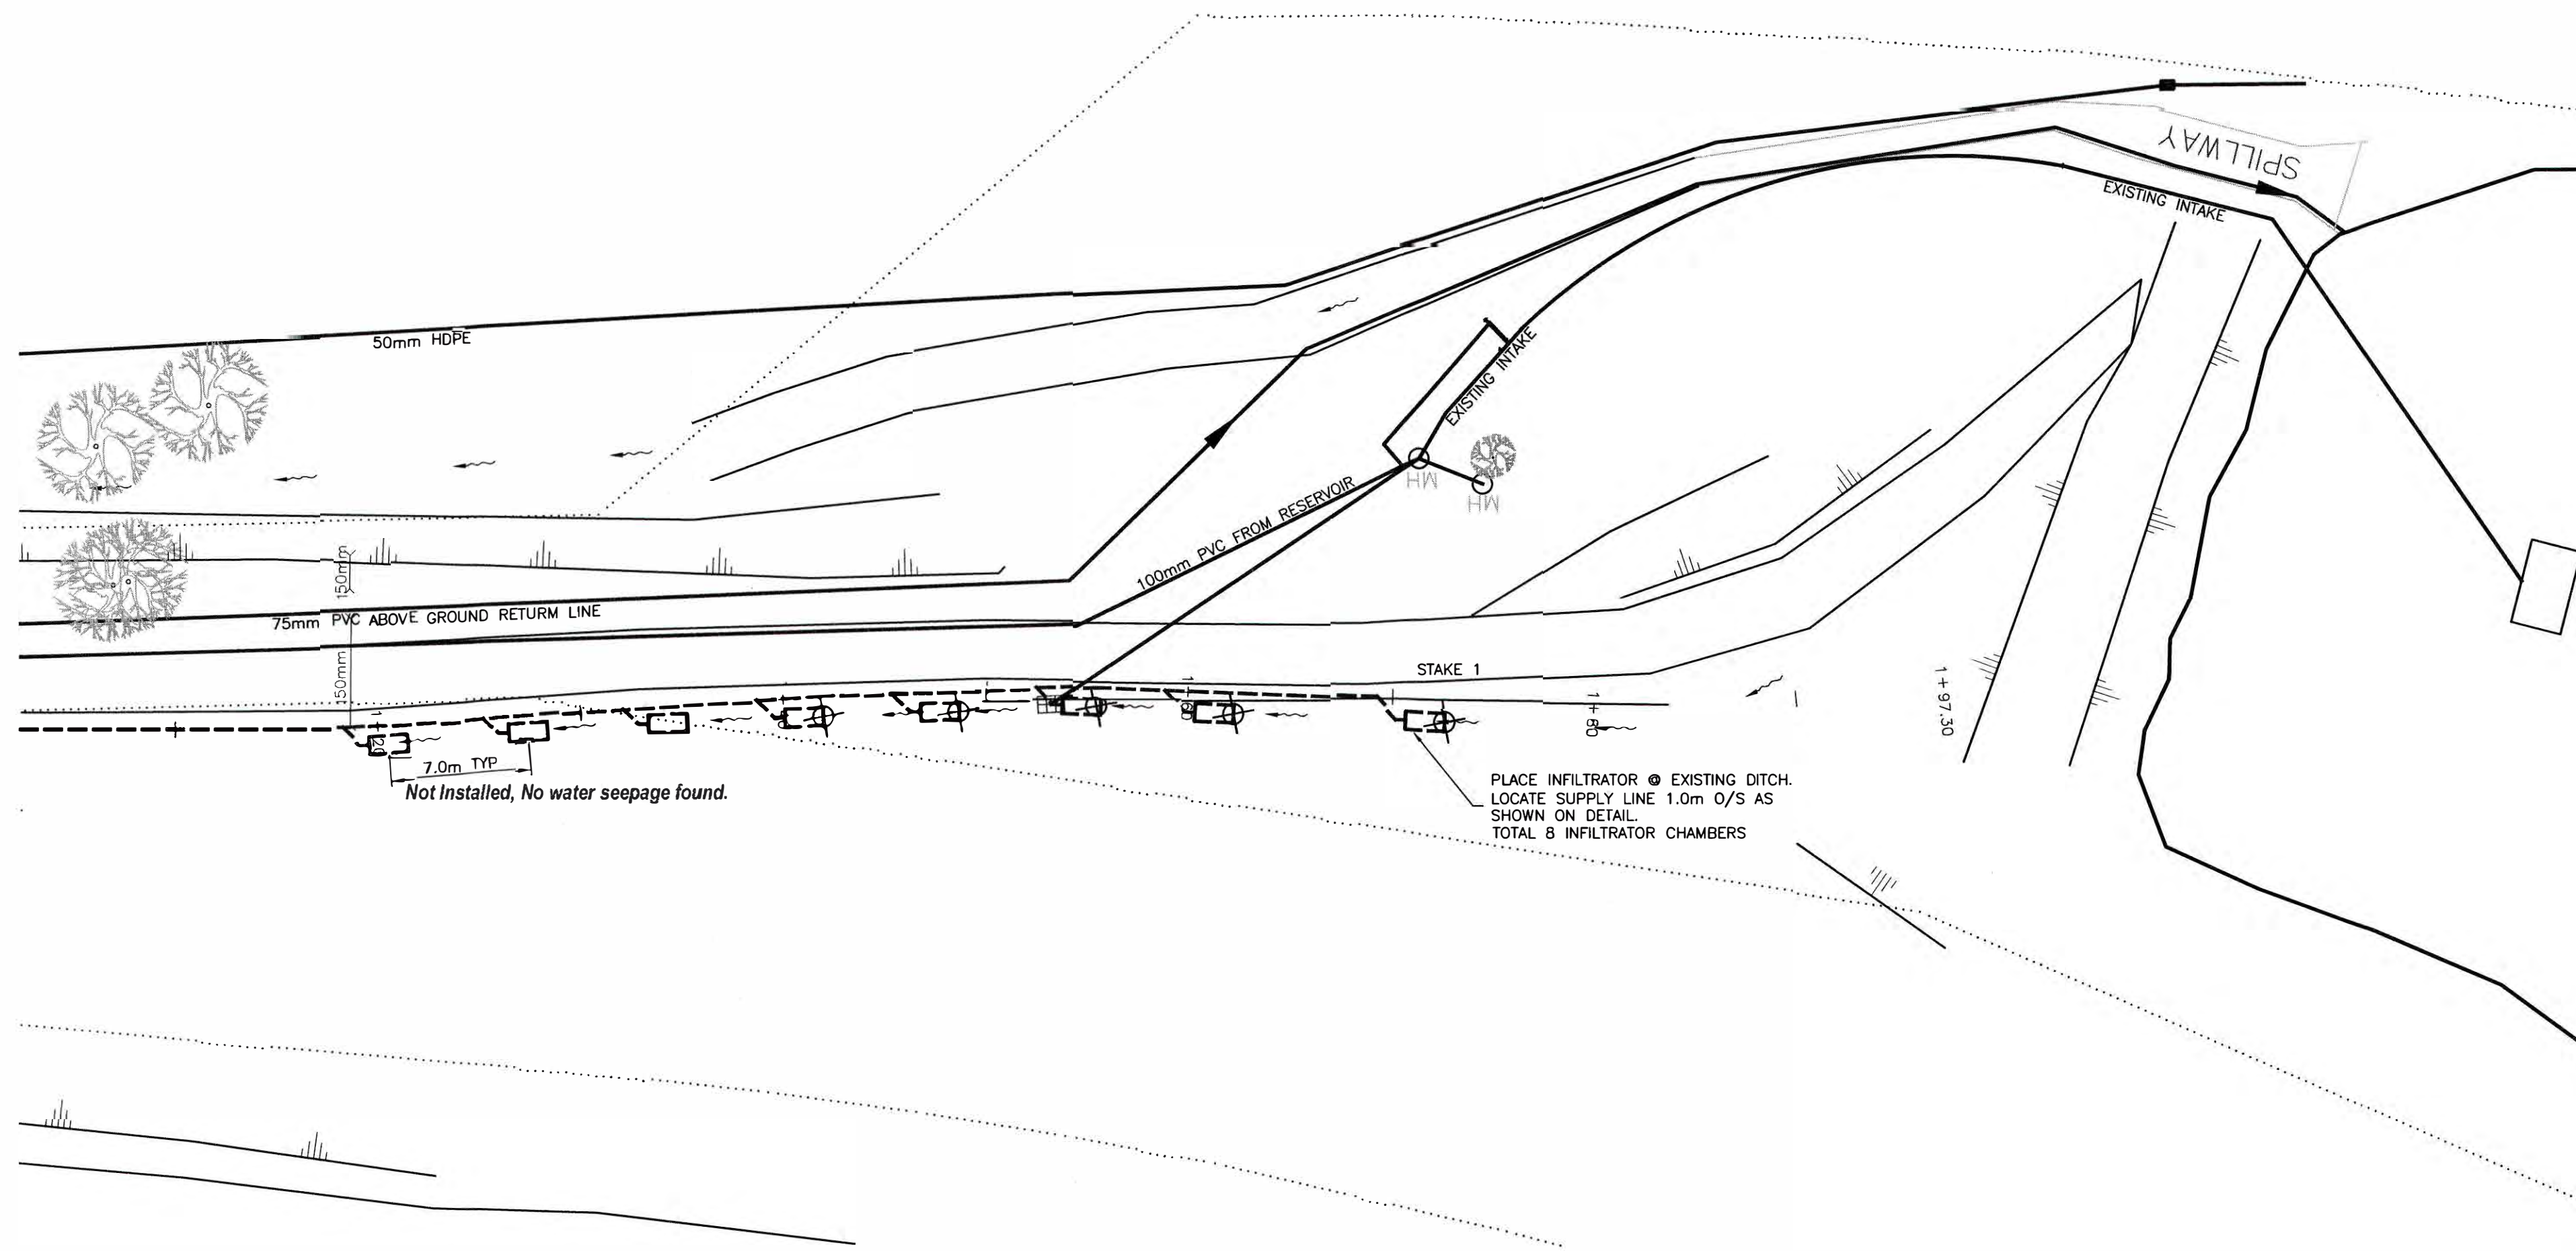
LYALL HARBOUR BOOT COVE
MONEY LAKE DAM
PIPEWORK SCHEMATIC

2. DURING PREVIOUS SITE INSPECTIONS MANHOLE No.1 (MH1) HAS BEEN OBSERVED TO HAVE CLEAR WATER FLOWING FROM THE LID.
3. PIPE A IS A 300mm ϕ CSP THAT CONNECTS MH1 AND MH2. MH1 & PIPE A WERE INSTALLED IN 1979 PRIOR TO THE INSTALLATION OF MH2.

4. PIPE B. THERE ARE NO RECORD DRAWINGS SHOWING DETAILS REGARDING PIPE B, HOWEVER THIS PIPE SHOWS UP ON HAND DRAWN RECORDS DATED JAN 84. ACCORDING TO RICHARD EDWARDS, P.ENG. PIPE B WAS INSTALLED TO ACT AS AN OVER-FLOW FROM MH1 TO THE DITCH WHERE THE INFILTRATORS NOW ARE LOCATED. ACCORDING TO JOSEPH MARR, P.ENG., AT THE TIME OF THE INSTALLATION OF THE INFILTRATORS THE CATCH BASIN THAT WAS AT THE DITCH WAS REMOVED, FILTER CLOTH COVERED THE OPEN PIPE AND DRAIN MATERIAL WAS PLACED AROUND THE END OF THE PIPE.

5. PIPE C IS A 300mm ϕ CSP DRAIN THAT RUNS FROM EITHER MH1 OR MH2. NO RECORDS FOR THIS PIPE. THE END IS VISIBLE IN THE SPILLWAY CHANNEL AND IS IN VERY POOR CONDITION. THERE WAS NO VISIBLE WATER AT THE CHANNEL END AT THE TIME OF INSPECTION. ACCORDING TO RICHARD EDWARDS THIS PIPE MAY HAVE BEEN CRUSHED.

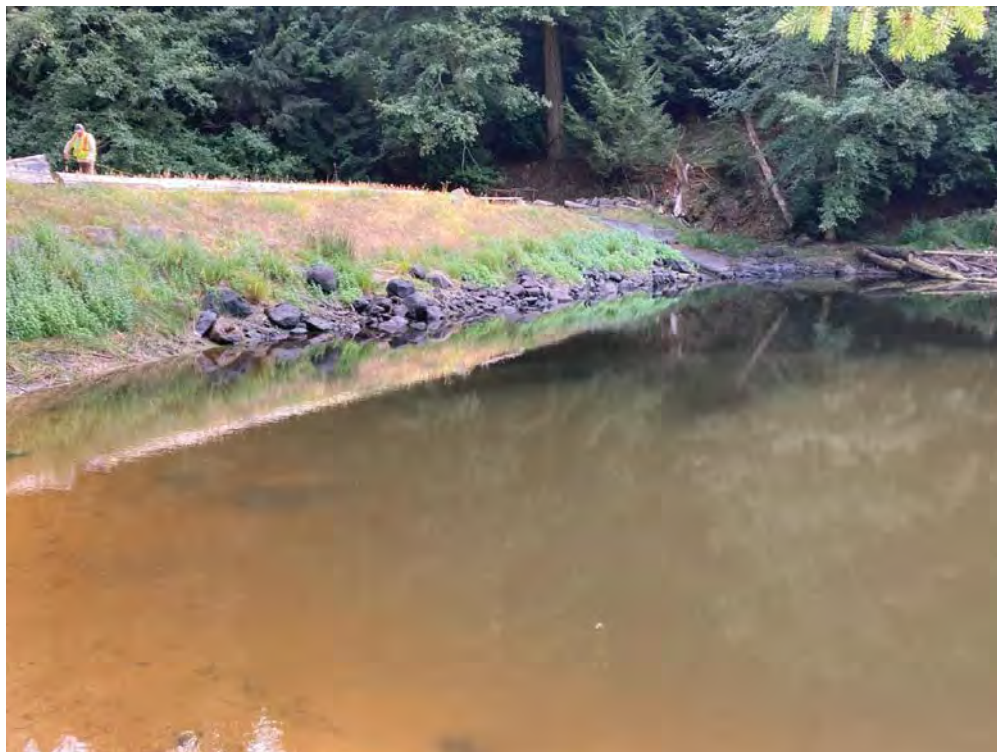
Photo 6: Looking northeast at upstream slope of dam from left abutment area. (2022-08-31, JDM).

Item No.	Observation	Comment	Action Required	Photo No.
1.	Upstream Slope			
1.1	Approximate Slope Angle	~2H to 1V to water line		11
1.2	Vegetation	Grass – needs trimming		11
1.3	Slope Protection	Riprap extending most of the way across upstream slope from spillway		6
1.4	Erosion	Very minor beaching at full supply elevation – no concern		
1.5	Evidence of Slides	Minor rockfall apparent on slope upstream of left abutment		5
1.6	Evidence of Cracking	No		
1.7	Bulges / Depressions	None observed on slope. Small sinkhole located above reservoir level upstream of dam's left abutment. Likely related to collapse in buried talus.	Mo – monitor sinkhole for changes	5
1.8	Burrows / Ruts	No		
1.9	Other Concerns	No		
2.	Crest			
2.1	Accessibility	From ramp crossing downstream slope. No issues		13, 15
2.2	Vegetation	Grass – needs trimming		12
2.3	Evidence of Overtopping	No		
2.4	Evidence of Settlement	No

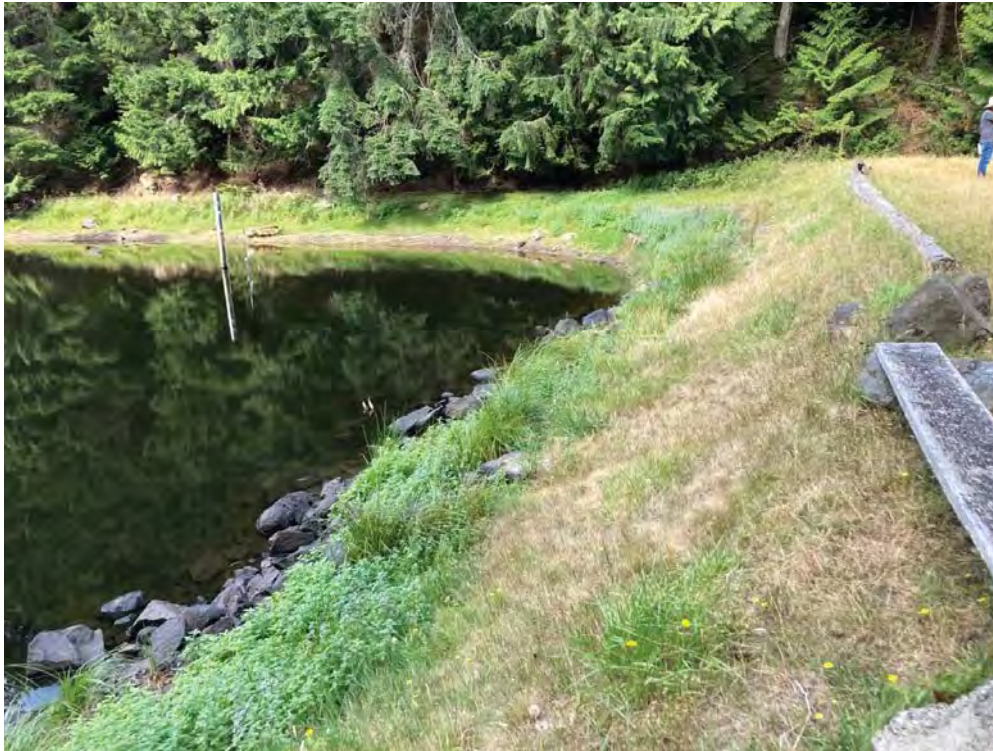
Photo 11: Upstream slope of dam from right abutment. (2022-08-31, JDM)

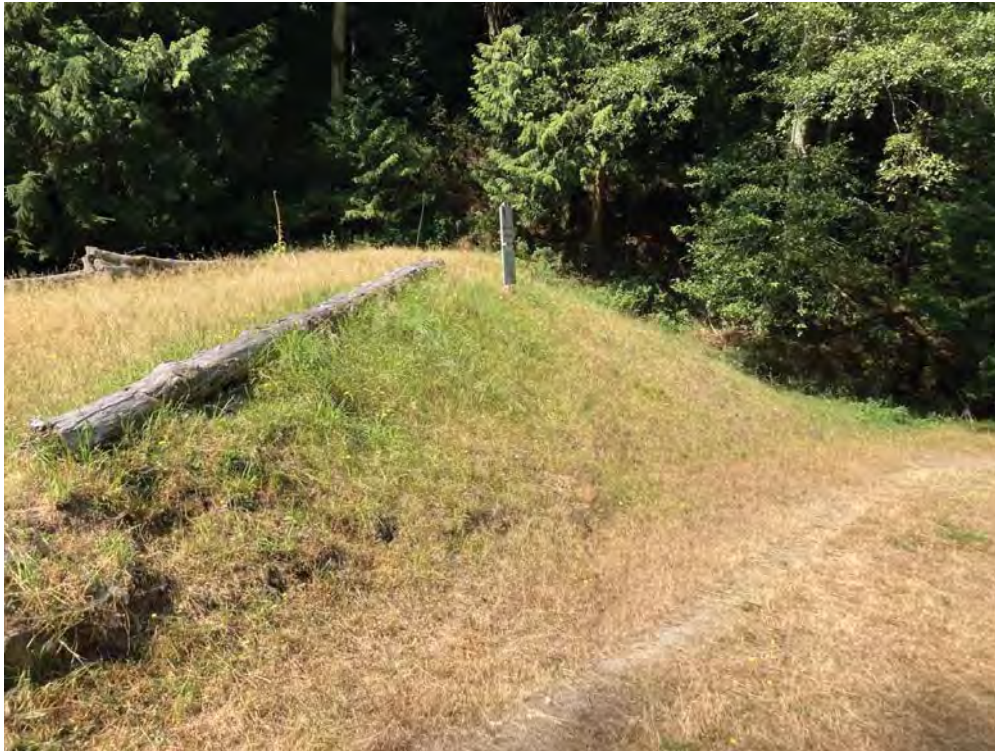
Photo 13: Downstream slope. (2022-08-31, JDM)

2.5	Evidence of Cracking	No		
2.6	Burrows, Ruts	No		
2.7	Concrete Barrier Condition	n/a		
2.8	Other Concerns	No		
3.	Downstream Slope			
3.1	Approximate Slope Angle	~2H:1V, but variable given ramp		13

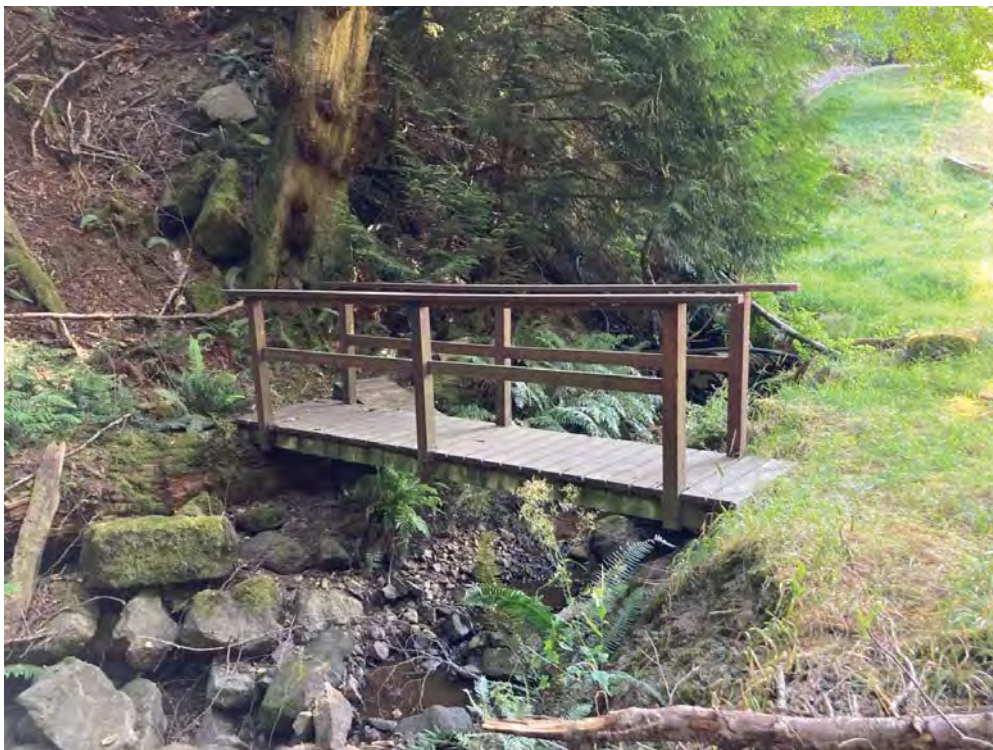
Photo 16: Pedestrian bridge downstream of spillway. Limited armour protection. (2022-08-31, JDM).

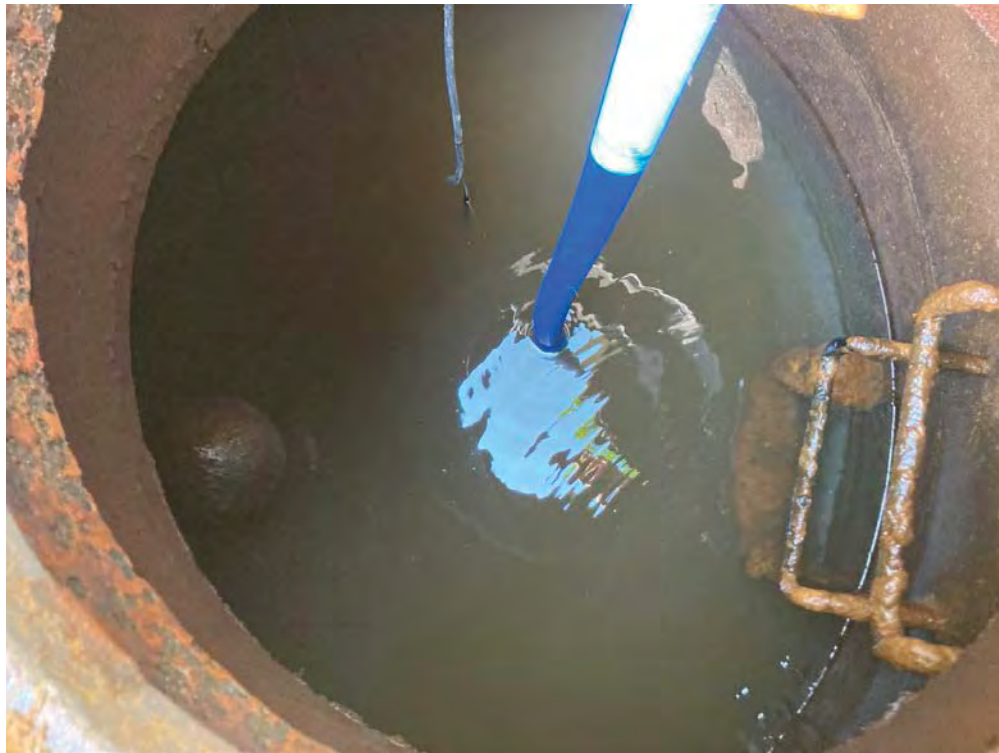
Photo 17: Interior of MH1 after partial lowering of water level using pump. (2022-08-31, JDM)

4.2	Quantity	Some of the standing water in MH1 pumped out using electric pump.		17
4.3	Sediment in Flow	Water pumped out of MH1 appeared cloudy. Sediment observed in base of MH2.	E – toe filter study underway	20, 21

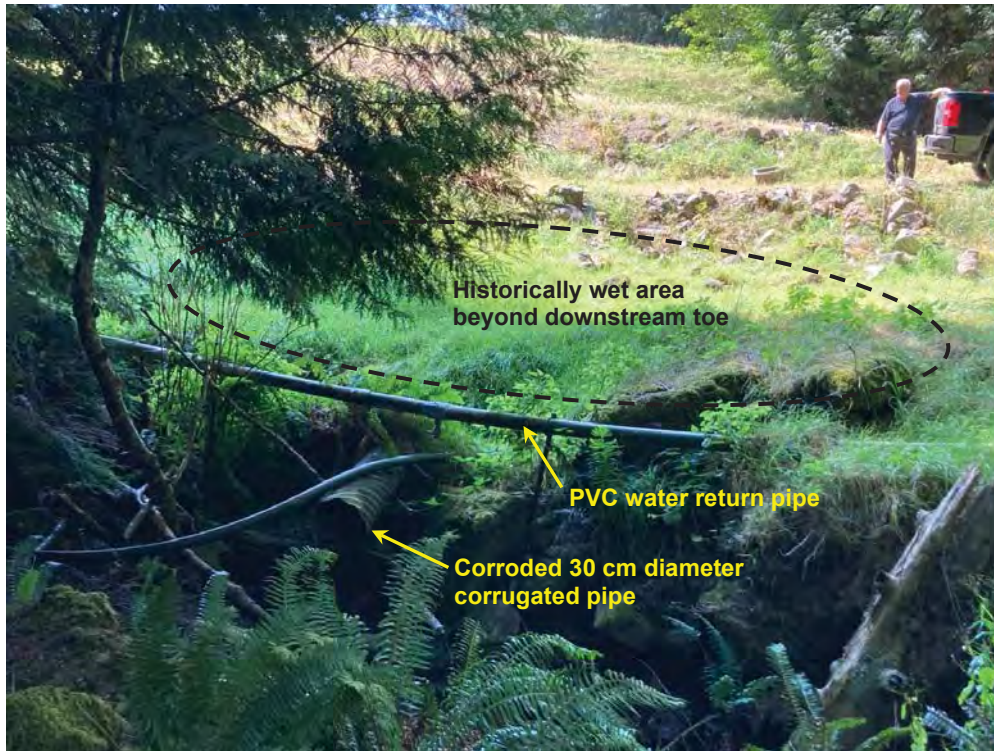
Photo 19: Area downstream of dam toe. (2022-08-31, JDM)

3.8	Burrows / Ruts	None observed		
3.9	Other Concerns	None		
4.	Seepage			
4.1	Seeps or Wet Areas	Green vegetation adjacent to spillway chute and along dam toe. Historic wet area near manholes but relatively dry at time of visit.		19

4.4	Aquatic Vegetation	n/a		
4.5	How Monitored?	Not monitored at dam		
4.6	Notes / Causes	Seepage through / under dam.		
4.7	Embankment Drains	Seepage collection system at d/s toe, functionality uncertain. 30 cm overflow pipe corroded and split at outlet.	R – remove or decommission old system	19

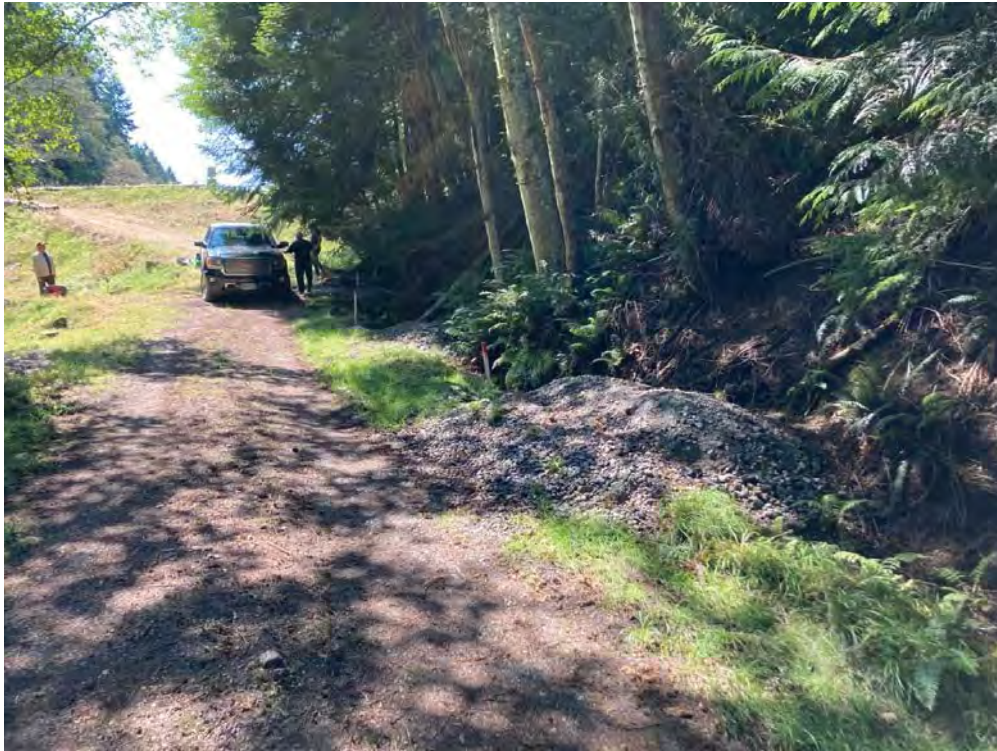
Photo 21: Seepage collecting infrastructure downstream of left abutment. (2022-08-31, JDM)

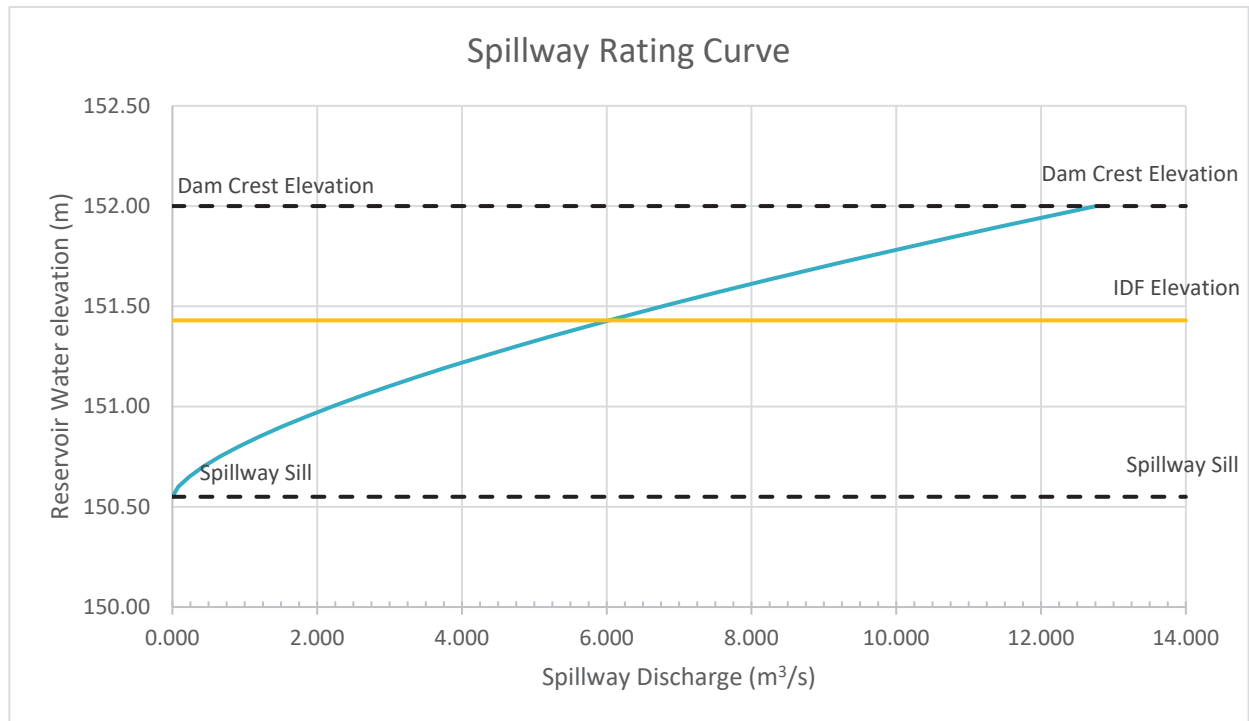
Figure 1: Spillway Stage-Discharge Curve for Money Lake Dam

The resulting spillway stage-discharge curve is available in Figure 1. The IDF is safety routed through the spillway. A capacity check of the culverts downstream at Staples Road and Harris Road was not completed, however, they are undersized for the IDF. Considering this access is the primary means to enable staff to complete OMS activities or implement emergency measures, the access roads crossings should be improved.

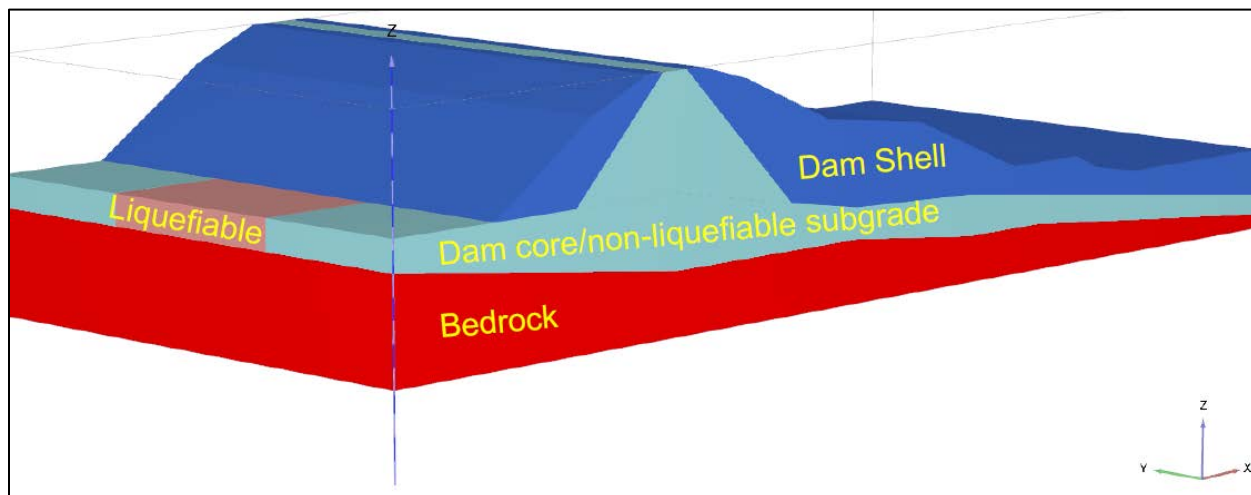
As discussed by Griffiths and Lane (1999) the elastic soil properties have an insignificant effect on the factor of safety and slope failure mode. Accordingly, the elastic modulus and Poisson’s ratio were taken and 100 MPa and 0.2 for all materials, respectively. The model configuration (looking downstream) is shown in Figure 1 below.

Figure 1: Plaxis 3D model configuration.

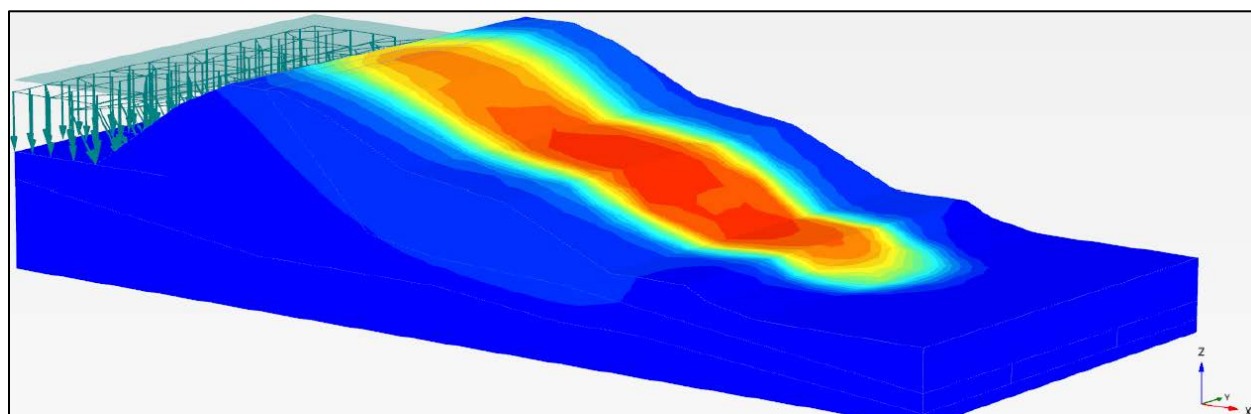
To assess the slope yield acceleration, a pseudo-static horizontal acceleration was applied in the downstream direction. The pseudo-static horizontal acceleration was incrementally increased until the model did not converge. The slope yield acceleration was taken as the highest pseudo-static horizontal acceleration where the model converged. Following convergence, a strength reduction factor analysis was completed to confirm the equivalent factor of safety. This analysis shows that at a pseudo-static horizontal acceleration of 0.185g, the downstream slope has a factor of safety of 1.05, which indicated the horizontal yield acceleration is about 0.185g. Output from the 3D finite element pseudo-static stability analysis is shown below. Small deformations are shown in blue and large deformations are shown in red. The model shows that the slope failure mode is a narrow “slice” above the liquefied channel deposits and not failure of the entire dam, as would be predicted by a 2D analyses.

Figure 2: Plaxis 3D deformation analysis results.

The results of the finite element seismic deformation analysis indicate there are significant benefits related to 3-dimensional effects at the Money Lake Dam site. It was determined that in-slab seismic events will cause in the largest permanent deformations, and that displacements in the downstream direction up to ~200 mm are predicted for the design earthquake (1/2,475 AEP). Given the inherent uncertainties related to modeling the performance of earthen structures during earthquakes, it is common to assume that the actual deformations could range from 50% to 200% of the predicted amount, which would correspond to permanent deformations in the order of 100 mm to 400 mm. These results are significantly less than the deformation predicted using simpler analytical methods. Although these findings indicate that post-earthquake repairs may be required, a sudden collapse of the structure is not predicted. The anticipated damage would include surface cracking and subsidence near the centre of the dam, following the general pattern illustrated in Figure 2 above.
