Colquitz River Watershed

Proper Functioning Condition Assessment

Appendices

July 2009

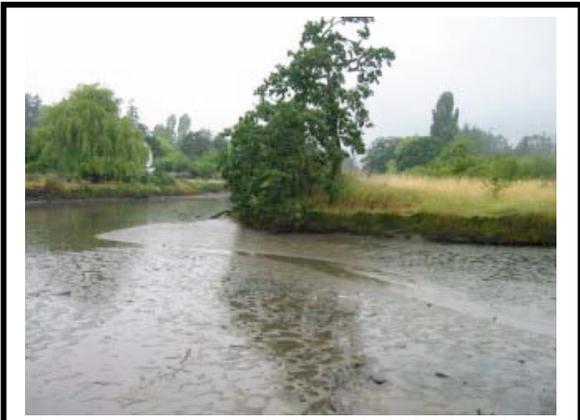
Colquitz River Reach 1, Photo 3, 2007-07-17. Small tributary entering Colquitz Creek. Area is subject to tidal fluctuations.

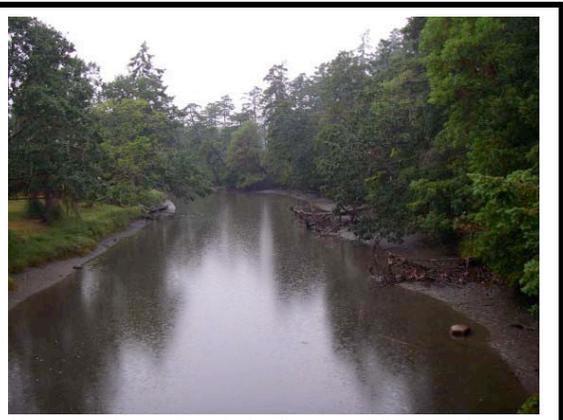
Colquitz River Reach 1, Photo 4, 2007-07-17. Facing upstream. Reach is highly vegetated on both sides.

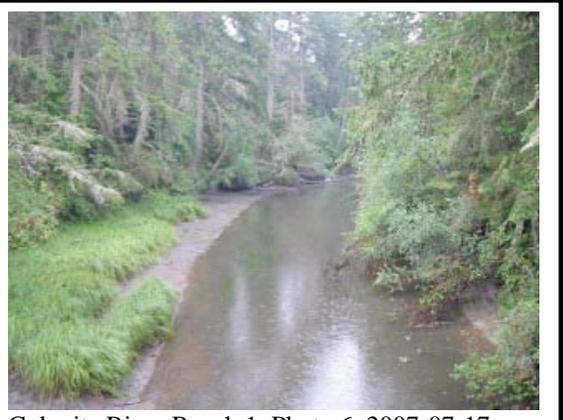
Colquitz River Reach 1, Photo 6, 2007-07-17. Facing upstream near the end of the reach.

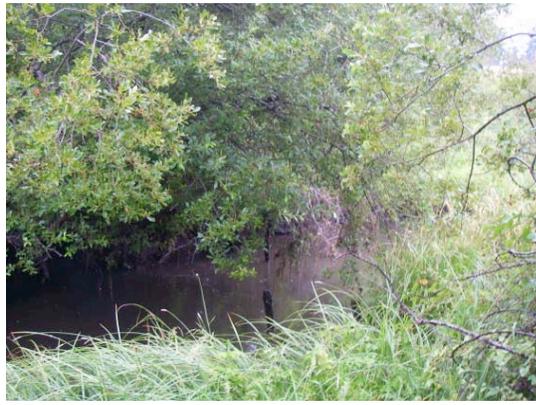
Colquitz River Reach 2, Photo 1, 2007-07-17. Upstream of the second footbridge in Cuthbert Holmes Park. Although there are large amounts of vegetation along this reach, the streambanks are eroding due to high seasonal flows.

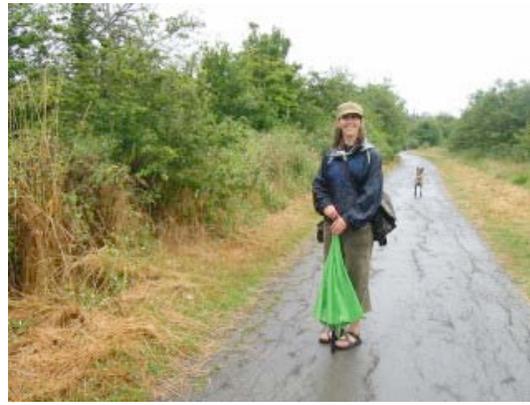
Colquitz River Reach 2, Photo 2, 2007-07-17. The trail is a considerable distance from the creek, thus very little vegetation trampling occurs, other than areas the municipality mows.

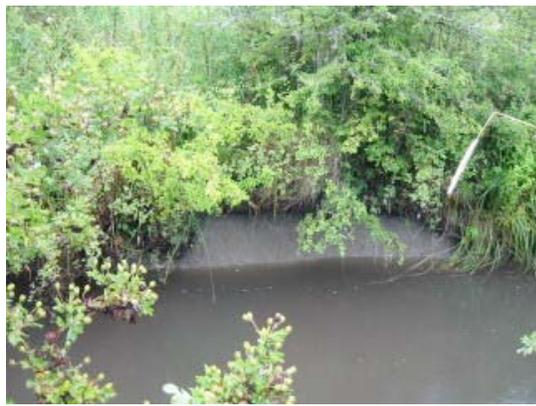
Colquitz River Reach 2, Photo 3, 2007-07-17. As seen above, large amount of streambank erosion has occurred within this reach.

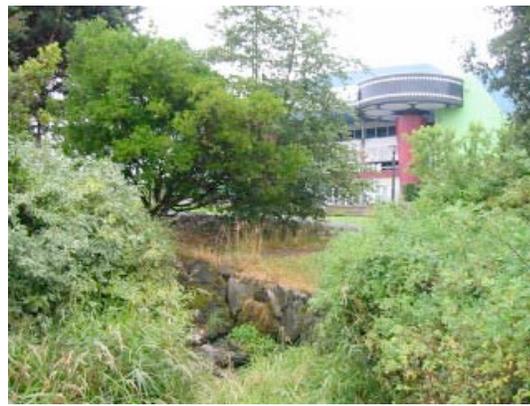
Colquitz River Reach 2, Photo 4, 2007-07-17. Stormwater treatment pond in foreground. Cineplex Odeon in the background.

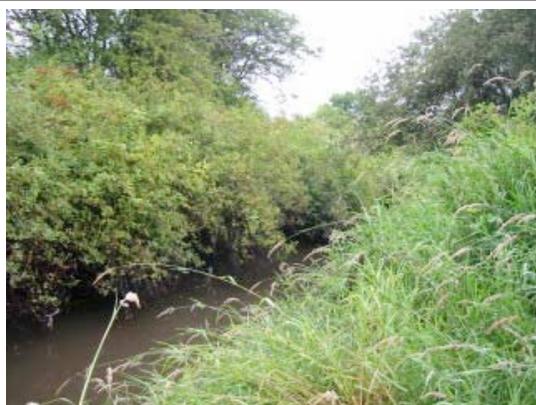
Colquitz River Reach 2, Photo 5, 2007-07-17. Facing upstream within reach.

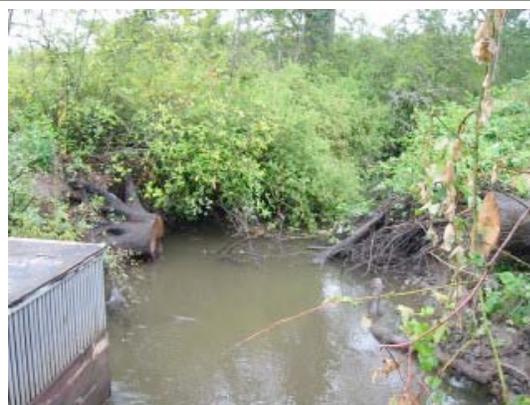
Colquitz River Reach 2, Photo 6, 2007-07-17. A fish fence and staff gauge has been installed in this reach. Recent storms have felled trees allowing for large woody debris to enter the channels.

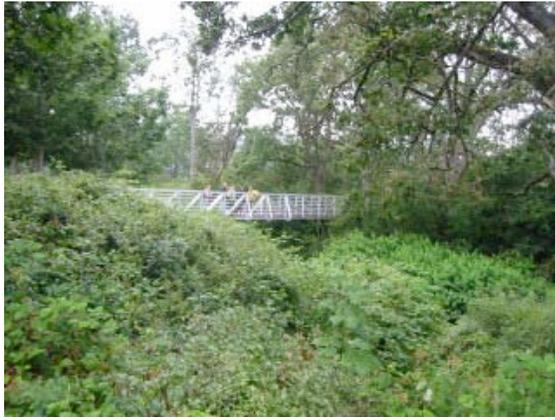
Colquitz River Reach 2, Photo 7, 2007-07-17. Looking downstream towards the recently installed pedestrian bridge adjacent to the Tillicum Mall area. Large amounts of vegetation has grown over the channel.

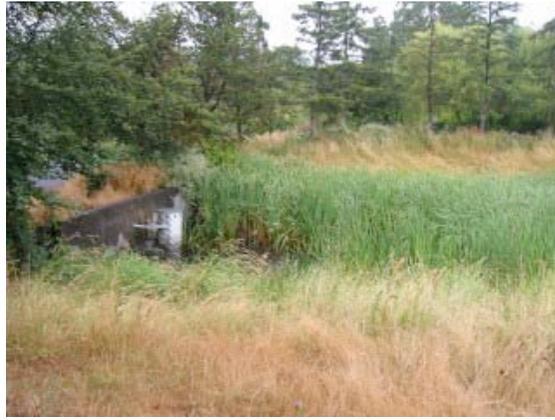
Colquitz River Reach 2, Photo 8, 2007-07-17. Stormwater from Tillicum Mall parking lot enters into the stormwater wetland seen above and then drains into Colquitz Creek.

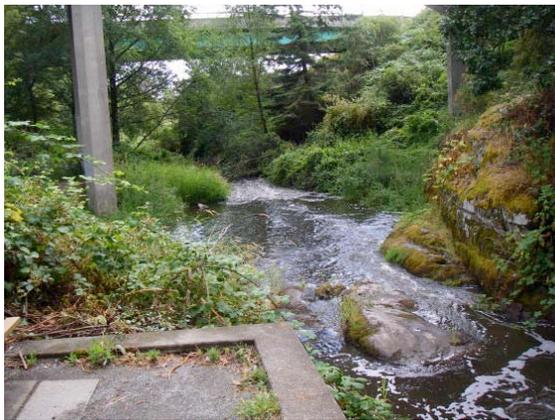
Colquitz River Reach 3, Photo 1, 2007-07-17. Facing downstream, below the Trans Canada Highway bridge. Channel banks consist largely of bedrock (as seen in the photo).

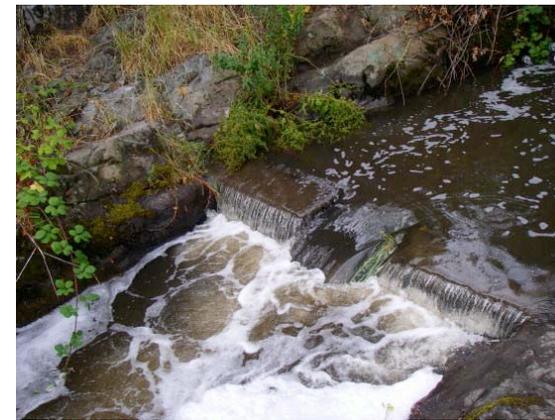
Colquitz River Reach 3, Photo 2, 2007-07-17. Concrete weir installed to control water flow in the reach.

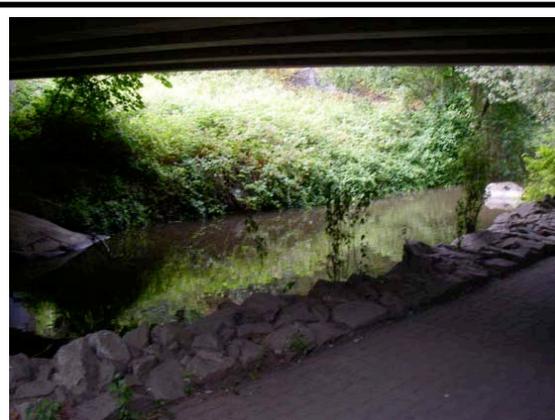
Colquitz River Reach 3, Photo 3, 2007-07-18. Facing upstream. Channel underneath bridge has been completely armoured with rock and concrete.

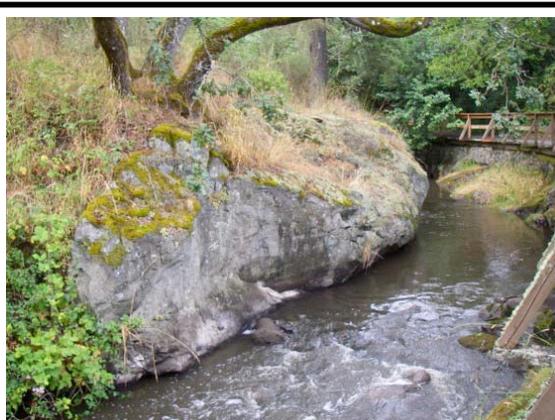
Colquitz River Reach 3, Photo 4, 2007-07-18. Facing upstream, large amounts of natural bedrock on the left and a pedestrian walkway on the right.

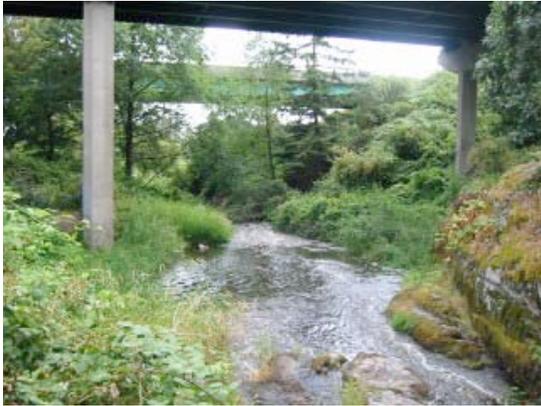
Colquitz River Reach 3, Photo 5, 2007-07-18.
Facing downstream looking towards Trans
Canada Highway bridge.

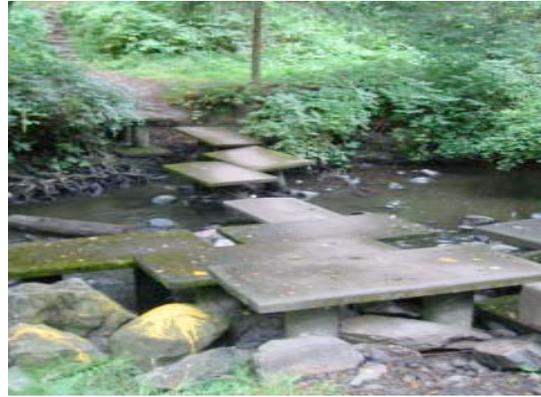
Colquitz River Reach 4, Photo 1, 2007-07-18.
Concrete stepping stones have been previously
installed to allow trail users to cross the creek.

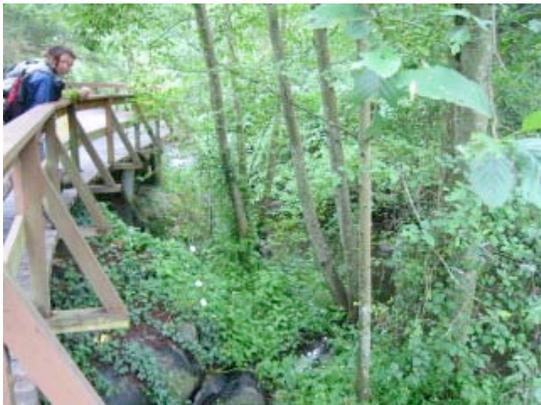
Colquitz River Reach 4, Photo 2, 2007-07-18.
Facing downstream from pedestrian bridge.

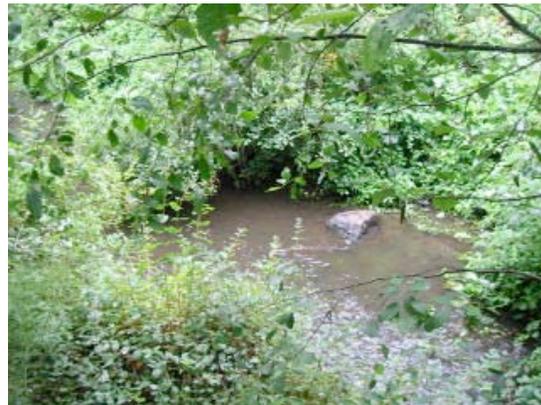
Colquitz River Reach 4, Photo 3, 2007-07-18.
Looking downstream. Although the reach is
heavily vegetated, its composition mainly consists
of invasive species.

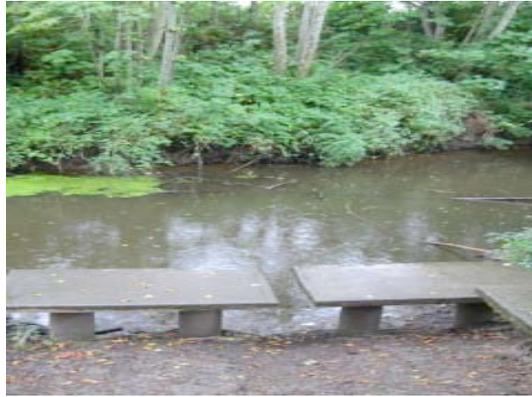
Colquitz River Reach 5, Photo 2, 2007-07-18.
Installation of raised concrete path has led to trampling and erosion of the streambank.

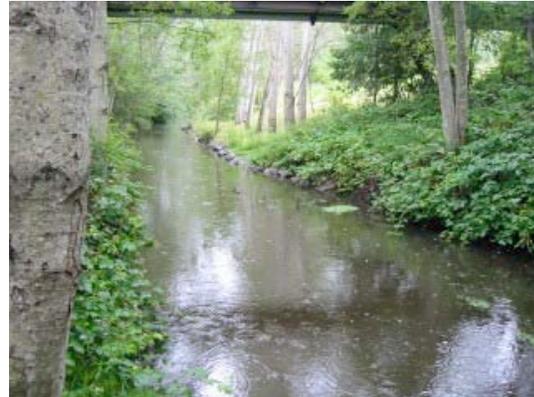
Colquitz River Reach 5, Photo 3, 2007-07-18.
Looking upstream.

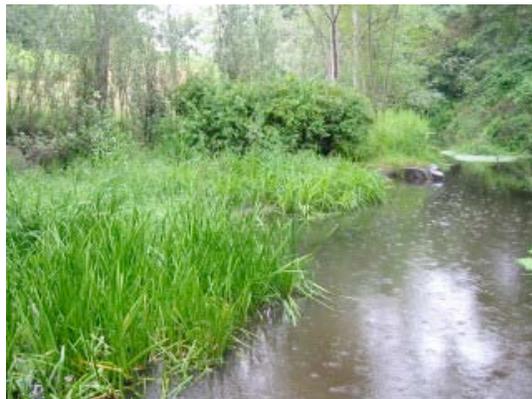
Colquitz River Reach 5, Photo 4, 2007-07-18.
Continued encroachment of vegetation within channel may lead to low DO levels and change the hydrology of the reach.

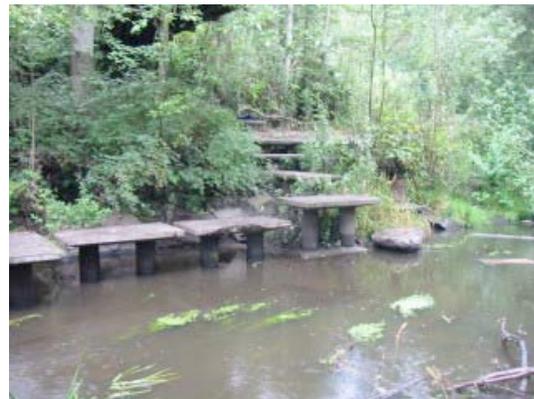
Colquitz River Reach 5, Photo 5, 2007-07-18.
The area may have been dug out to install the raised paths. This portion of the reach appears to be forming into a pond or pool.

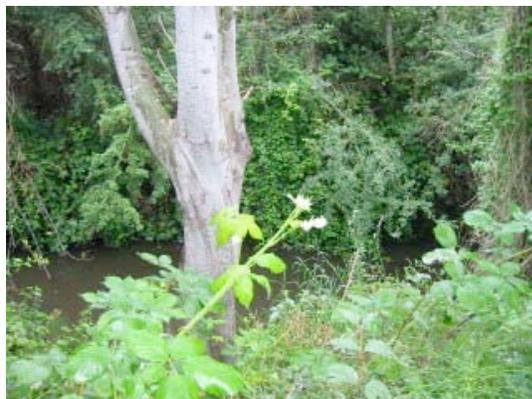
Colquitz River Reach 6, Photo 2, 2007-07-18.
Reach is heavily inundated with invasive species such as English Ivy (background) and Himalayan Blackberries (foreground).

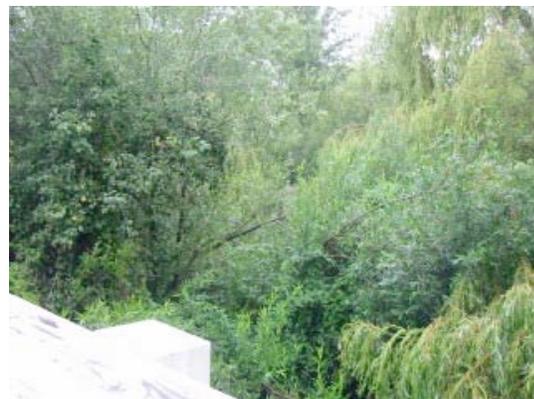
Colquitz River Reach 6, Photo 3, 2007-07-18.
Facing downstream on Interurban Road bridge crossing.

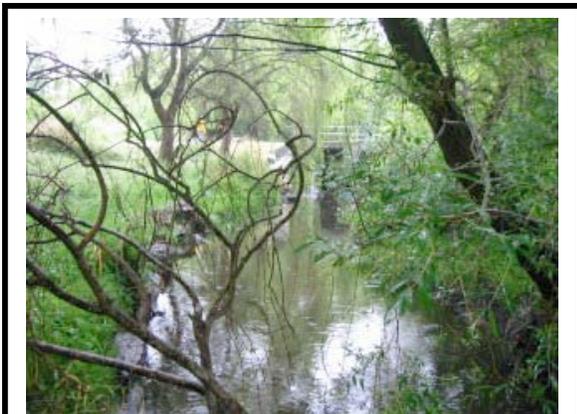
Colquitz River Reach 7, Photo 1, 2007-07-18.
Facing upstream towards the Violet Ave bridge.
Floodplain present on the right hand side.

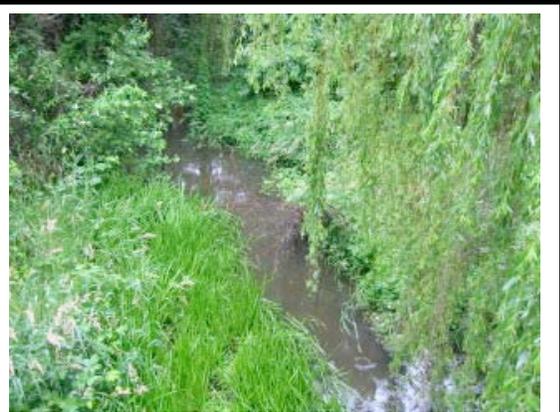
Colquitz River Reach 7, Photo 4, 2007-07-18.
Vegetation is encroaching on channel.

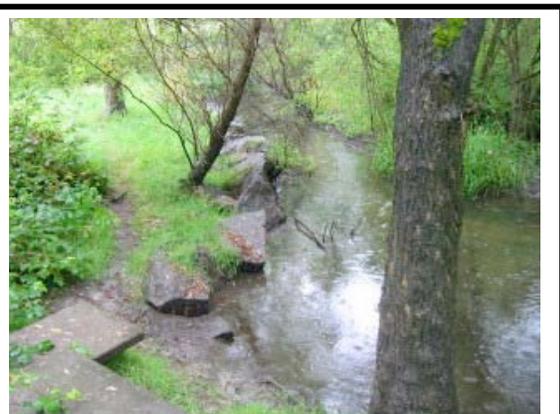
Colquitz River Reach 7, Photo 6, 2007-07-18.
Off path trampling is leading to streambank erosion. Left side of the bank is armoured with large rocks.

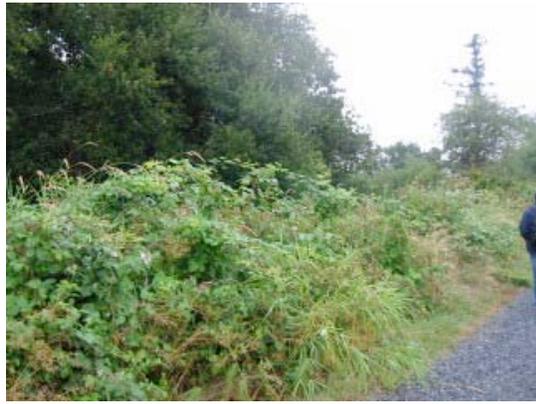
Colquitz River Reach 8, Photo 1, 2007-07-18. Channel is on the West side of Panama Flats. Area is over-grown with Himalayan Blackberries and is difficult to access.

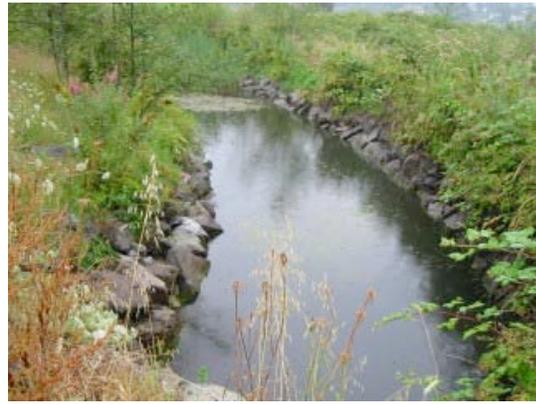
Colquitz River Reach 8, Photo 2, 2007-07-18. Armoured channel connected to the isolated stormwater pond (Photo's 3&4). This system is not believed to be connected to the Colquitz.

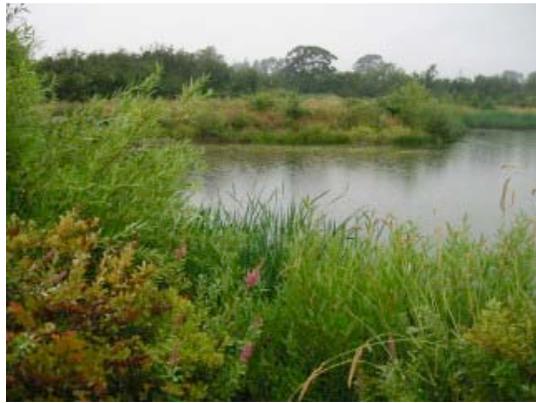
Colquitz River Reach 8, Photo 3, 2007-07-18. Isolated stormwater pond.

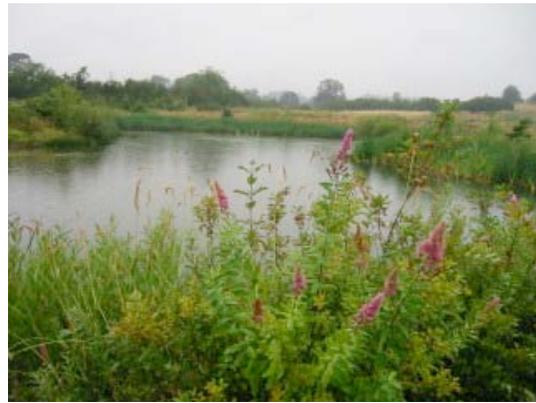
Colquitz River Reach 8, Photo 4, 2007-07-18. Isolated stormwater pond.

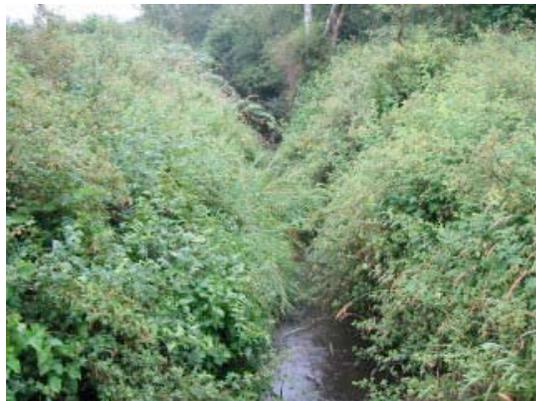
Colquitz River Reach 8, Photo 5, 2007-07-18. As seen above the channel is a ditch and is inundated with invasive species.

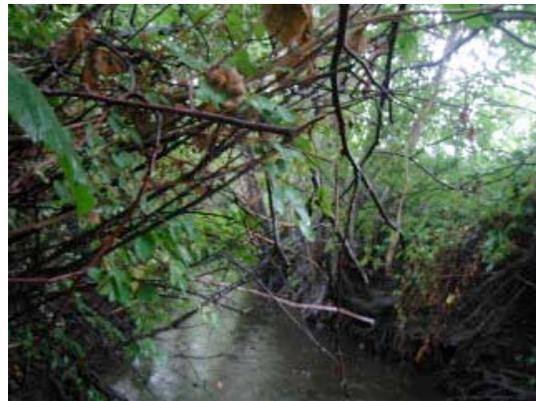
Colquitz River Reach 8, Photo 6, 2007-07-18. Channel is a dug out ditch with gully characteristics. Facing downstream.

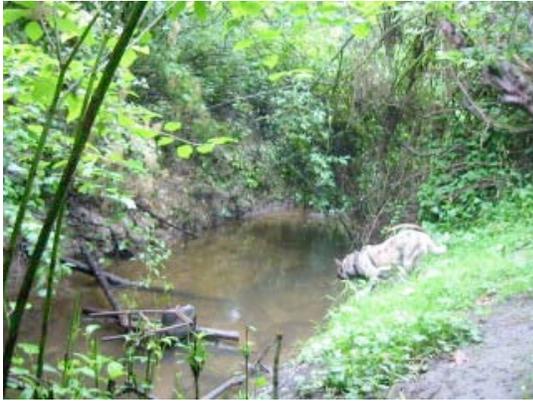
Colquitz River Reach 9, Photo 1, 2007-07-23.
Streambank is eroding and downcutting.

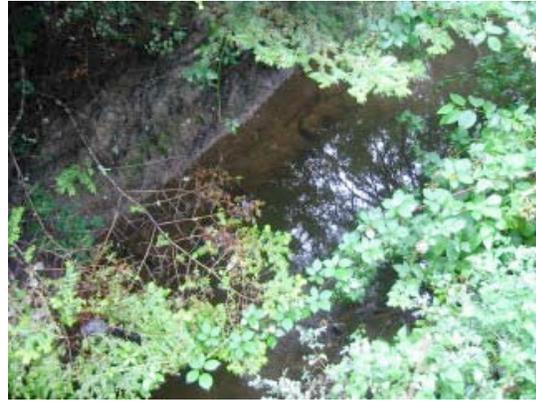
Colquitz River Reach 9, Photo 2, 2007-07-23.
Creek is entrenched and is eroding.

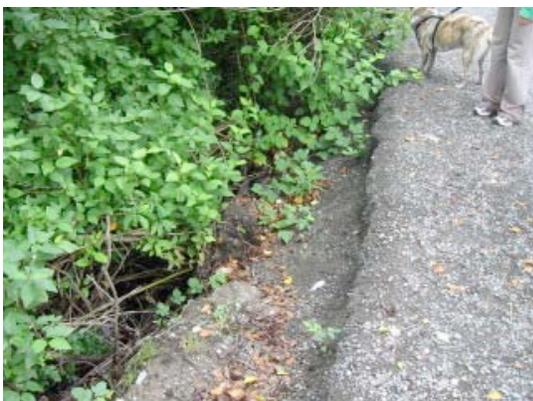
Colquitz River Reach 9, Photo 5, 2007-07-23.
Gravel bridge at Copley Park entrance. Roadside debris and bank erosion is entering creek.

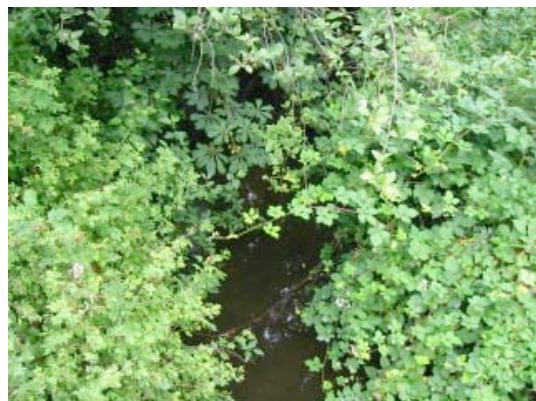
Colquitz River Reach 9, Photo 6, 2007-07-23.
Facing downstream at the gravel bridge. Area is heavily vegetated with invasive species.

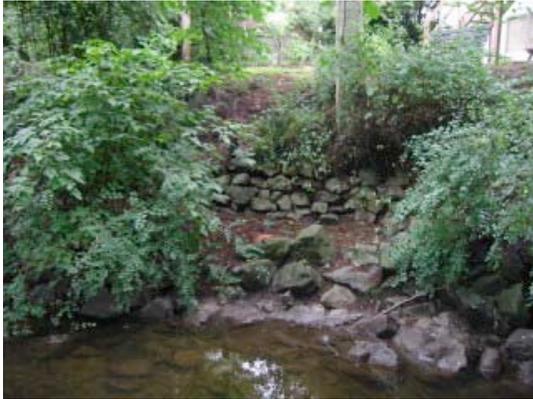
Colquitz River Reach 9, Photo 7, 2007-07-23. Copley Park residence. Trampling from residence has led to decreased vegetation and erosion. Banks have been armoured with rock.

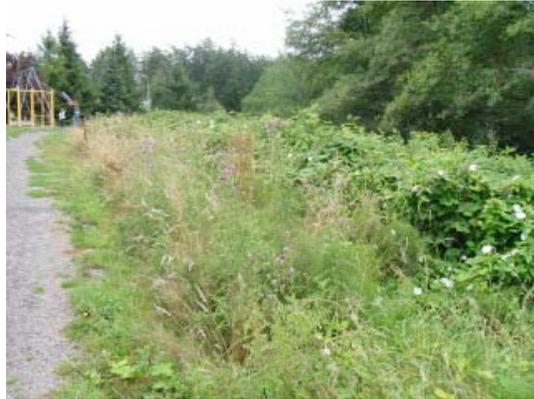
Colquitz River Reach 9, Photo 8, 2007-07-23. Copley Park. As seen at the right side of the photo, the streambank is inundated with invasive species.

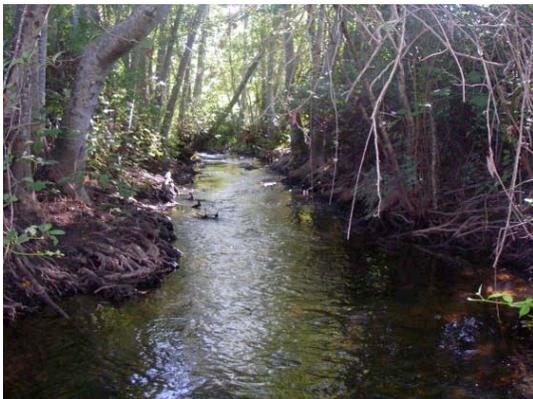
Colquitz Creek Reach 9, Photo 9, 2007-07-25. Copley Park, facing upstream. Right bank is over-steepened. The left bank allows for some floodplain access and dissipation of energy.

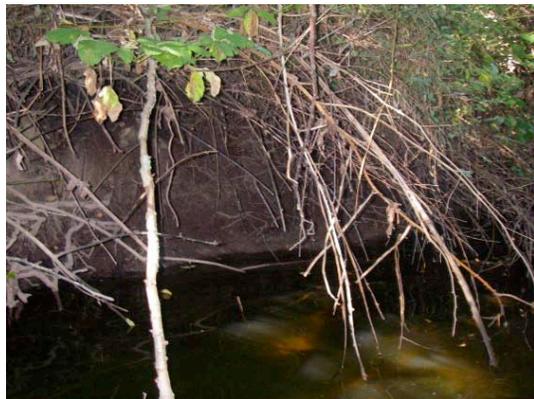
Colquitz Creek Reach 9, Photo 10, 2007-07-25. Copley Park. The bank is over-steepened and eroded.

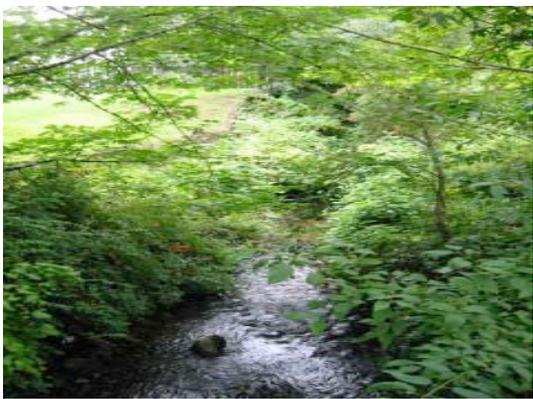
Colquitz River Reach 9, Photo 11, 2007-07-23. Facing upstream at the Rosee Grove pedestrian bridge.

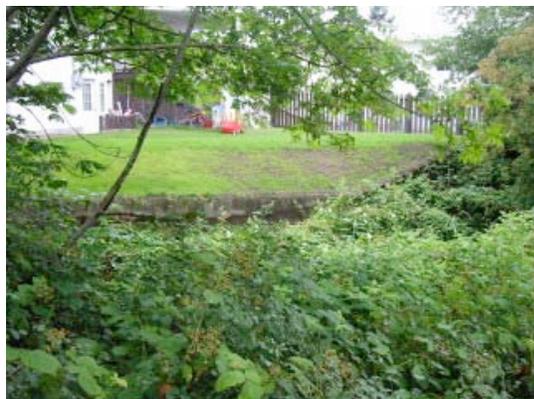
Colquitz River Reach 9, Photo 12, 2007-07-23. Rosee Grove. Standing downstream from the pedestrian bridge. Seen above, trampling in the residential backyard is accelerating erosion.

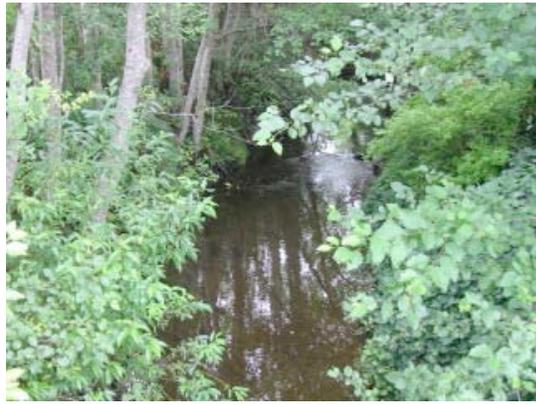
Colquitz River Reach 9, Photo 13, 2007-07-23. Facing downstream from the Vanalman Avenue bridge.

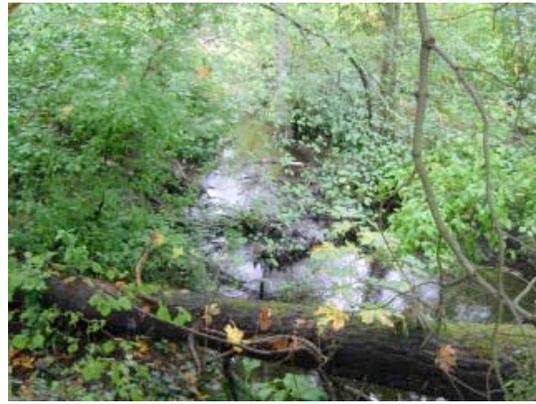
Colquitz River Reach 10a, Photo 1, 2007-07-23. Rosee Grove facing upstream. Note large wood.

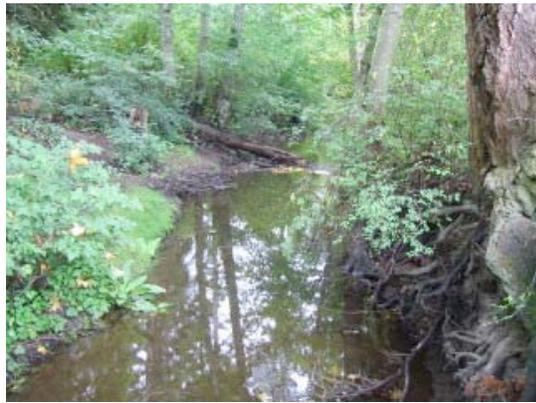
Colquitz River Reach 10a, Photo 2, 2007-07-23. High flows have severely eroded the right bank. The left bank has had some floodplain access to dissipate energy.

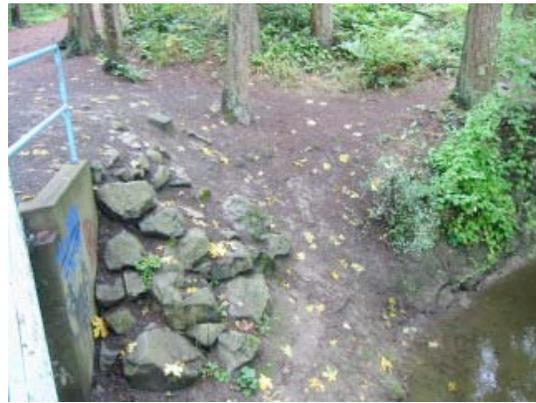
Colquitz River Reach 10a, Photo 3, 2007-07-23. Trampling has aggravated the erosion occurring from high seasonal flows.

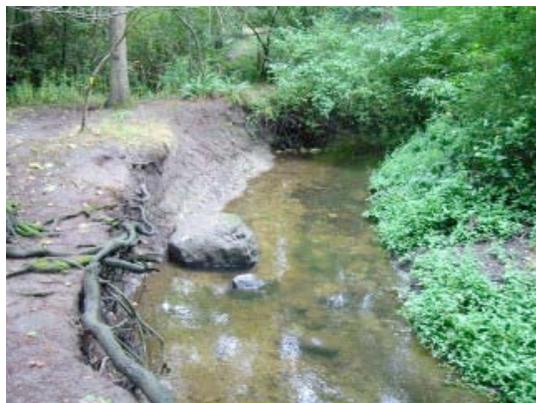
Colquitz River Reach 10a, Photo 4, 2007-07-23. Large flows have eroded and down-cut the banks, exposing the root base.

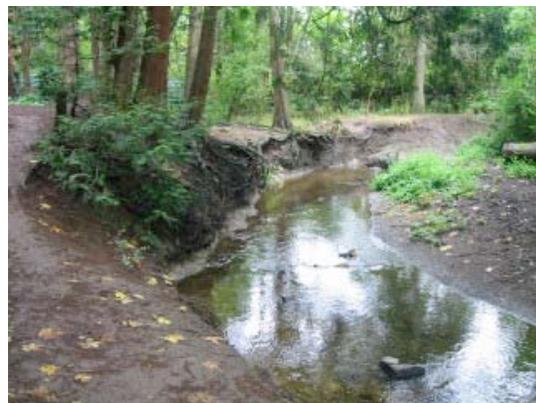
Colquitz River Reach 10a, Photo 5, 2007-07-23. Severe erosion and trampling is occurring.

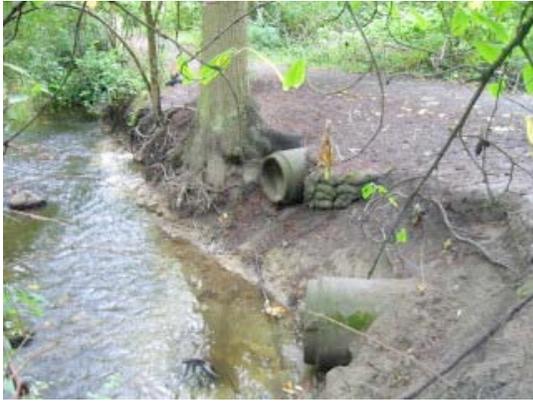
Colquitz River Reach 10a, Photo 6, 2007-07-23. Two large culverts discharge stormwater directly into the creek thus increasing the volume of water and negatively impacting the hydrology.

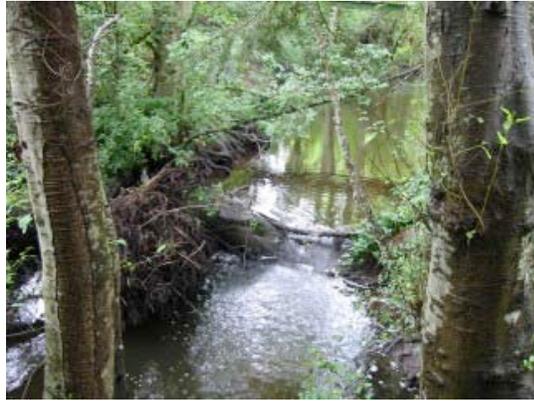
Colquitz River Reach 10a, Photo 7, 2007-07-23. Rosee Grove, facing upstream. Tree root is acting as a weir, channeling water to the middle and aiding in controlling flows to an extent.

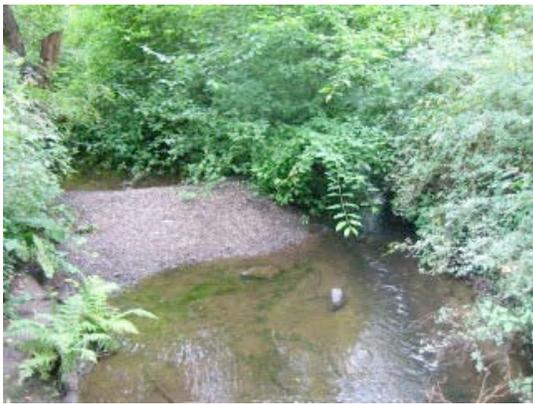
Colquitz River Reach 10a, Photo 8, 2007-07-23. Gravel material likely placed in creek after building pedestrian bridge. The deposit is not revegetating.

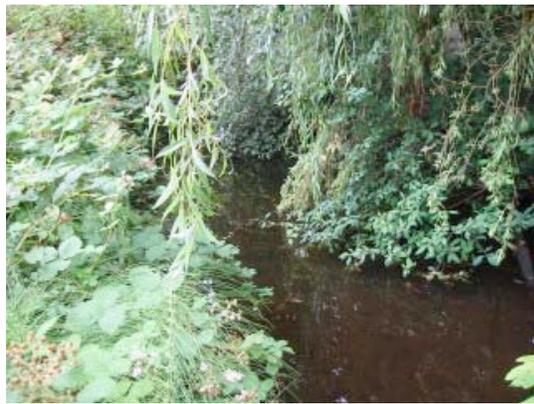
Colquitz River Reach 10a, Photo 9, 2007-07-23. Facing downstream. Dense vegetation has buffered the banks against high flows and erosion.

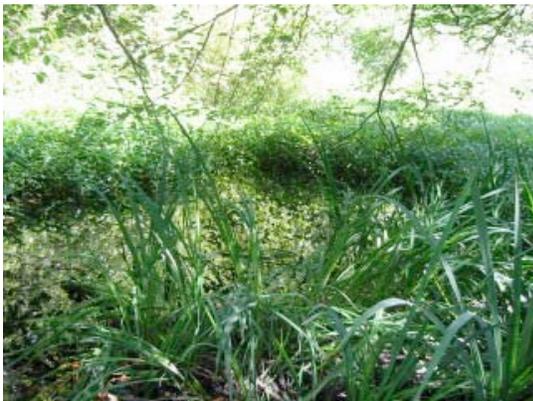
Colquitz River Reach 10b, Photo 1, 2007-07-23. A small vegetated wetland, adjacent to creek.

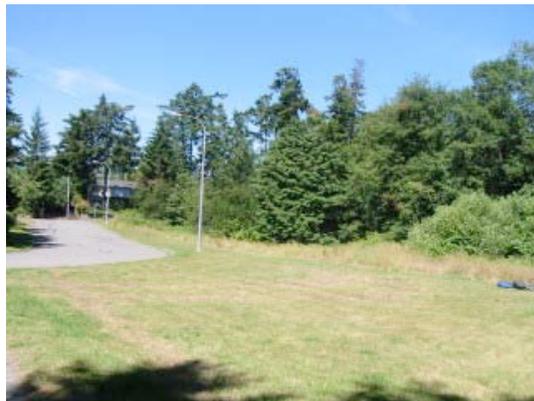
Colquitz River Reach 10b, Photo 2, 2007-07-23. Wetland is located to the right (Vanalman Avenue and Northridge Crescent).

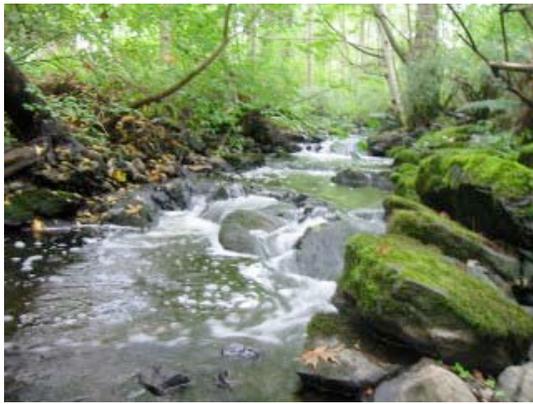
Colquitz River Reach 11, Photo 1, 2007-07-23. Facing upstream, creek is lined with large rocks able to dissipate energy and reduce erosion that occurs with high flows.

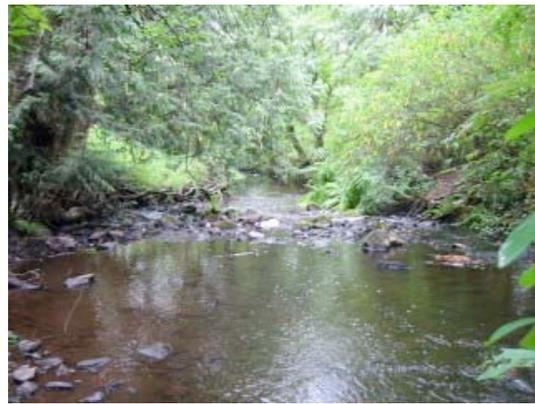
Colquitz River Reach 11, Photo 2, 2007-07-23. Facing downstream. The hydrology of the creek is altered (hence the reach break) at this point due to the change in substrate.

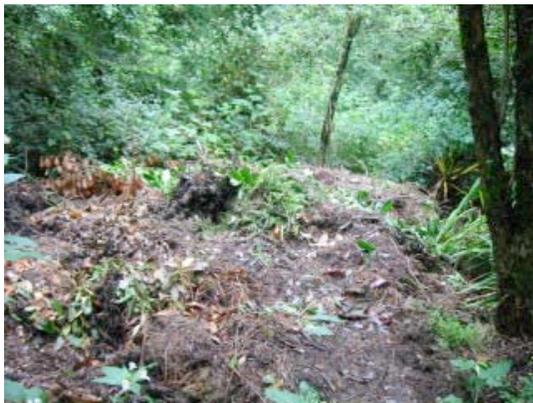
Colquitz River Reach 11, Photo 3, 2007-07-23. Adjacent to Lindsay Road, residences have been dumping yard waste.

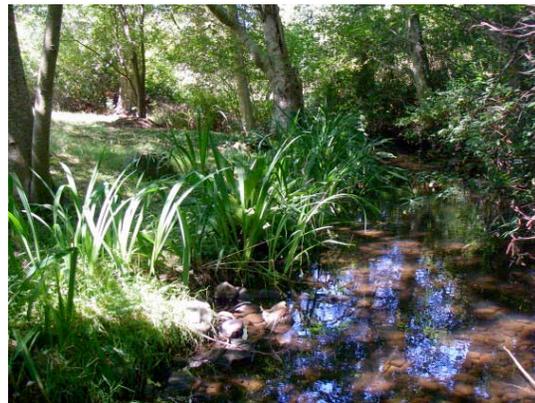
Colquitz River Reach 11, Photo 5, 2007-07-25. Residential backyard maintenance (i.e. mowing, non-riparian species) is encroaching on the riparian plant growth.

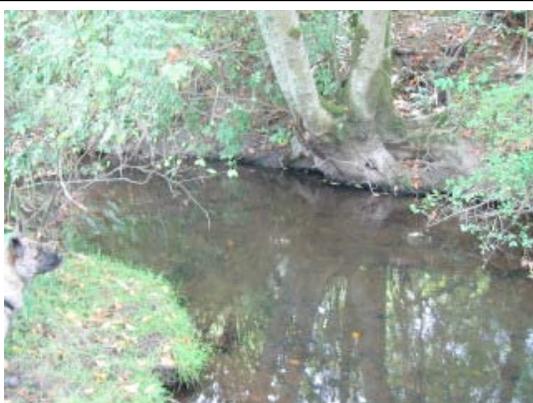
Colquitz River Reach 12, Photo 1, 2007-09-18. Facing downstream from 4450 Wilkinson Road. Note the presence of floodplain on the left bank.

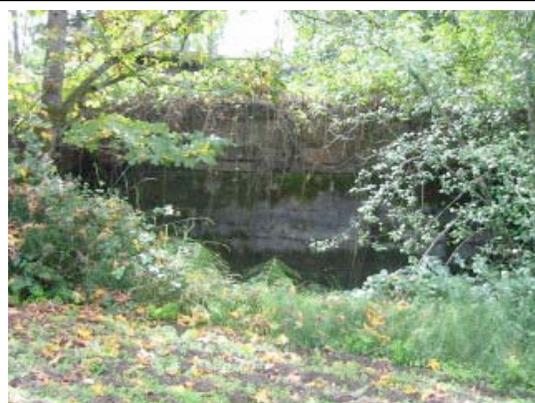
Colquitz River Reach 12, Photo 2, 2007-09-18. Vertical concrete and wood wall constraining the creek channel.

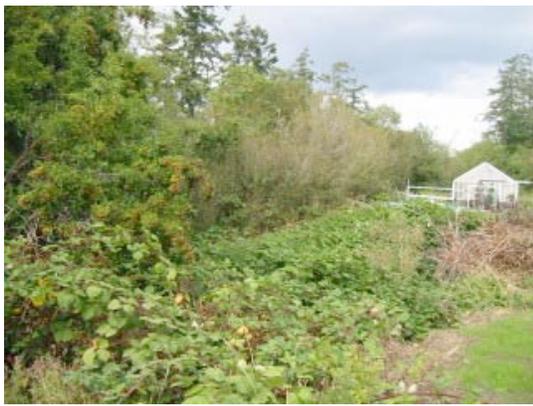
Colquitz River Reach 12, Photo 3, 2007-09-18.
Facing upstream toward Quick's Bottom.
Invasive species are abundant.

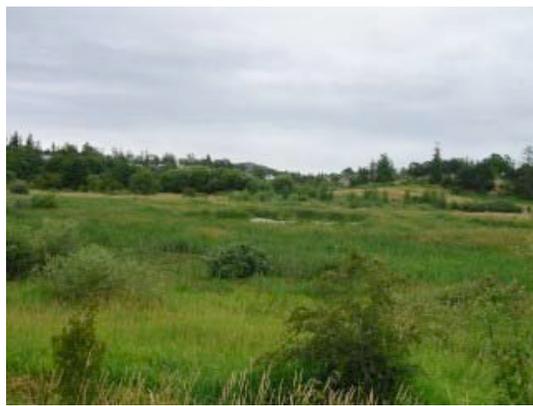
Colquitz River Reach 13, Photo 1, 2007-07-23.
Vantage point from the bird blind in Quick's
Bottom.

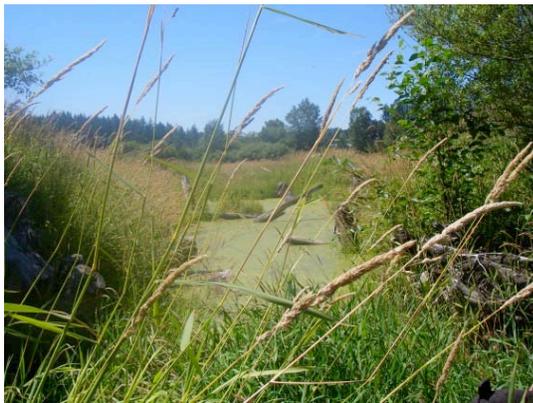
Colquitz River Reach 13, Photo 2, 2007-07-25.
Quick's Bottom wetland.

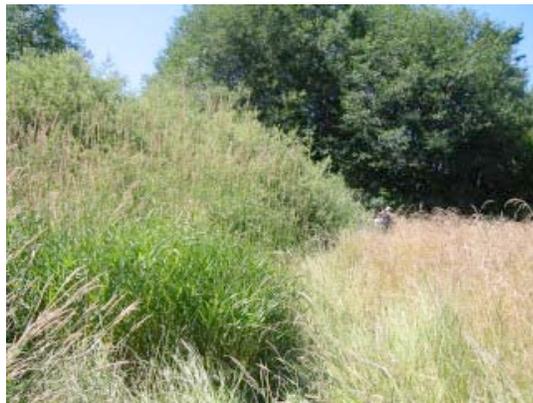
Colquitz River Reach 14, Photo 1, 2007-07-25.
Creek runs adjacent to Quick's Bottom wetland
(left side). Creek is heavily vegetated and reed
canary grass encroachment is narrowing channel.

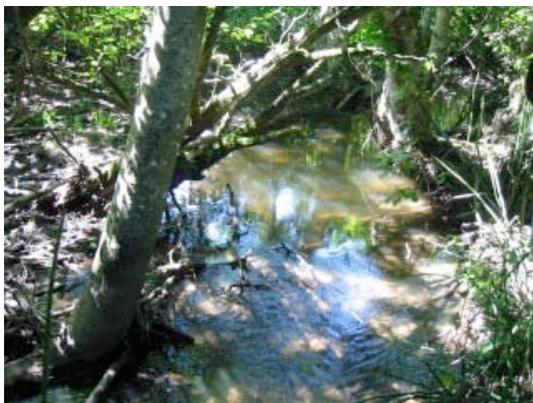
Colquitz River Reach 14, Photo 2, 2007-07-25.
Property of 4654 West Saanich Road. The creek
is heavily vegetated with large trees.

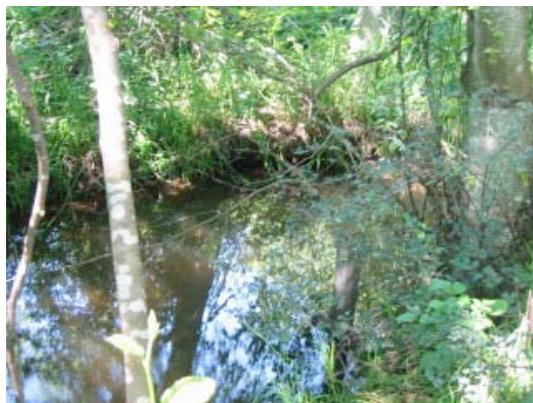
Colquitz River Reach 14, Photo 3, 2007-07-25.
Facing upstream on the property of 4654 West
Saanich Road.

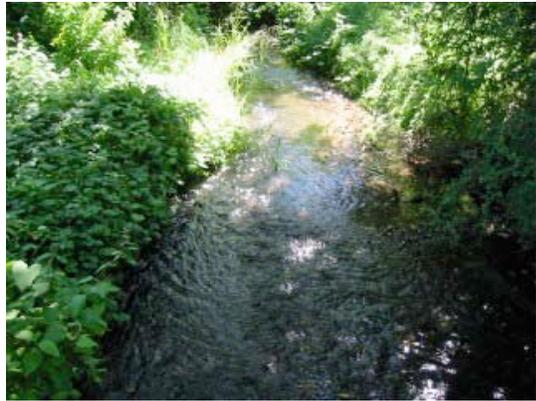
Colquitz River Reach 15, Photo 1, 2007-07-25.
Standing on pedestrian bridge facing upstream.

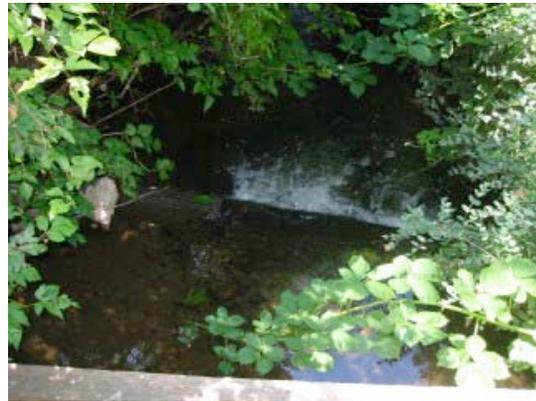
Colquitz River Reach 15, Photo 2, 2007-07-25.
Stranding on driveway of 4654 West Saanich Road facing downstream. Concrete weir is installed.

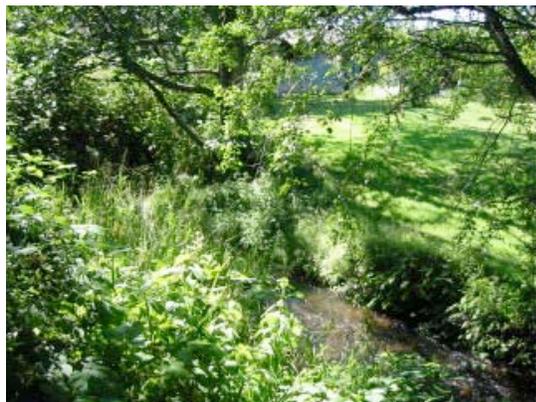
Colquitz River Reach 15, Photo 3, 2007-07-25.
Facing downstream on the property of 4624 West Saanich Road. Residential lawn and lawn maintenance has encroached upon riparian vegetation.

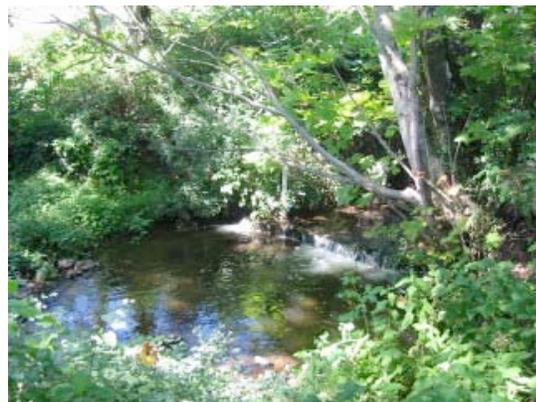
Colquitz River Reach 15, Photo 4, 2007-07-25.
Facing upstream on the property of 4634 West Saanich Road.

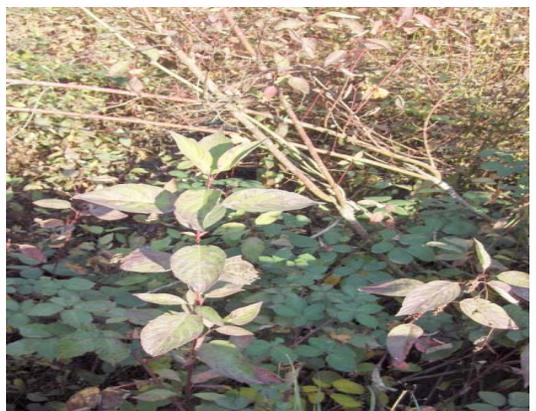
Colquitz River Reach 16, Photo 1, 2007-10-30.
Facing upstream from West Saanich Road crossing. Vegetation is abundant in the channel.

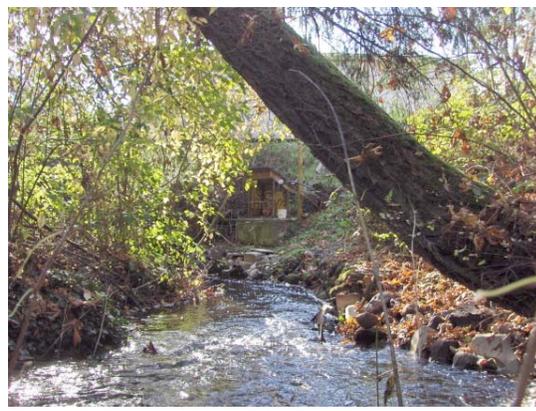
Colquitz River Reach 16, Photo 2, 2007-10-30.
Facing downstream at 4641 West Saanich Road. Note pump station in the background.

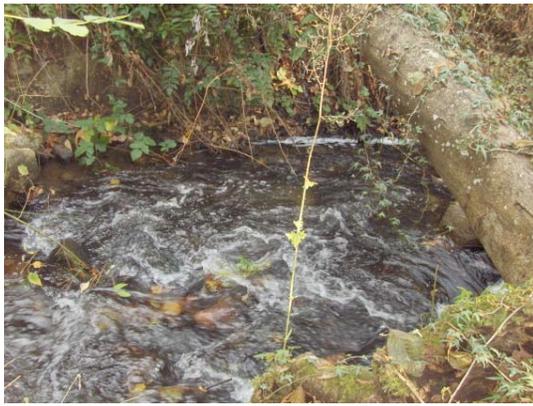
Colquitz River Reach 16, Photo 3, 2007-10-30.
Facing downstream at 4641 West Saanich Road.
Large wood still has root wad attached.

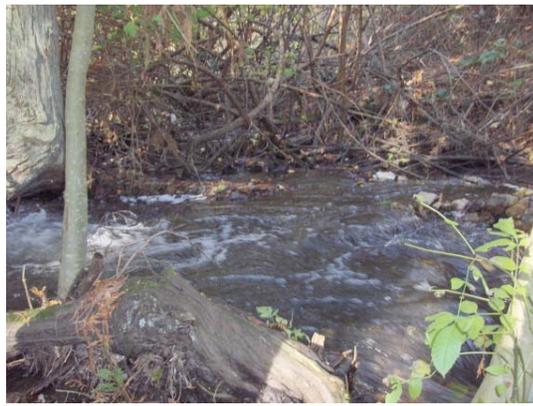
Colquitz River Reach 16, Photo 4, 2007-10-30.
Facing upstream at 4641 West Saanich Road just
below Hunt's Falls.

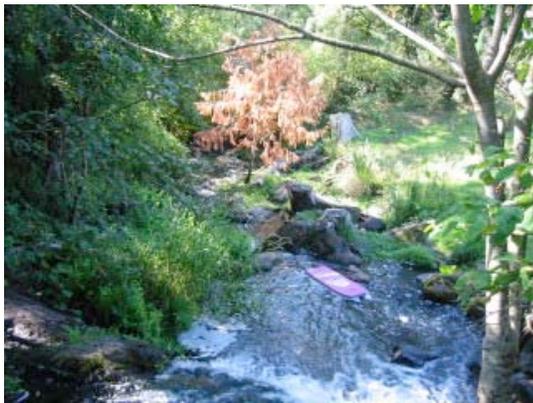
Colquitz River Reach 17, Photo 1, 2007-07-30.
Facing downstream. The channel is dominated by
bedrock and contains small cascades, waterfalls
and pools.

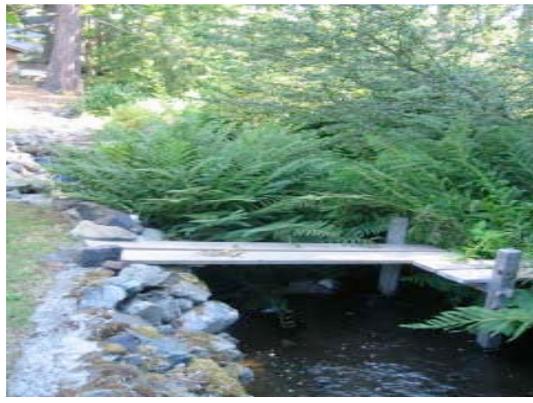
Colquitz River Reach 17, Photo 2, 2007-07-30.
Facing upstream towards pedestrian crossing.
Left bank is armoured with rip-rap and a
manicured lawn is set right to the waters edge.

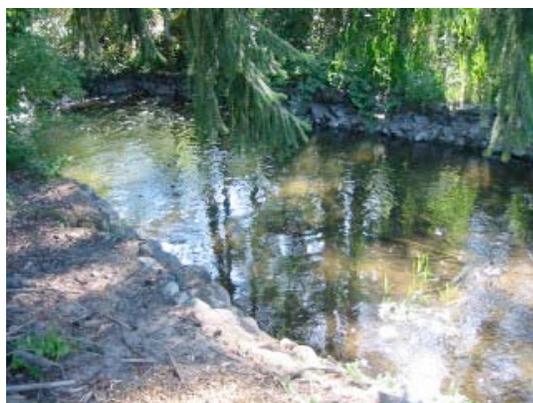
Colquitz River Reach 17, Photo 3, 2007-07-30.
Facing upstream. An old stop-log dam manages
the flows of the water.

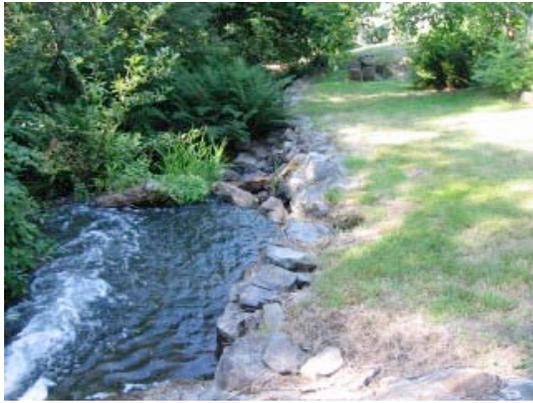
Colquitz River Reach 17, Photo 4, 2007-07-30.
Upstream of stop-log damn. Due to the dam a
small pond exists. Both sides are armoured with
rip-rap. Lots of silt present at bottom of pond.

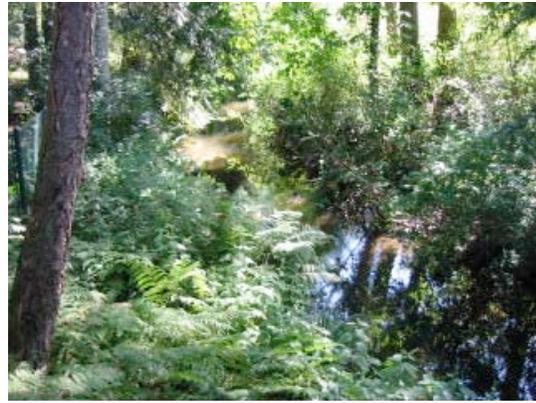
Colquitz River Reach 17, Photo 5, 2007-07-30. Facing downstream with the 4525 Cheeseman Road property to the right. Note armoured banks with grass are eroding due to high flows and inappropriate vegetation.

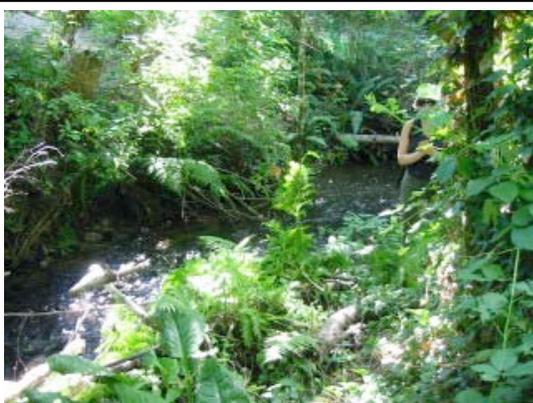
Colquitz River Reach 18, Photo 3, 2007-07-30. Facing downstream. Woody debris has lined the channel providing some protection from erosion.

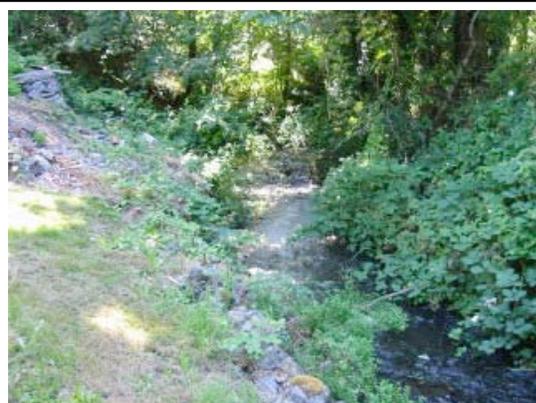
Colquitz River Reach 18, Photo 4, 2007-07-30. Upstream from the property, facing downstream. Heavily vegetated upper banks, but erosion is occurring underneath the cover.

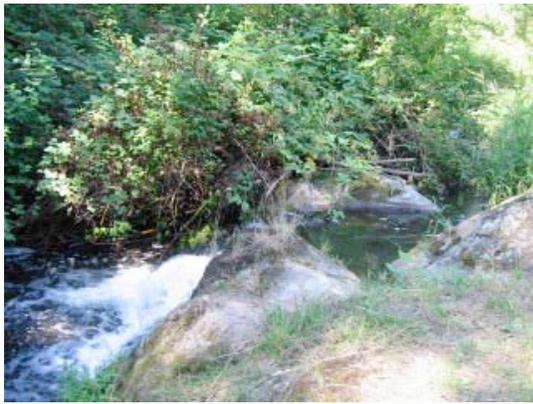
Colquitz River Reach 19, Photo 1, 2007-07-30. Facing downstream. The creek is heavily vegetated with invasive species on the right. Opposite this is a lawn right up to the waters edge.

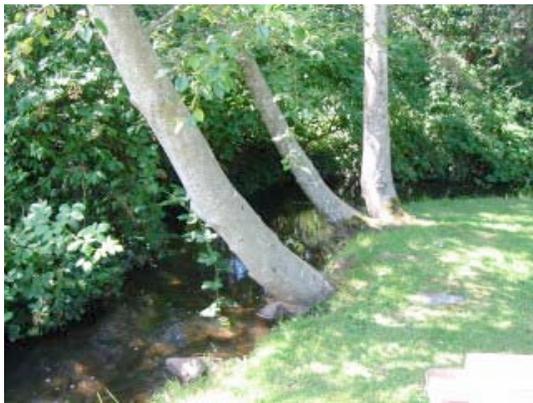
Colquitz River Reach 20, Photo 1, 2007-07-30. Facing downstream at the beginning of reach 20.

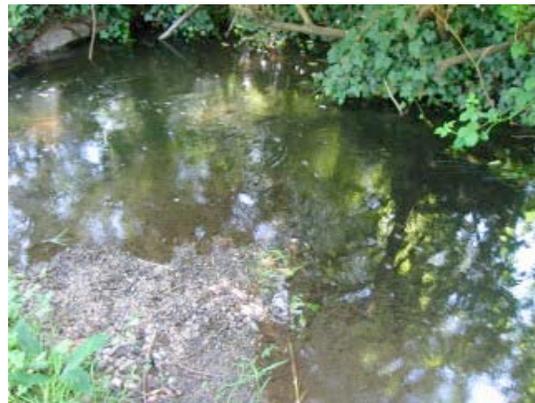
Colquitz River Reach 20, Photo 2, 2007-07-30. Facing upstream. The right bank consists of a manicured lawn right to the waters edge. The opposite side is heavily vegetated with invasives.

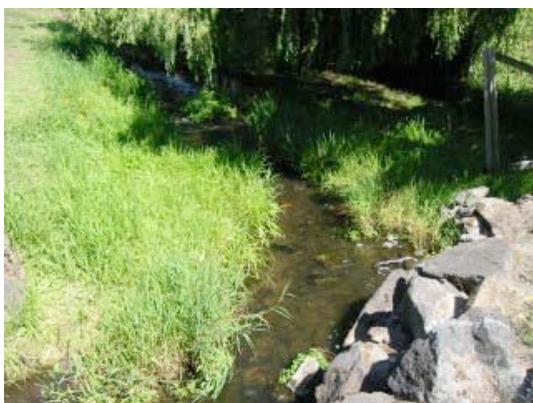
Colquitz River Reach 20, Photo 3, 2007-07-30. Small point bar formation due to erosion and deposition processes.

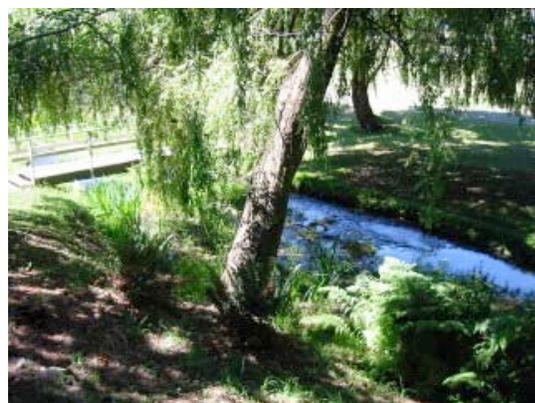
Colquitz River Reach 20, Photo 4, 2007-07-30. Facing downstream. Streambank consists of lawn on both sides.

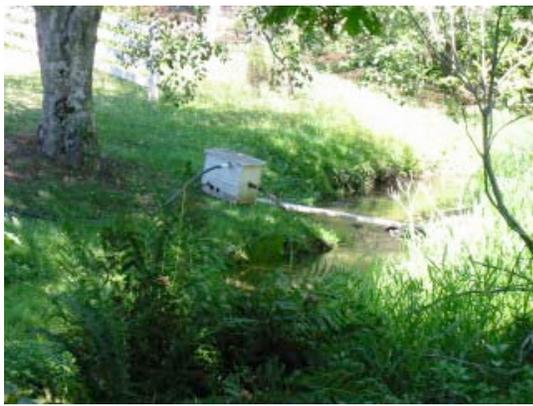
Colquitz River Reach 20, Photo 5, 2007-07-30. Facing upstream. Streambank consists of lawn on both sides with undercutting and erosion occurring along both banks.

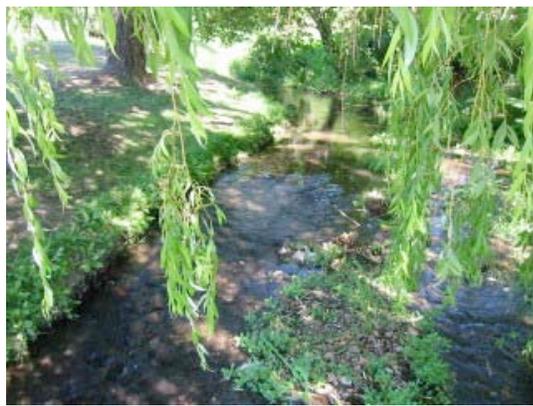
Colquitz River Reach 20, Photo 6, 2007-07-30. Facing upstream. Property owners appear to be pumping water from the creek.
