Colquitz River Watershed

Proper Functioning Condition Assessment

Appendices

July 2009

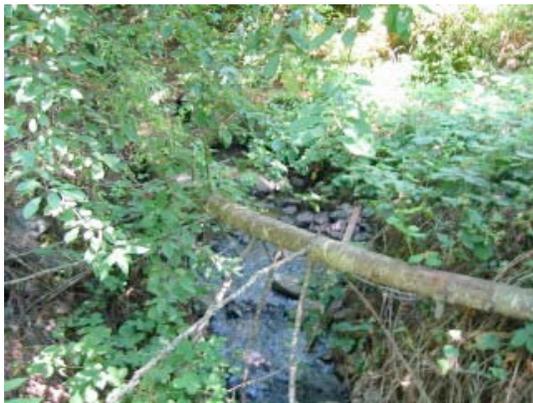
Colquitz River Reach 20, Photo 7, 2007-07-30. On pedestrian bridge facing upstream. Banks are eroding and under-cut. Channel is forming an island from upstream erosion.

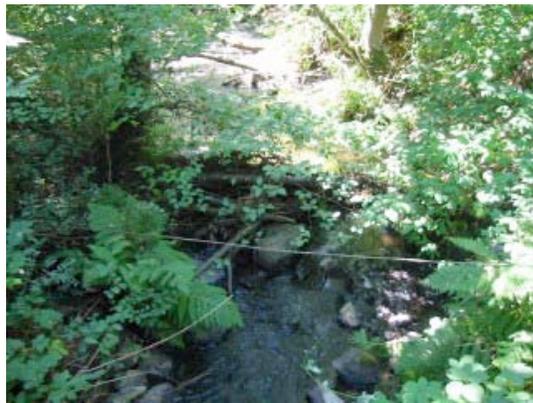
Colquitz River Reach 21, Photo 1, 2007-07-30. Facing upstream. Channel consists mainly of bedrock and silt/clay banks.

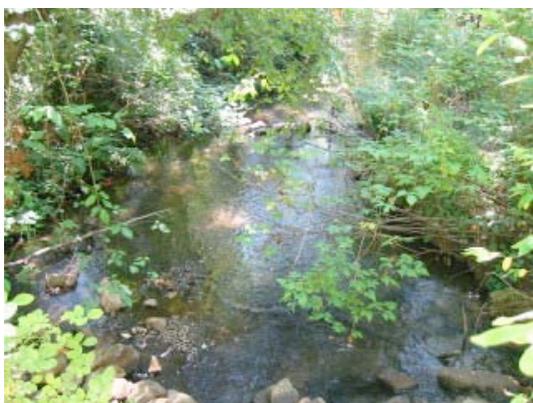
Colquitz River Reach 21, Photo 2, 2007-07-30. Standing on first pedestrian bridge (nearest Pipeline Road), facing downstream towards entrance of park. Note fence crossing channel.

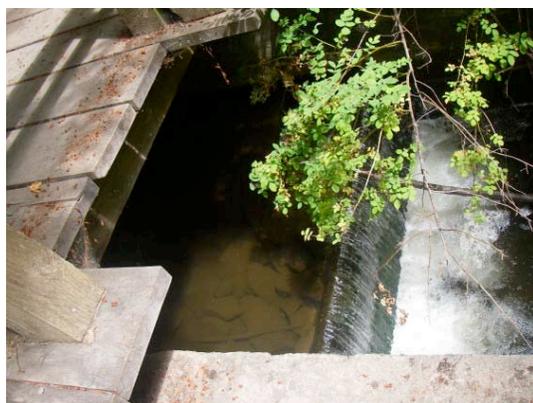
Colquitz River Reach 21, Photo 3, 2007-07-30. Standing on second pedestrian bridge (with weir underneath) facing downstream.

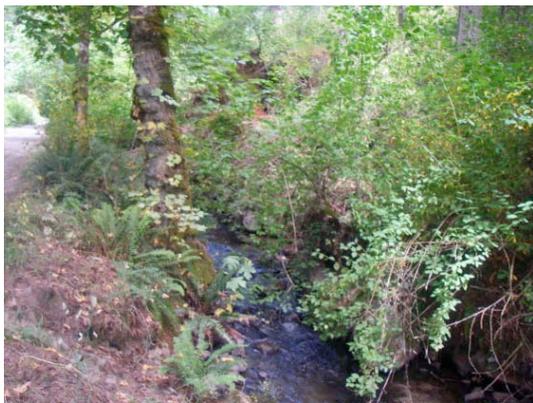
Colquitz River Reach 22, Photo 1, 2007-07-16. Concrete weir at the second pedestrian bridge.

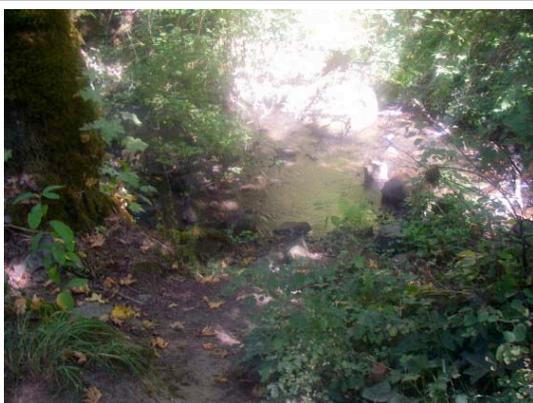
Colquitz River Reach 22, Photo 3 2007-07-16. Facing north next to 2nd pedestrian bridge. Trampling of vegetation and trail widening has occurred due to misuse of the trail by horses.

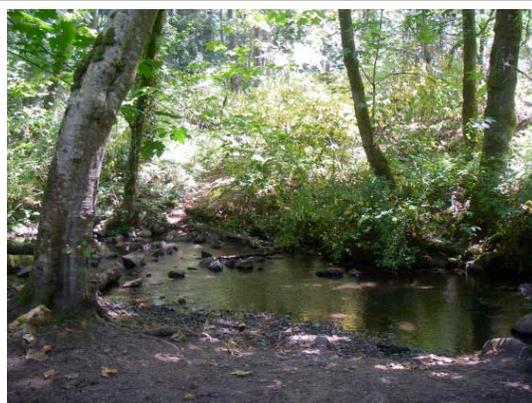
Colquitz River Reach 22, Photo 4, 2007-07-16. Facing east towards creek. Trampling and trail formation through the creek is due to horses.

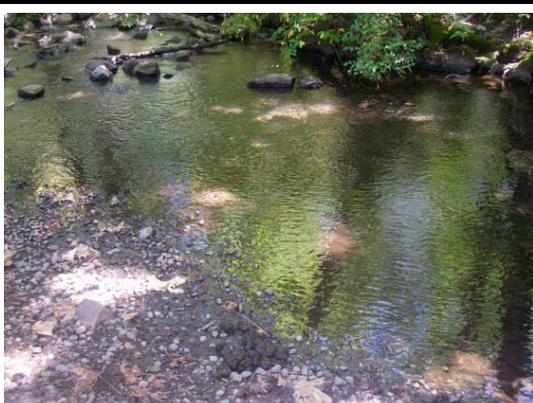
Colquitz River Reach 22, Photo 5, 2007-07-16. Facing northeast. Lack of riparian vegetation growth and soil erosion is due to trampling.

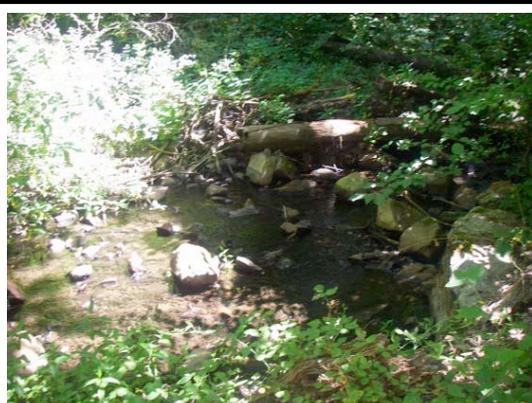
Colquitz River Reach 22, Photo 6, 2007-07-16. Facing northeast. Horse feces left next to the creek.

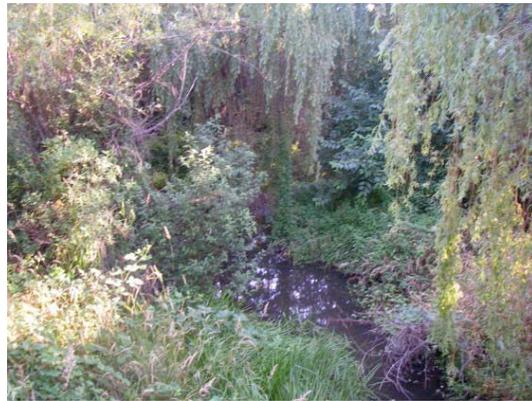
Swan Creek Reach 1, Photo 2, 2007-08-06. On
Violet Avenue facing upstream. Area is heavily
vegetated.

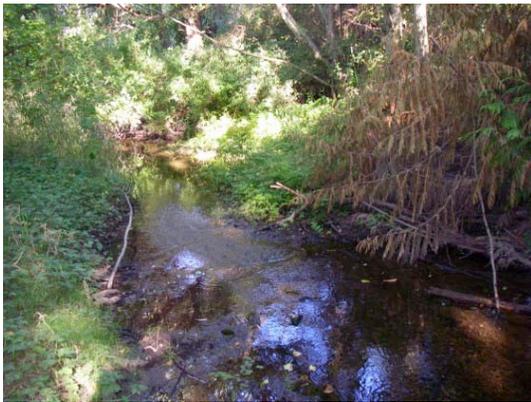
Swan Creek Reach 1, Photo 3, 2007-08-06.
Facing downstream toward Violet Avenue
bridge. Floodplain is available and accessible.

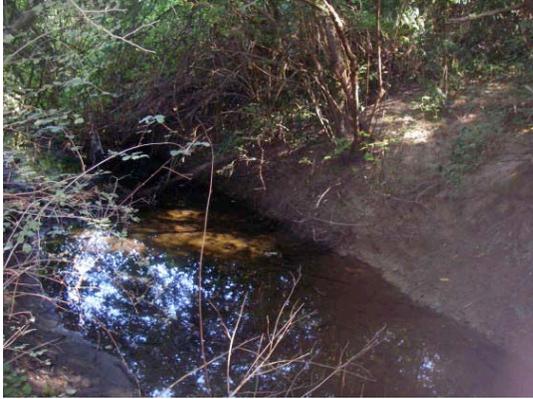
Swan Creek Reach 2, Photo 2, 2007-08-06. Facing downstream. Lack of vegetation and high flows are eroding the banks.

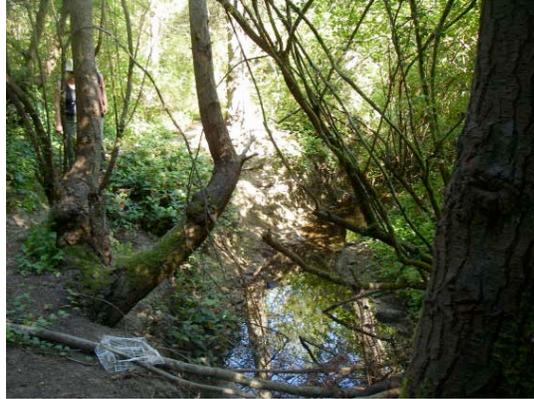
Swan Creek Reach 2, Photo 3, 2007-08-06. Facing downstream. Channel has down-cut and is eroding throughout.

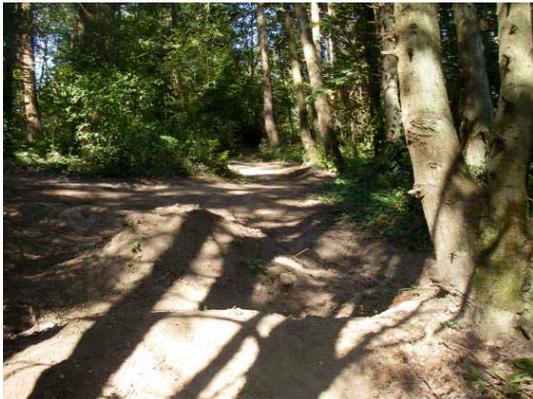
Swan Creek Reach 2, Photo 4, 2007-08-06. Bike users are modifying off trail areas for jumps and bike paths creating areas capable of being easily eroded.

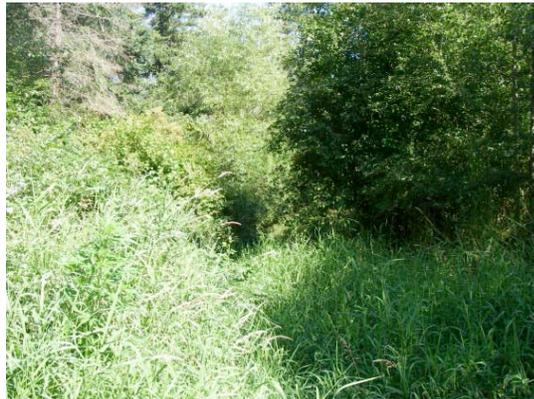
Swan Creek Reach 3, Photo 1, 2007-08-06. Facing downstream. Reach is inundated with reed canary grass.

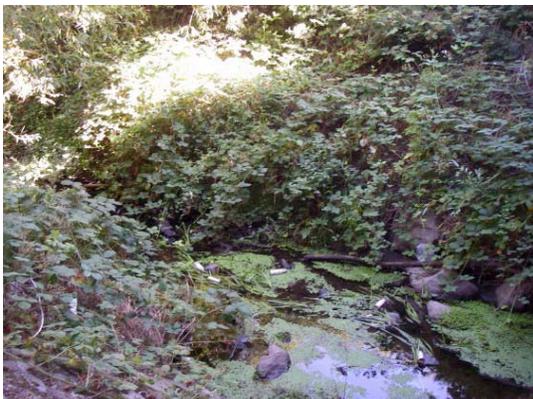
Swan Creek Reach 3, Photo 2, 2007-08-06. Facing downstream beneath McKenzie Road overpass. Channel is lined with rocks and is over-grown with Himalayan blackberries.

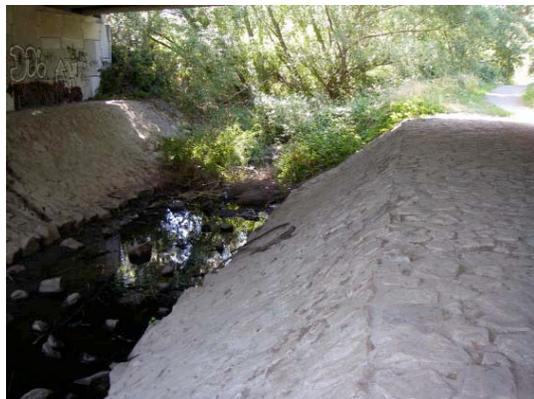
Swan Creek Reach 4, Photo 1, 2007-08-06. Facing upstream underneath McKenzie Road overpass. Channel underneath overpass is completely lined with concrete.

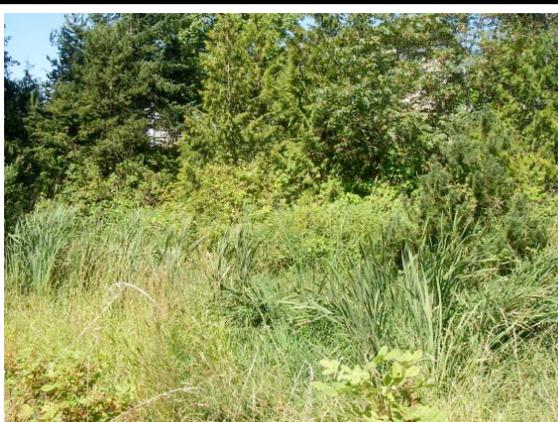
Swan Creek Reach 4, Photo 6, 2007-08-06. Facing downstream.

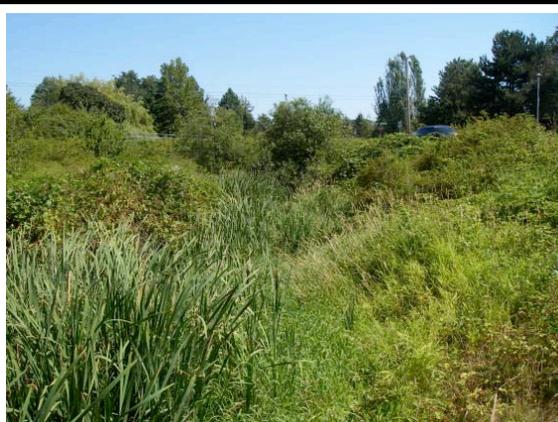
Swan Creek Reach 4, Photo 8, 2007-08-06. Facing upstream toward Carey Road. Reach is heavily vegetated.

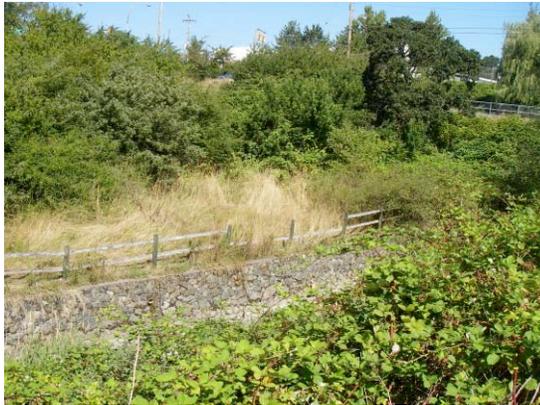
Swan Creek Reach 5, Photo 1, 2007-08-06.
Facing east toward channel. Channel is armoured on both sides with cement and rock.

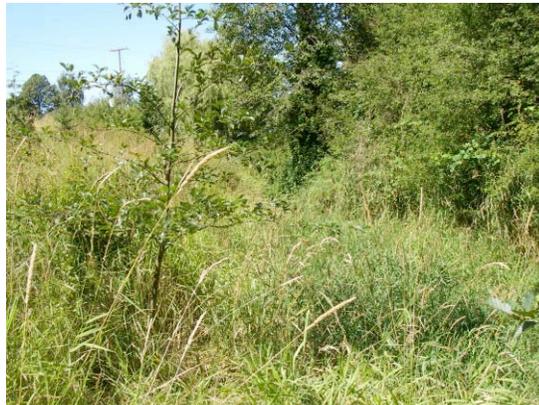
Swan Creek Reach 5, Photo 2, 2007-08-06.
Upstream of Carey Avenue facing north. Creek is heavily vegetated and banks are steep.

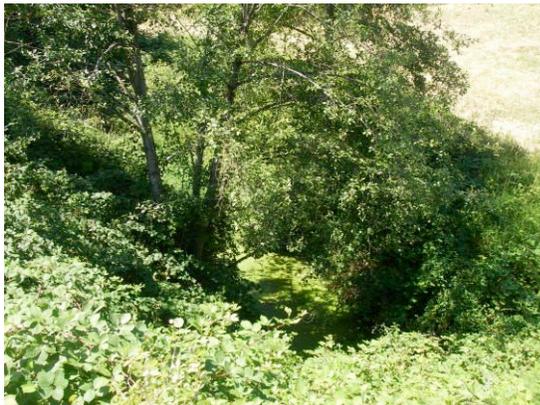
Swan Creek Reach 5, Photo 3, 2007-08-06.
Facing West (Glanford Avenue and McKenzie Avenue crossroads). Area is heavily vegetated with invasive species.

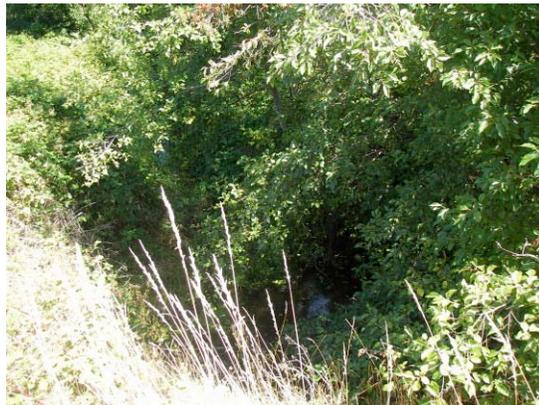
Swan Creek Reach 6, Photo 1, 2007-08-06.
Isolated trampling is occurring off the gravel path bordering Willowbrook subdivision.

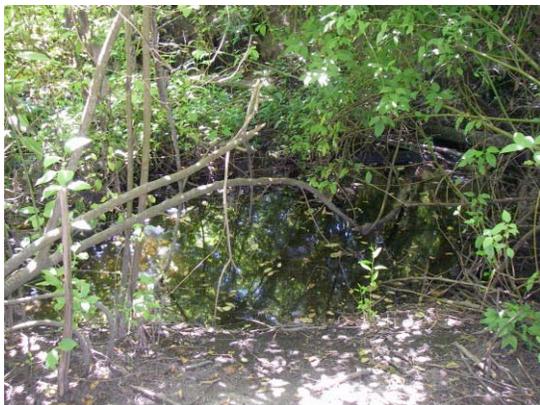
Swan Creek Reach 6, Photo 2, 2007-08-06.
Facing downstream towards the Willowbrook subdivision. Area was restored using the PFC approach in 2003.

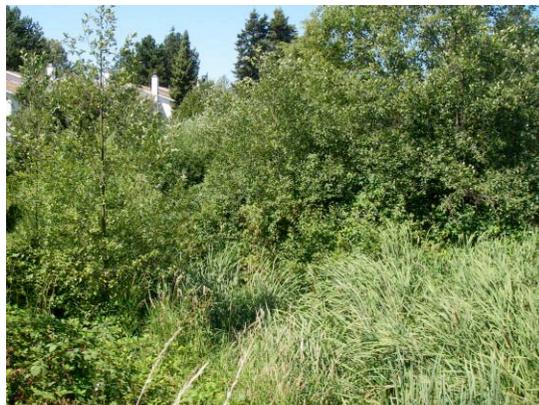
Swan Creek Reach 7, Photo 1, 2007-08-06. Jolly Place Culvert Crossing. Facing downstream towards McKenzie Ave. Channel is inundated with invasive species.

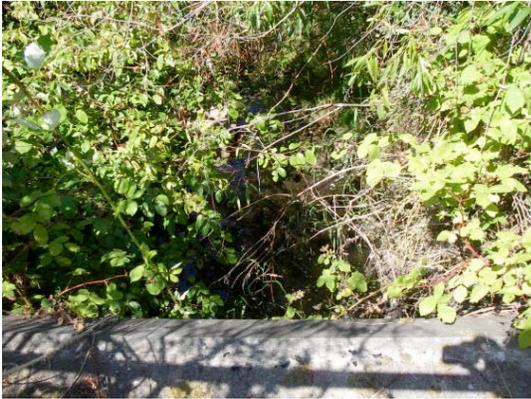
Swan Creek Reach 7, Photo 2, 2007-08-06. Jolly Place Culvert Crossing. Facing upstream towards the allotment gardens.

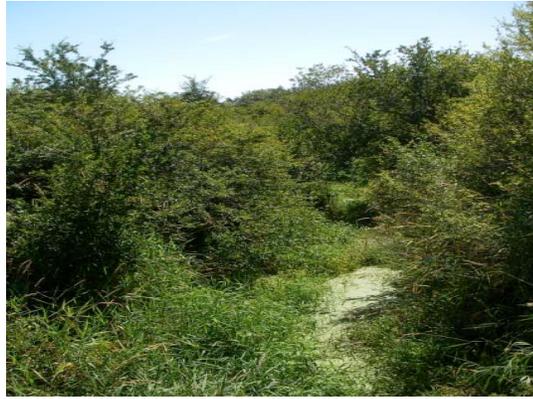
Swan Creek Reach 7, Photo 3, 2007-08-06. Ralph Street Culvert Crossing. Facing downstream. Garbage noted in channel.

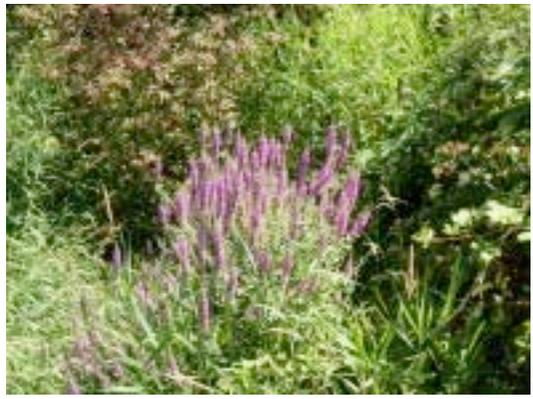
Swan Creek Reach 8, Photo 2, 2007-08-06.
Allotment gardens. Banks are steepened and bare in spots.

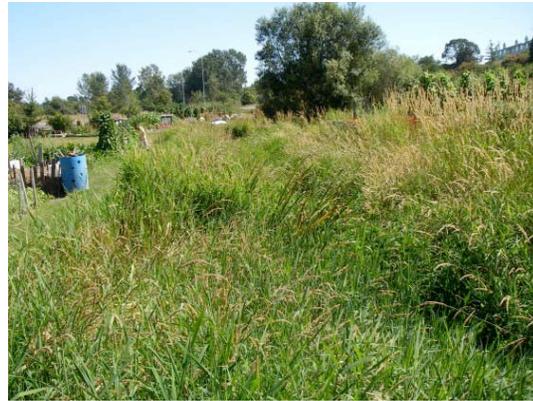
Swan Creek Reach 8, Photo 3, 2007-08-06.
Facing upstream on the Allotment gardens 2nd pedestrian bridge. Channel is heavily vegetated with reed canary grass.

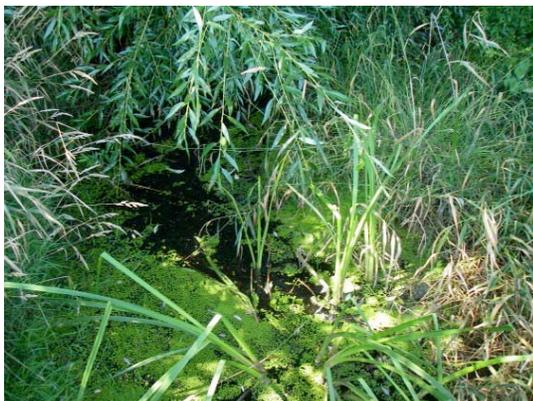
Swan Creek Reach 8, Photo 4, 2007-08-06.
Facing downstream on the Allotment gardens 2nd pedestrian bridge. Channel surface is overgrown with duckweed.

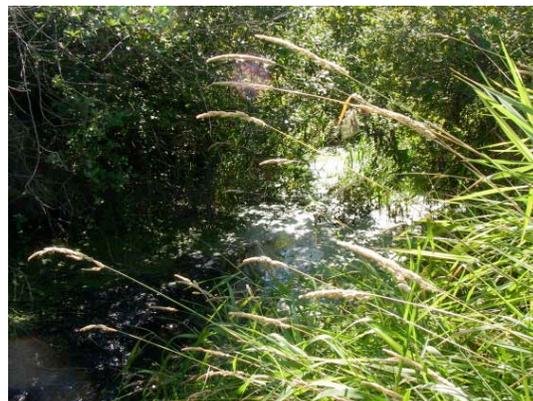
Swan Creek Reach 8, Photo 5, 2007-08-06.
Upstream of the allotment gardens facing east toward the Patricia Bay Highway.

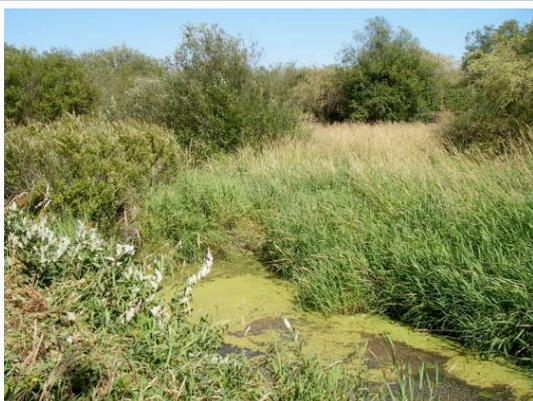
Swan Creek Reach 9, Photo 1, 2007-08-06.
Facing upstream on trail towards Swan Lake. Outlet is inundated with duckweed.

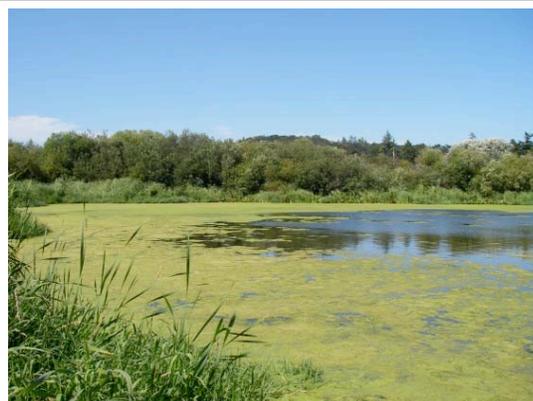
Swan Lake Reach 9, Photo 2, 2007-08-06. Swan Lake has a very high nutrient load and thus has become eutrophic.

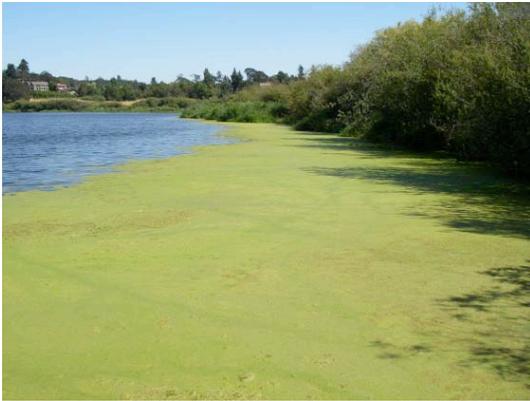
Swan Lake Reach 9, Photo 3, 2007-08-06.
Large amounts of algae and duckweed exist in
the lake.

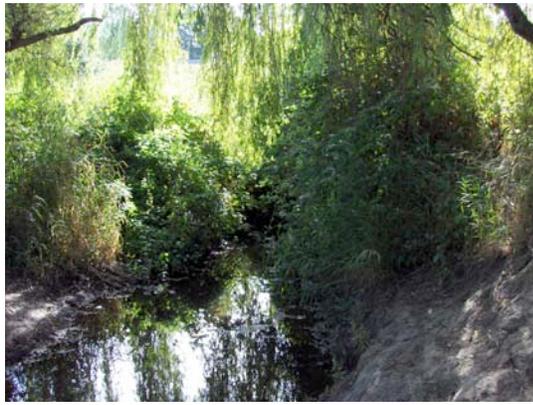
Blenkinsop Creek Reach 1, Photo 1, 2007-08-08. Upstream of Swan Lake on pedestrian bridge. Low vegetation in foreground due to trampling and high flows (see Photo 2 for close-up).

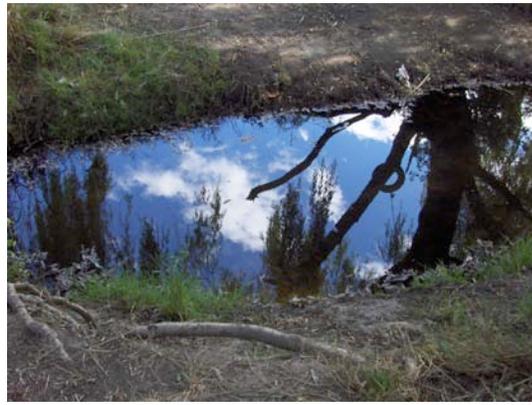
Blenkinsop Creek Reach 1, Photo 2, 2007-08-08. Upstream of Swan Lake on pedestrian bridge. Continual trampling and high flows has led to vegetation loss and streambank erosion.

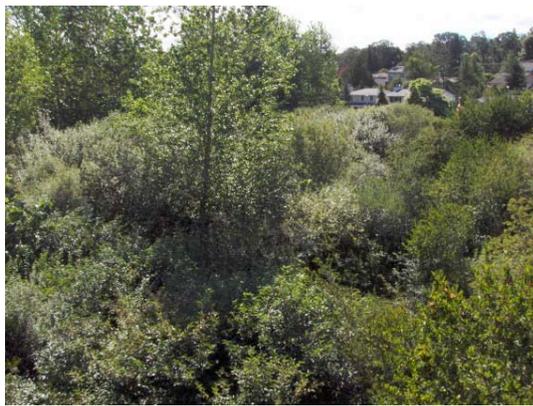
Blenkinsop Creek Reach 1, Photo 3, 2007-08-08. Facing south on Swan Lake Trestle. Blenkinsop Creek connects with Leeds Dr. residential stormwater management wetlands.

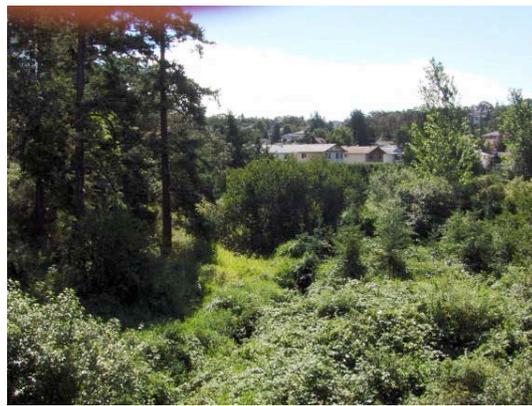
Blenkinsop Creek Reach 1, Photo 4, 2007-08-08. Facing south on Swan Lake Trestle (Saanich Road). Blenkinsop Creek in the center foreground.

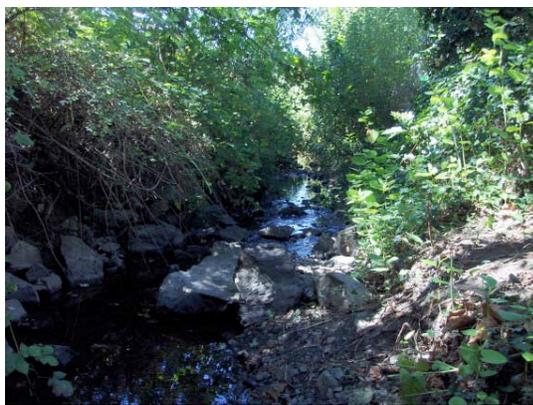
Blenkinsop Creek Reach 2, Photo 1, 2007-08-08. Upstream of Swan Lake Trestle. Large rocks have been placed along the banks to prevent erosion. Residential yards back onto the creek.

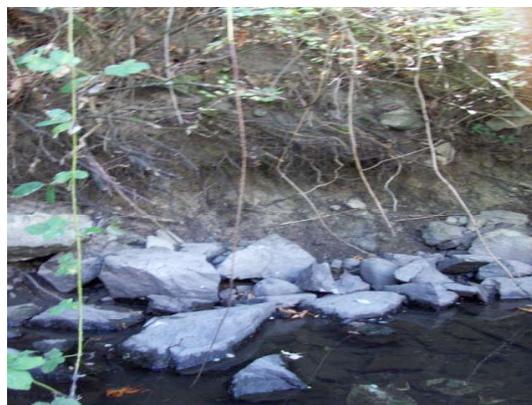
Blenkinsop Creek Reach 2, Photo 2, 2007-08-08. High flows have eroded the stream banks even though they have been armoured with rock.

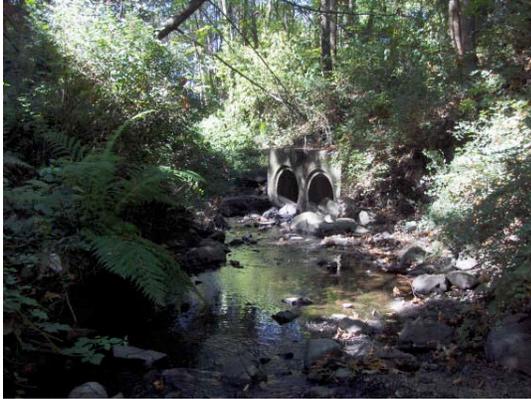
Blenkinsop Creek Reach 2, Photo 3, 2007-08-08. Facing downstream, the creek passes underneath Lochside trail through two large culverts. Streambed is full of blast rock material.

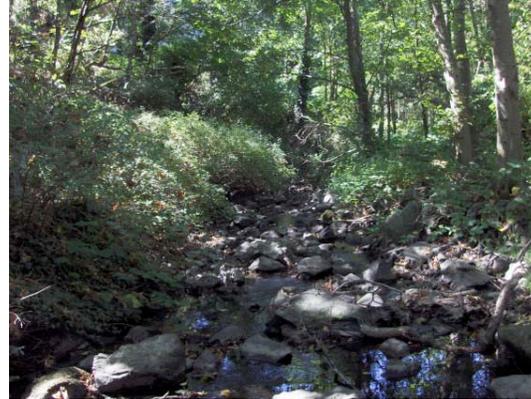
Blenkinsop Creek Reach 2, Photo 4, 2007-08-08. Facing Blenkinsop Creek upstream towards Quadra Street. Channel is full of rock but banks lack energy dissipating structures.

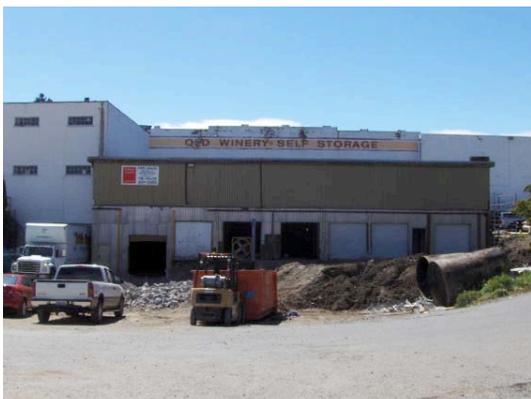
Blenkinsop Creek Reach 3, Photo 1, 2007-08-08. The reach is currently in a culvert below the building. The site (SW corner of Quadra and McKenzie) is being examined for redevelopment.

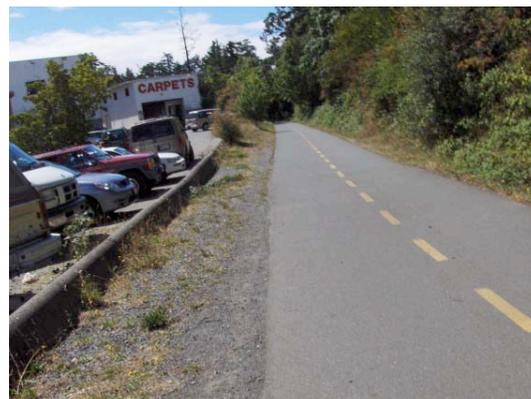
Blenkinsop Creek Reach 3, Photo 2, 2007-08-08. Facing South on Lochside Trail. Area proposed for development is to the left. Daylighting the creek has been suggested.

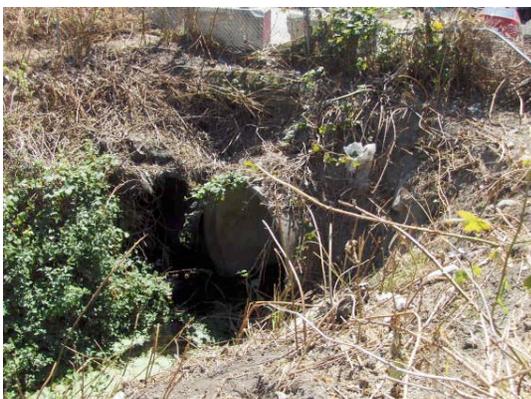
Blenkinsop Creek Reach 4, Photo 1, 2007-08-08. On Quadra property, above is the day-lighted portion of creek. Surrounding street drainage (Quadra St.) enters into the creek at this location.

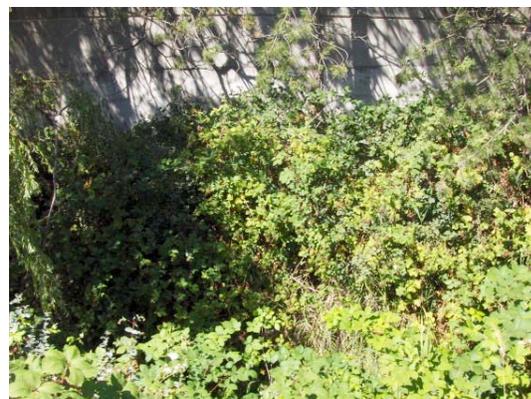
Blenkinsop Creek Reach 4, Photo 2, 2007-08-08. Upstream of McKenzie, behind London Drugs, the creek is heavily entrenched, constrained, and the banks are covered in invasive species.

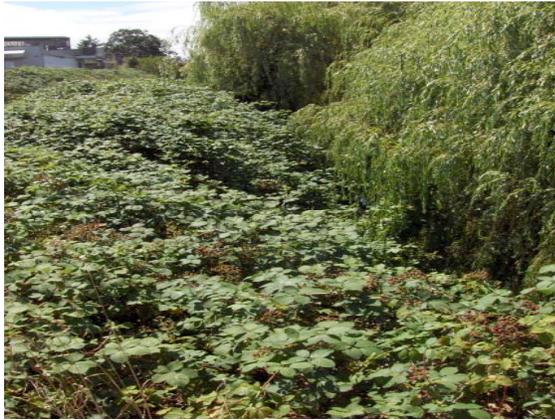
Blenkinsop Creek Reach 4, Photo 3, 2007-08-08. Facing downstream, standing on McKenzie Ave (London Drugs is to the right). Banks are heavily overgrown with invasive species.

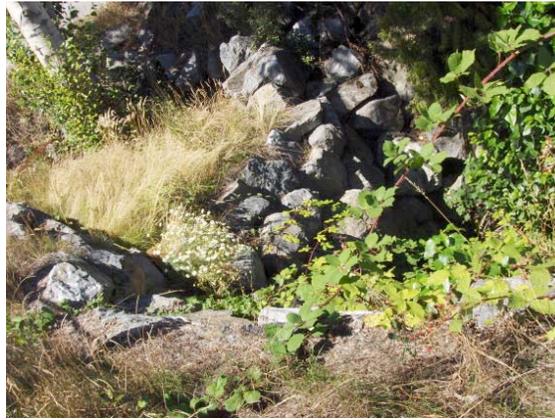
Blenkinsop Creek Reach 4, Photo 4, 2007-08-08. Creek is culverted from McKenzie and daylights again at Lochside Trail (adjacent to Lochside sub-station). Area has been ditched and lined with blast rock

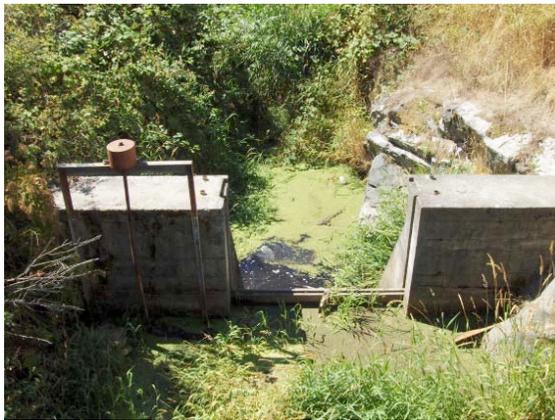
Blenkinsop Creek Reach 4, Photo 5, 2007-08-08. Blenkinsop Creek Dam. The dam controls flows and leads to flooding of upstream areas in the winter months.

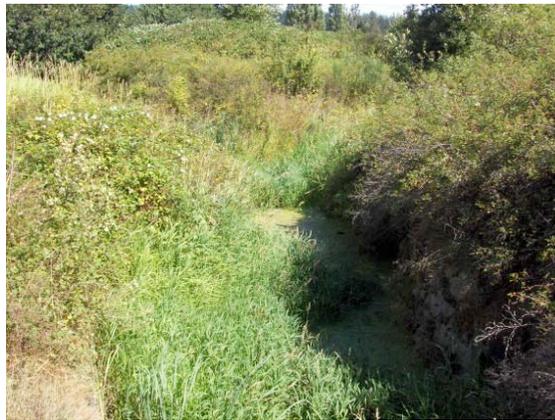
Blenkinsop Creek Reach 4, Photo 6, 2007-08-08. Looking upstream of dam. Area has been ditched and offers little in regards to diversity of vegetation.

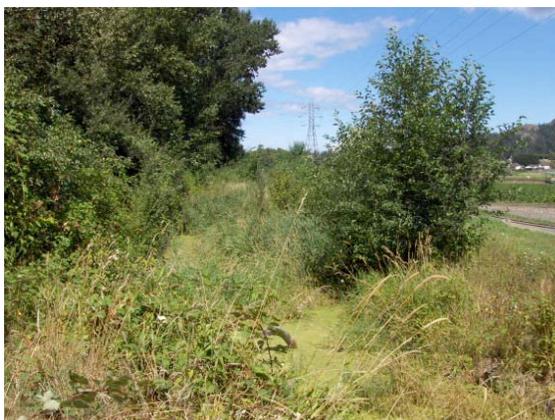
Blenkinsop Creek Reach 5, Photo 1, 2007-08-08. Facing North looking upstream with the Galey's farm in the background. Creek was restored from a ditch in 2000.

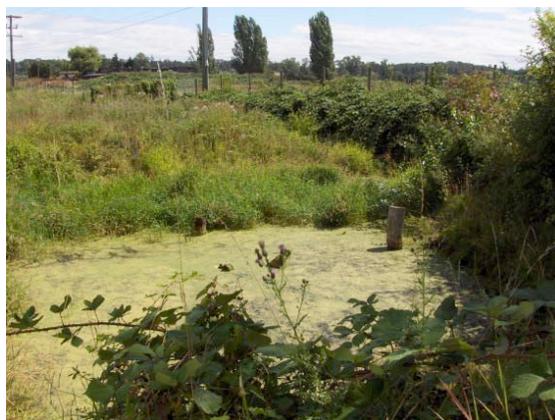
Blenkinsop Creek Reach 5, Photo 2, 2007-08-08. Facing downstream towards Cumberland Creek. The pond was created as a part of the restoration to dissipate high-energy flows and detain water.

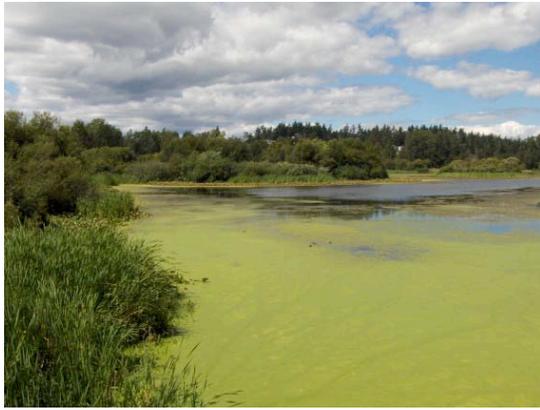
Blenkinsop Creek Reach 6, Photo 1, 2007-08-08.
Facing north on Lochside Trail. Blenkinsop Lake appears to have a high nutrient load (ie. excessive algae and duckweed) growth and is eutrophic.

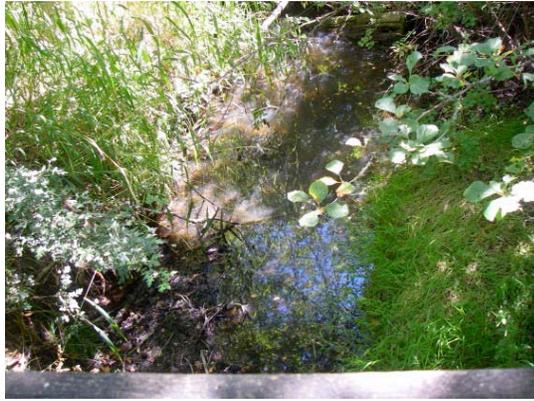
Viaduct Creek Reach 1, Photo 1, 2007-08-01. Quick's Bottom Park pedestrian bridge, facing downstream. Reach is heavily vegetated.

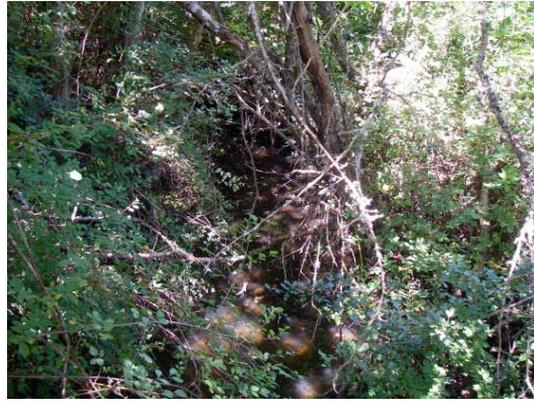
Viaduct Creek Reach 1, Photo 2, 2007-08-01. Quick's Bottom Park pedestrian bridge, facing upstream. Some floodplain is noted.

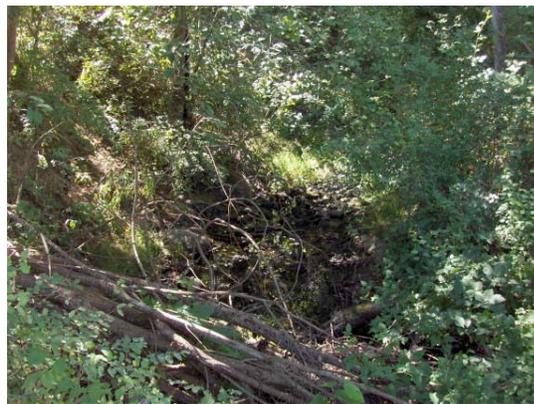
Viaduct Creek Reach 2a, Photo 1, 2007-08-08. Facing upstream on property of 4484 Markham Road. Large woody debris has piled up due to high flows.

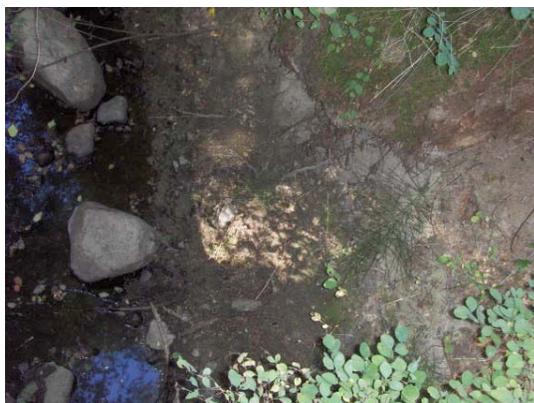
Viaduct Creek Reach 2a, Photo 2, 2007-08-08. Lack of vegetation and peak water flows has eroded and negatively impacted the stream banks.

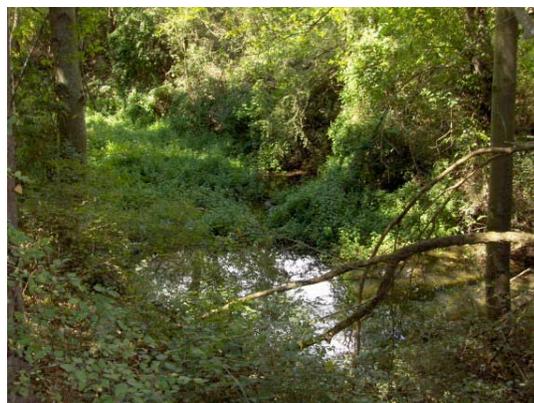
Viaduct Creek Reach 2a, Photo 3, 2007-08-08. Property of 4484 Markham Road. Historically, a ponding area, but due to upstream erosions it is now filling up with sediment.

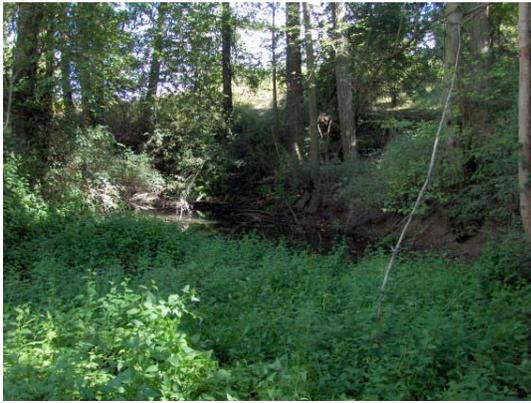
Viaduct Creek Reach 2a, Photo 4, 2007-08-08.
Pond area filled in with sediment and has re-vegetated.

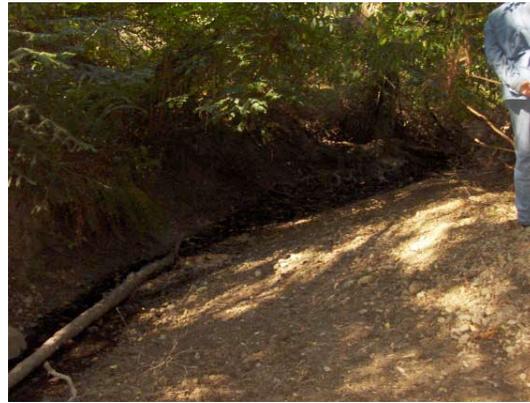
Viaduct Creek Reach 2a, Photo 5, 2007-08-08.
VITP Property. Facing downstream. Layritz Park tributary headcut has deposited a large sidebar and has begun to fill in the channel with sediment.

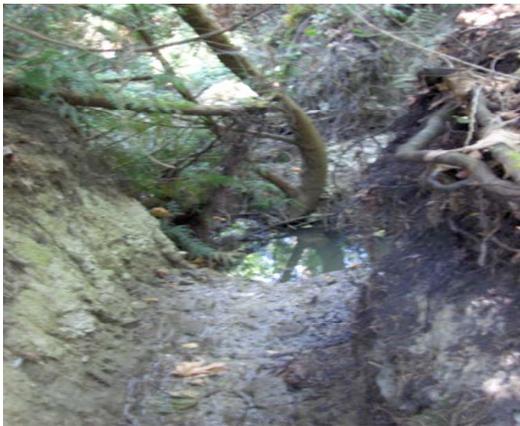
Viaduct Creek Reach 2a, Photo 6, 2007-08-08.
Layritz Park tributary, facing upstream.
Tributary has head-cut and has eroded the clay banks. Trees have collapsed into the stream bed.

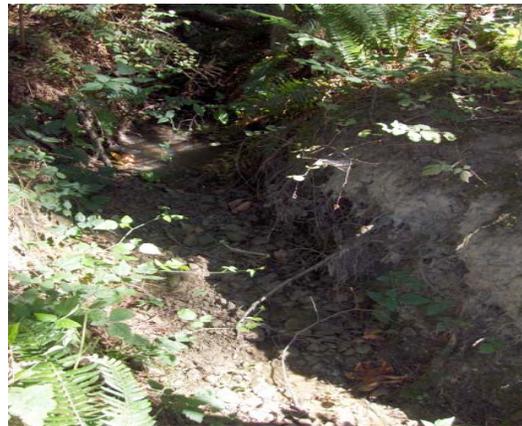
Viaduct Creek Reach 2a, Photo 7, 2007-08-08.
Layritz Park tributary, facing upstream.
Tributary has downcut.

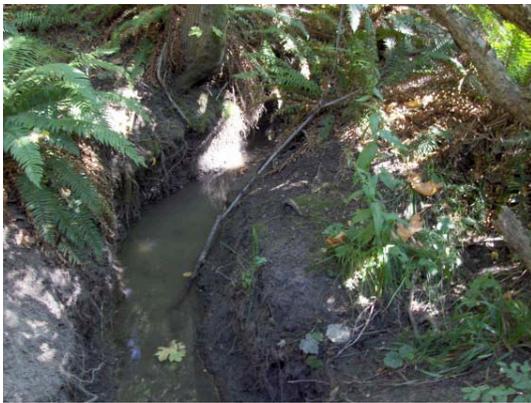
Viaduct Creek Reach 2a, Photo 8, 2007-08-08.
Layritz Park tributary, facing upstream.
Tributary has down-cut severely.

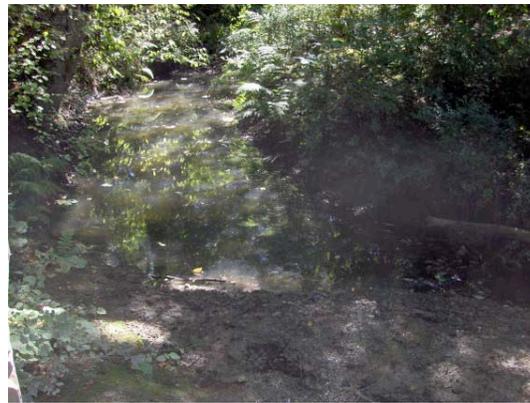
Viaduct Creek Reach 2a, Photo 9, 2007-08-08.
Facing upstream. Viaduct and Layritz Park tributary confluence. Layritz Park tributary enters into Viaduct creek.

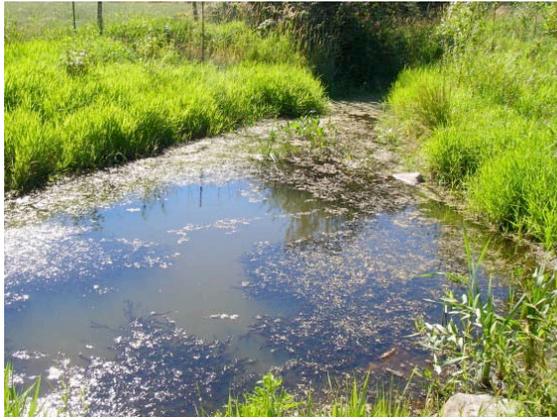
Viaduct Creek Reach 2b, Photo 1, 2007-08-01. Pond area, facing downstream toward VITP. Vegetation in this area consists mainly of reed canary grass and thistles.

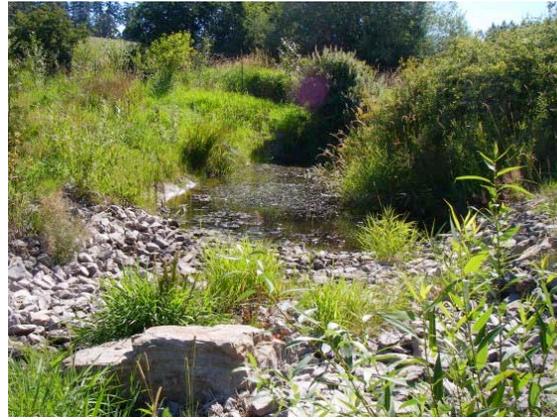
Viaduct Creek Reach 2b, Photo 2, 2007-08-01. Facing downstream toward rock weir. Gardens and Woodland Group has installed the rock weir and restored a portion of the area.

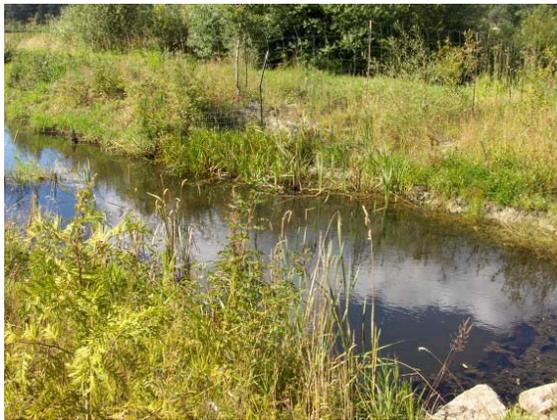
Viaduct Creek Reach 2b, Photo 3, 2007-08-08. Standing at rock weir, facing upstream.

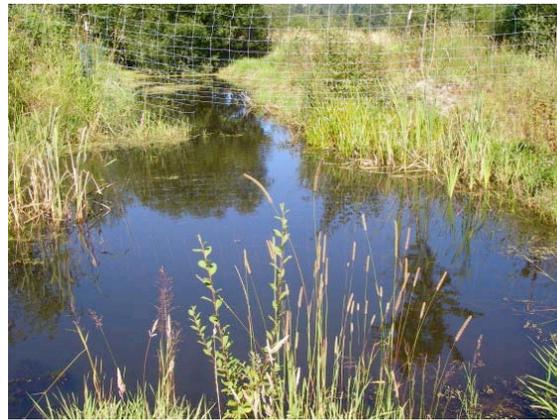
Viaduct Creek Reach 2b, Photo 4, 2007-08-01. Pond area, facing downstream.

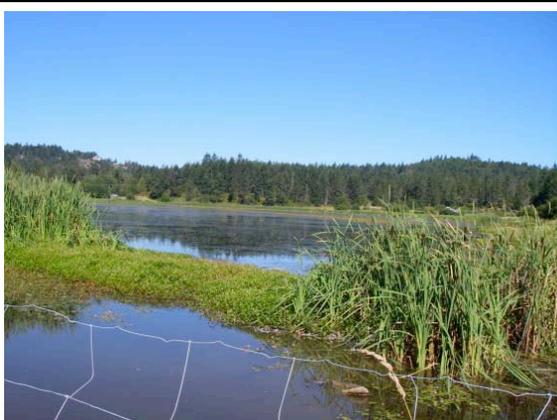
Viaduct Creek Reach 3, Photo 1, 2007-08-01. Viaduct Flats, facing upstream.

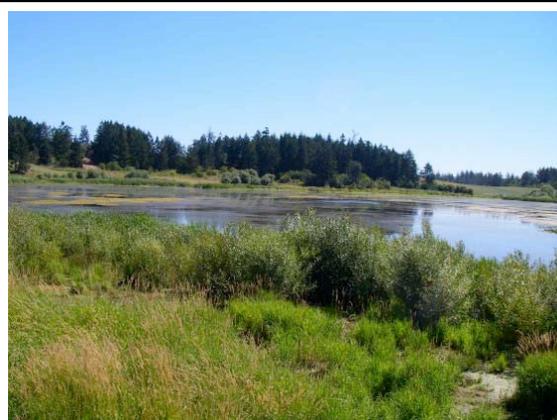
Viaduct Creek Reach 3, Photo 2, 2007-08-01. Viaduct flats. Picture taken from concrete bird blind.

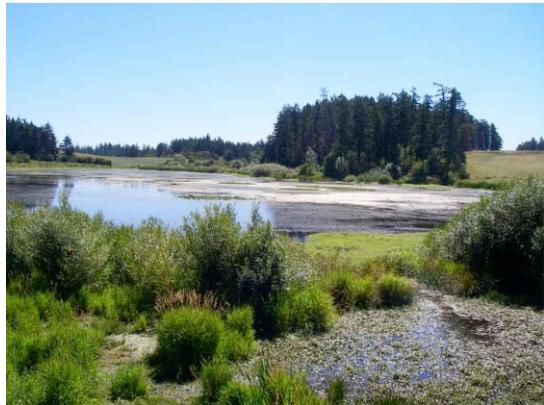
Viaduct Creek Reach 3, Photo 3, 2007-08-01.
Viaduct flats. Picture taken from concrete bird blind.

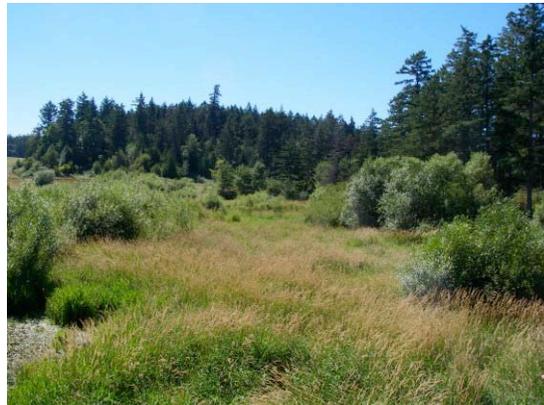
Viaduct Creek Reach 4, Photo 1, 2007-08-01.
Viaduct creek enters into Viaduct flats. Facing downstream, picture taken from bird blind.

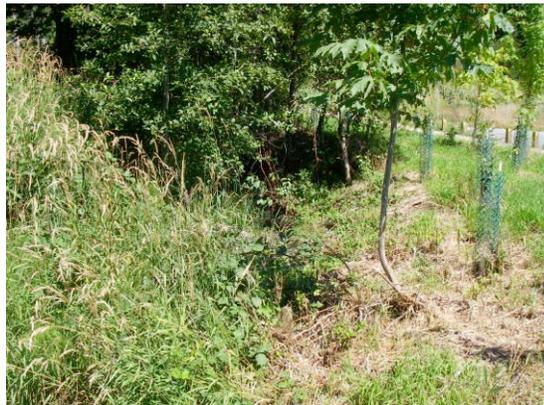
Viaduct Creek Reach 4, Photo 2, 2007-08-01.
Viaduct park entrance, facing upstream. Creek is inundated with reed canary grass.

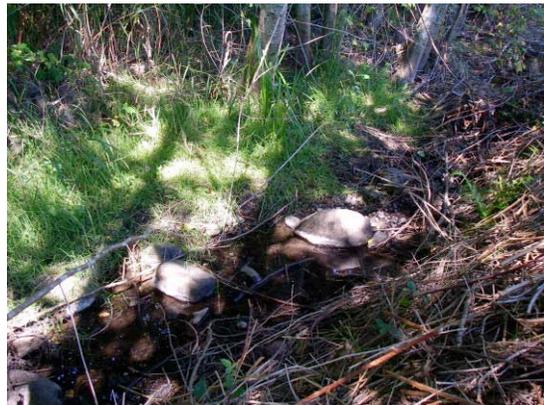
Viaduct Creek Reach 4, Photo 3, 2007-08-01.
Upstream of Viaduct park entrance. Very low water levels noted.

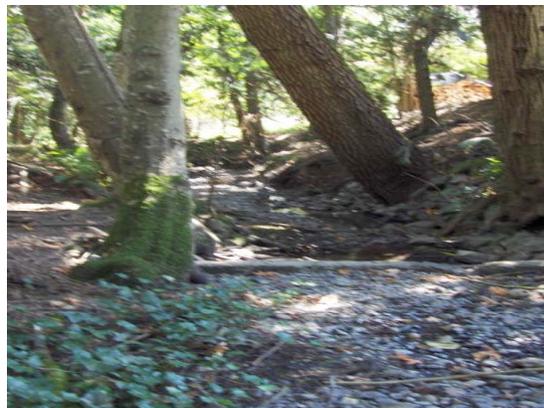
Viaduct Creek Reach 5, Photo 2, 2007-08-16.
Facing downstream toward concrete weir. Stream is armoured throughout as an attempt to stop the continued erosion.

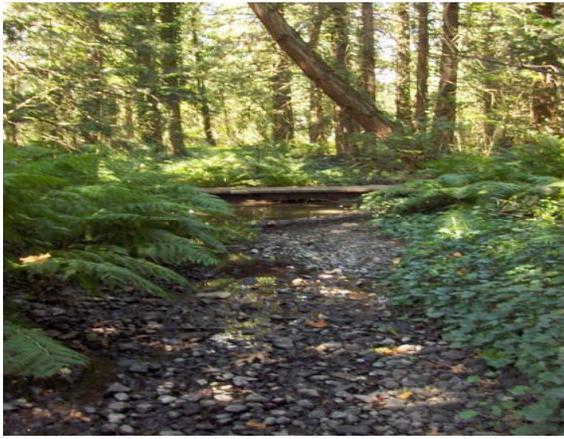
Viaduct Creek Reach 5, Photo 3, 2007-08-16.
Facing upstream toward pedestrian bridge and
confluence with Goward Springs A.

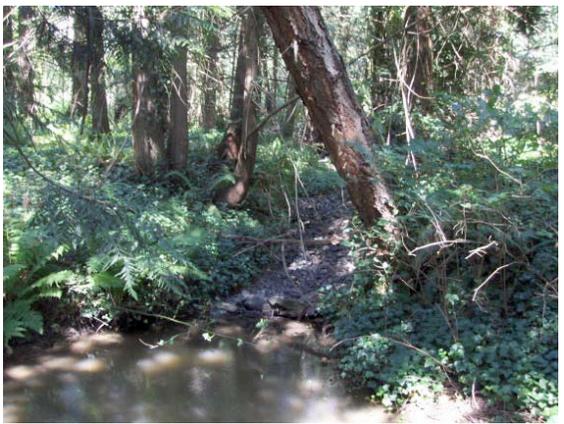
Viaduct Creek Reach 6, Photo 2, 2007-08-16.
Standing on pedestrian bridge, facing upstream
towards the Goward Springs and Viaduct Creek
confluence.

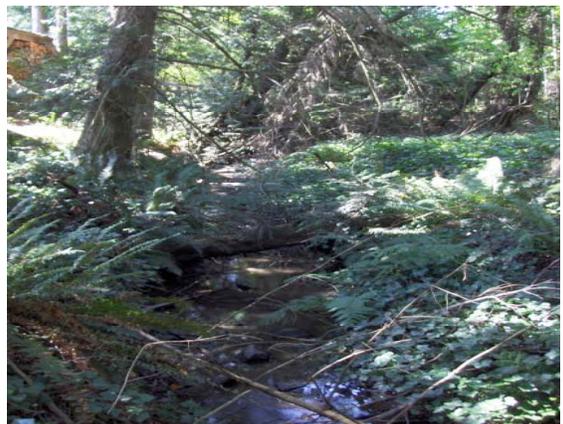
Viaduct Creek Reach 6, Photo 3, 2007-08-16.
Viaduct Creek, upstream of confluence.

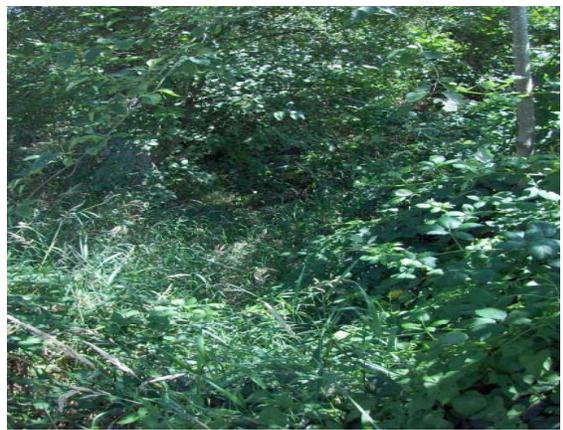
Viaduct Creek Reach 7, Photo 1, 2007-08-16.
Property of 458 Viaduct Ave, facing downstream.
Channel is heavily vegetated with reed canary
grass.

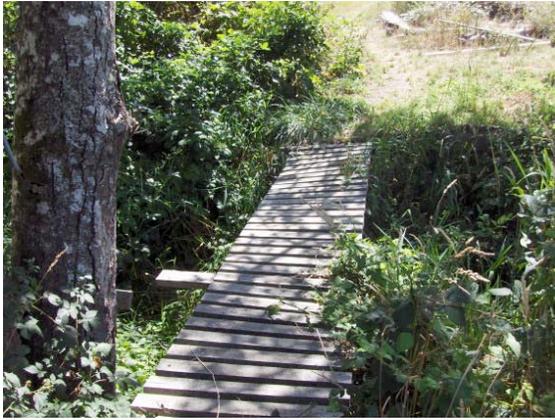
Viaduct Creek Reach 7, Photo 2, 2007-08-16.
Property of 458 Viaduct Ave, pedestrian bridge.
Channel has been ditched and over-grown with reed canary grass.

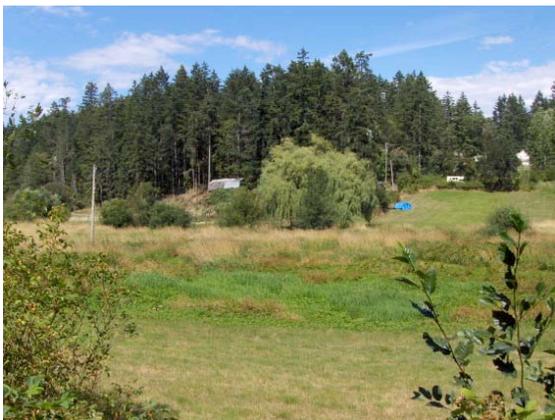
Viaduct Creek Reach 8, Photo 1, 2007-08-16.
Property of 455 Green Mountain Road. A ditch has been dug through the wetland to allow for drainage and usage of the surrounding farmland.

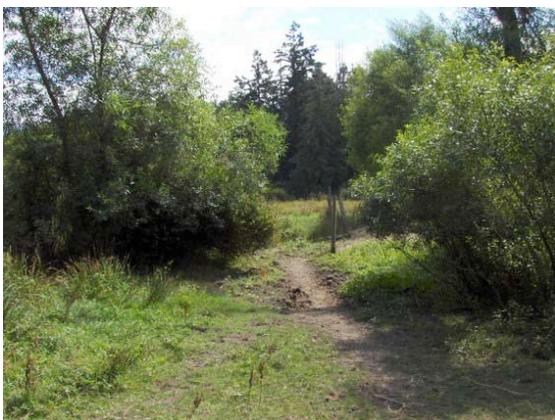
Viaduct Creek Reach 8, Photo 3, 2007-08-16.
Facing upstream on the property of 414 Viaduct Avenue. Area dries up in the summer and is grazed/trampled by horses.

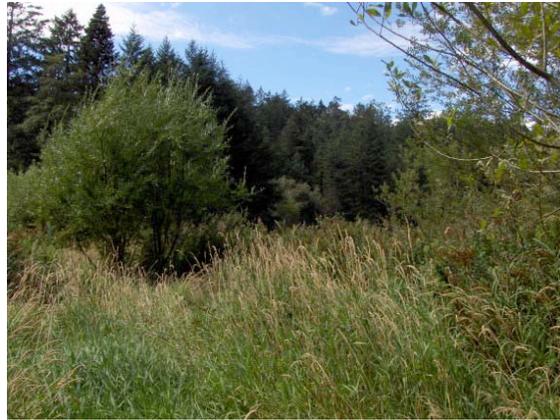
Viaduct Creek Reach 9, Photo 1, 2007-08-16. Property of 402 Viaduct Avenue. Facing the Viaduct Creek and Excelsior Creek confluence. Due to the lack of trampling, the channel has re-established itself.

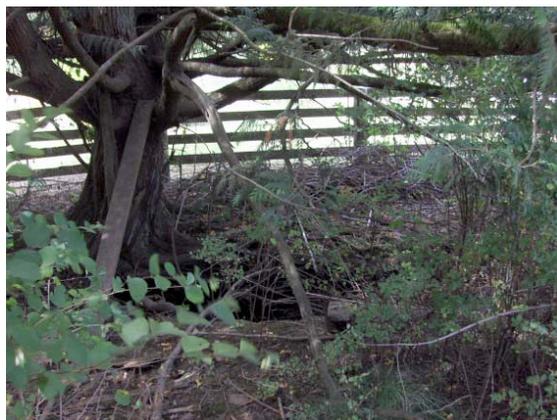
Viaduct Creek Reach 9, Photo 1, 2007-08-16. Property of 414 Viaduct Avenue. Upstream of the Viaduct Creek and Excelsior Creek confluence. Viaduct Creek is heavily down-cut and eroded.

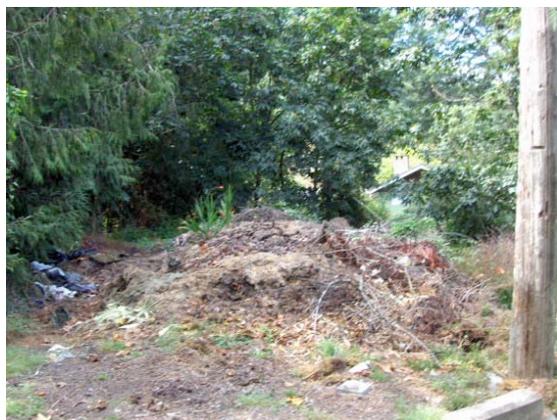
Viaduct Creek Reach 9, Photo 3, 2007-08-16. Property of 414 Viaduct Avenue. Current property owners have placed a large compost pile next to the creek.

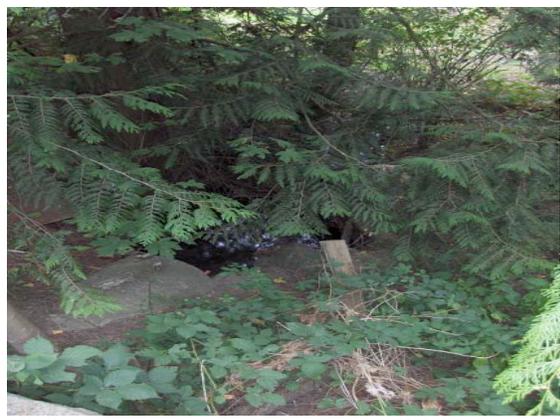
Viaduct Creek Reach 10, Photo 1, 2007-08-16. Facing downstream on Viaduct Avenue crossing. Creek crosses underneath road and enters into the 414 Viaduct Avenue Property.

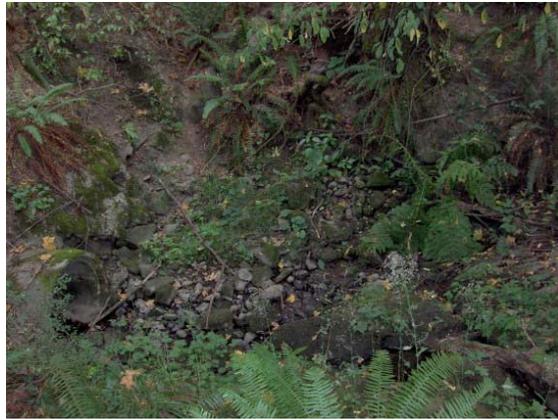
Viaduct Creek Reach 10, Photo 2, 2007-08-16. Facing downstream towards Viaduct Avenue. Noted large substrate and bedrock at culvert crossing.

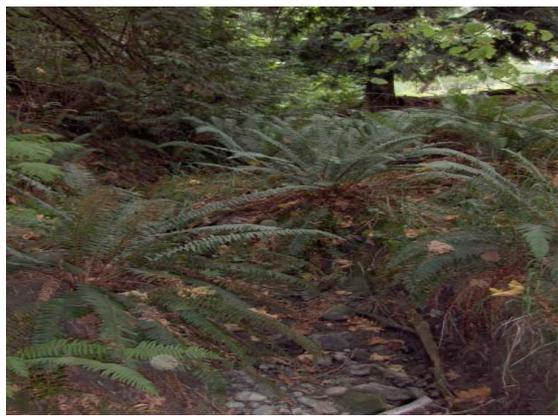
Viaduct Creek Reach 10, Photo 4, 2007-08-16. Facing upstream, creek appears to have down-cut due to a head-cut upstream.
