Colquitz River Watershed

Proper Functioning Condition Assessment

Appendices

July 2009

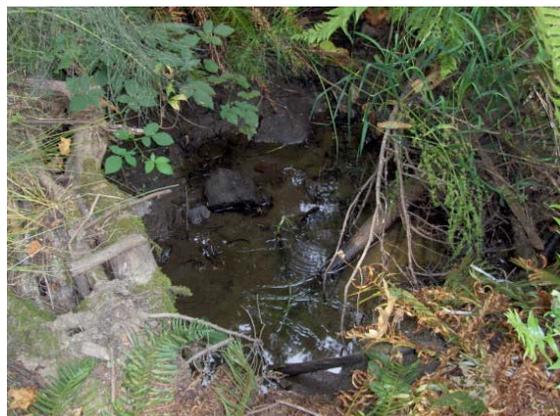
Viaduct Creek Reach 10, Photo 5, 2007-08-16. End of Reach 10 due to a headcut approximately 60cm in depth.

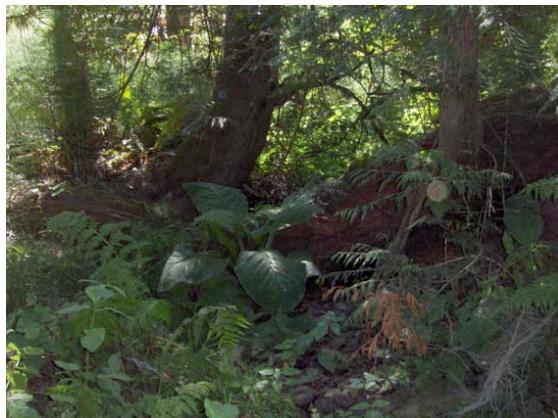
Viaduct Creek Reach 11, Photo 1, 2007-08-14. At headcut, facing upstream.

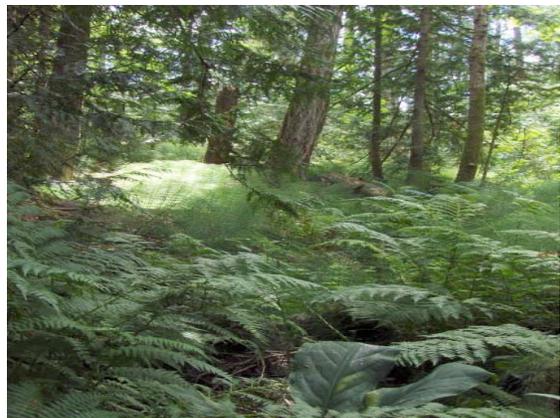
Viaduct Creek Reach 11, Photo 2, 2007-08-16. Facing upstream, channel is heavily vegetated and a large floodplain area is present.

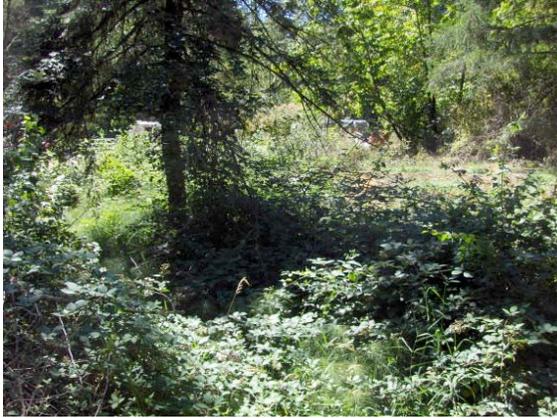
Viaduct Creek Reach 12, Photo 1, 2007-08-14. Facing upstream towards property of 365 Viaduct Avenue. Beginning of reach 12.

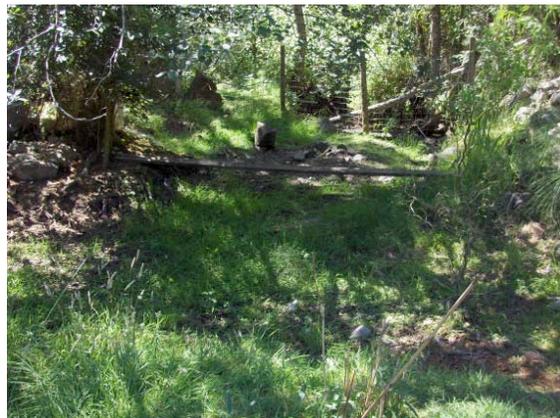
Viaduct Creek Reach 12, Photo 4, 2007-08-14. Facing upstream with the driveway behind the photographer. Creek-bed has some vegetation in the channel.

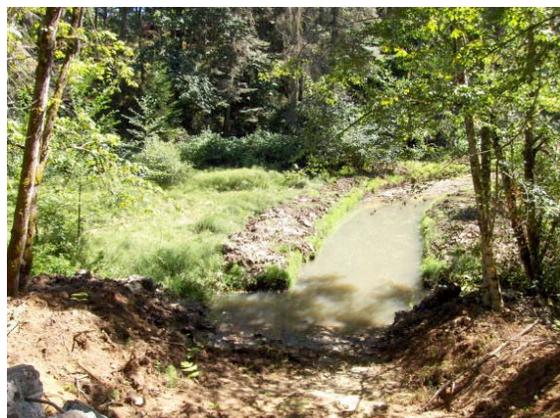
Viaduct Creek Reach 13, Photo 1, 2007-08-14. Facing property of 335 Viaduct Avenue. In 2007, 335 property owners attempted to dig a driveway to by-pass the driveway of property 345 Viaduct Ave.

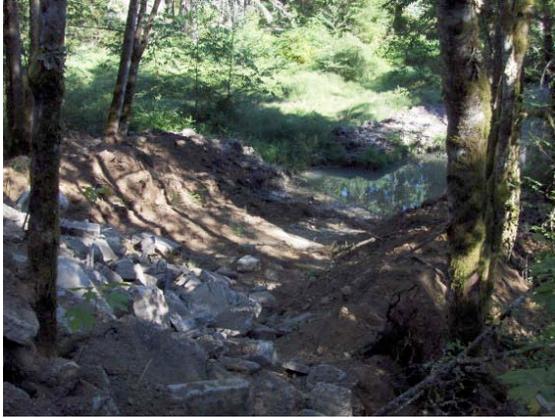
Viaduct Creek Reach 13, Photo 2, 2007-08-08. The riparian wetland area has been narrowed up and bermed, changing the hydrology of the creek.

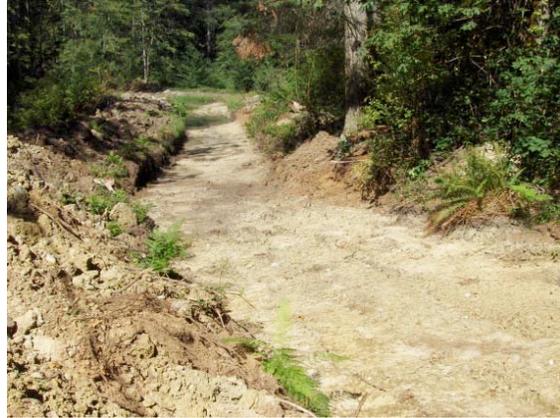
Viaduct Creek Reach 13, Photo 3, 2007-08-14. Facing Viaduct Avenue, the driveway extends from the road and connects to the driveway of 345 Viaduct Avenue.

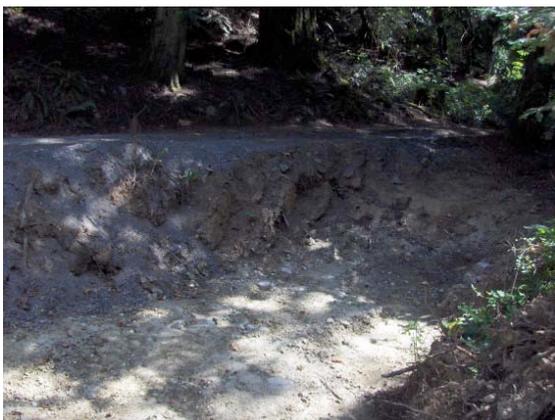
Viaduct Creek Reach 13, Photo 4, 2007-08-14. New driveway connecting to the existing driveway of 345 Viaduct Avenue.

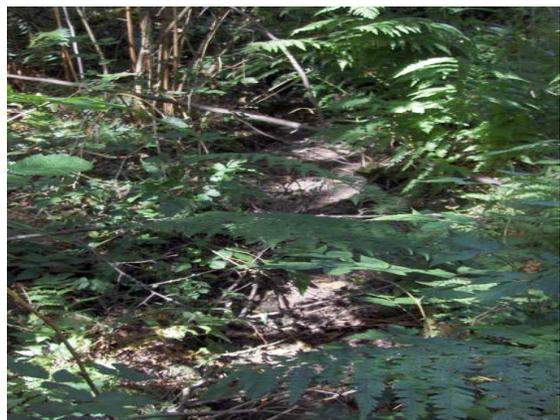
Viaduct Creek Reach 14, Photo 1, 2007-08-14. Facing upstream toward Logan Park.

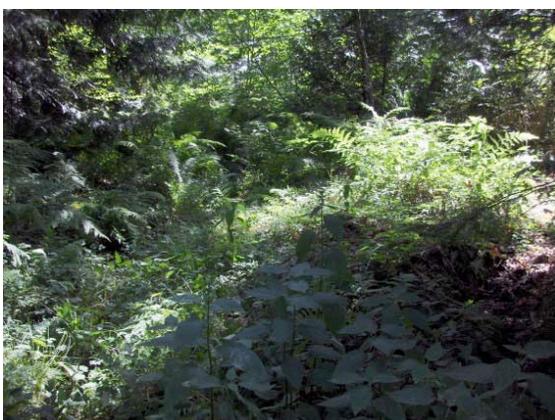
Viaduct Creek Reach 14, Photo 2, 2007-08-14. There are multiple small, narrow channels that seem to have likely been initiated by an old road whose ruts collected surface flow.

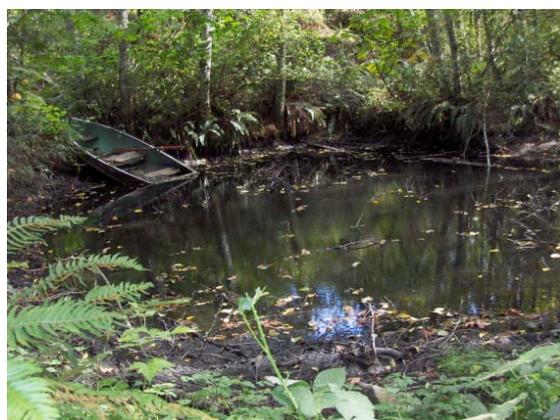
Viaduct Creek Reach 14, Photo 3, 2007-08-14. Facing upstream, pond near 235 Hector Road. Bullfrogs were observed in this pond.

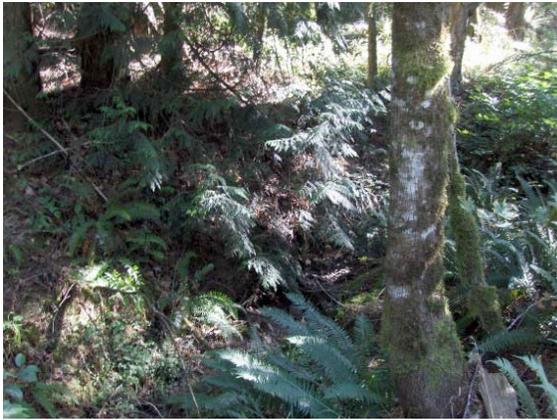
Viaduct Creek Reach 15, Photo 1, 2007-08-14.
Logan Park. Facing downstream.

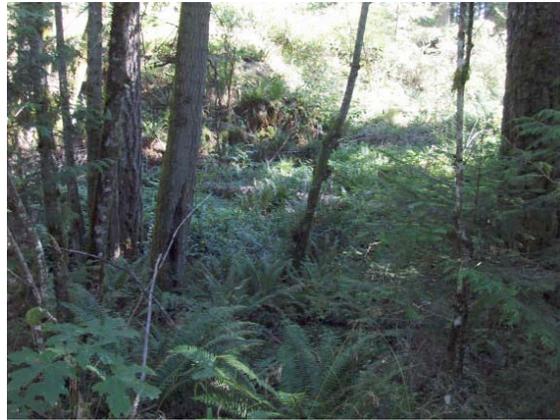
Viaduct Creek Reach 15, Photo 2, 2007-08-14.
Facing downstream from Logan Park trail culvert crossing. Channel is well vegetated with riparian vegetation.

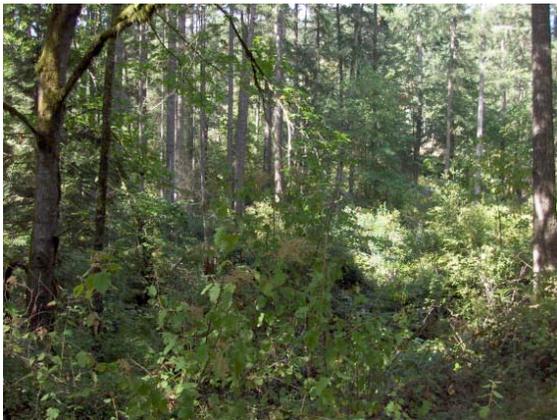
Viaduct Creek Reach 16, Photo 1, 2007-08-14.
Facing upstream from Logan Park trail culvert crossing. A definitive channel no longer exists.

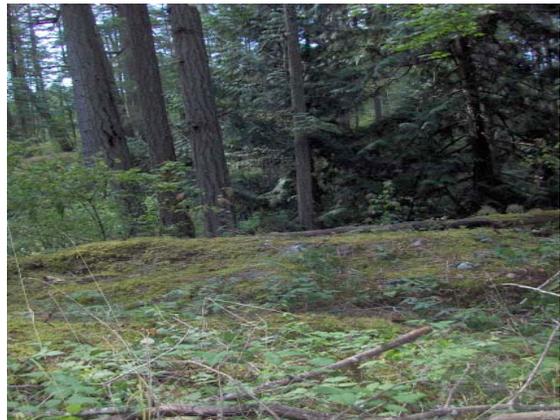
Viaduct Creek Reach 16, Photo 2, 2007-08-14.
Upstream from culvert trail crossing. Channel becomes a moist forested wetland.

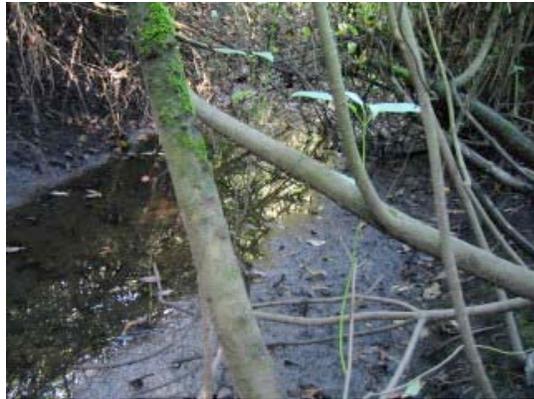
Durrell Creek Reach 1, Photo 1, 2007-09-18.
Facing downstream, toward its confluence with Colquitz Creek near Loenholm Road.

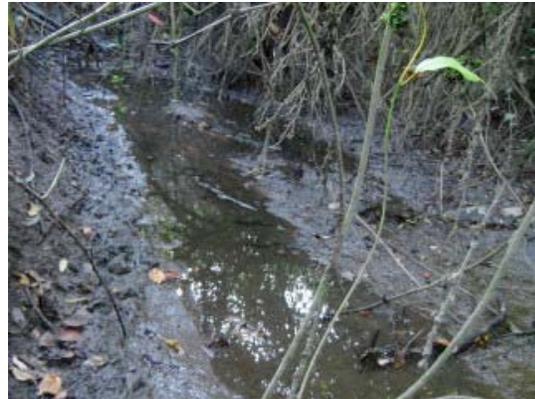
Durrell Creek Reach 1, Photo 2, 2007-09-18.
Facing upstream toward Wilkinson Road. Banks are bare and muddy.

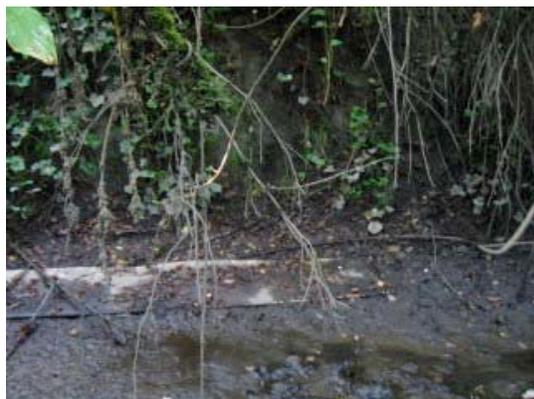
Durrell Creek Reach 1, Photo 3, 2007-09-18.
The banks are oversteepened and erosion is evident. Note the presence of English ivy.

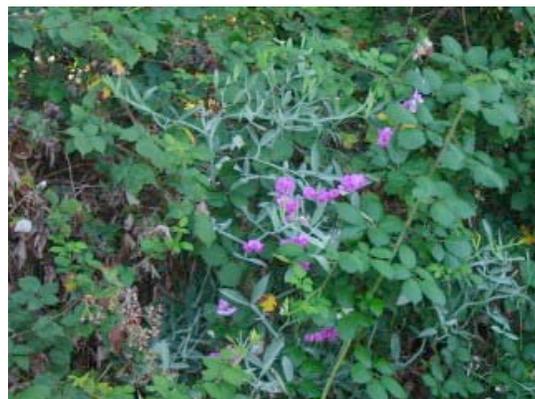
Durrell Creek Reach 1, Photo 4, 2007-09-18.
Looking downstream from Wilkinson Road at the end of reach 1. Himalayan blackberry and a variety of pea are in the forefront.

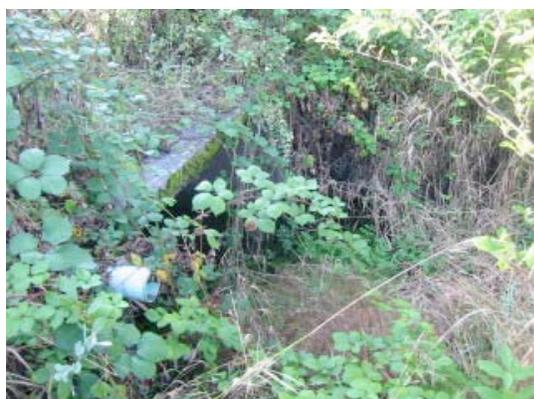
Durrell Creek Reach 2, Photo 1, 2007-09-18.
Culvert where the stream travels downstream under Wilkinson Road.

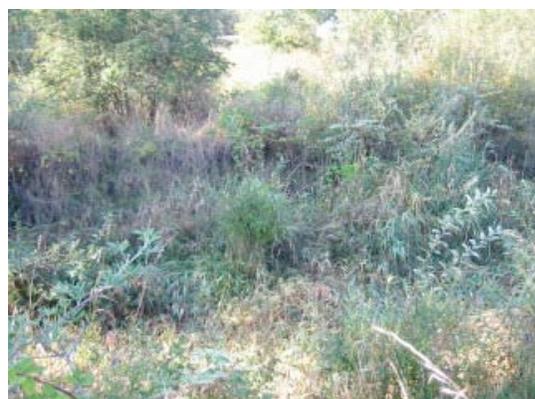
Durrell Creek Reach 2, Photo 2, 2007-09-18.
Upstream of Wilkinson Road. Banks are vegetated and some floodplain is present on the left bank.

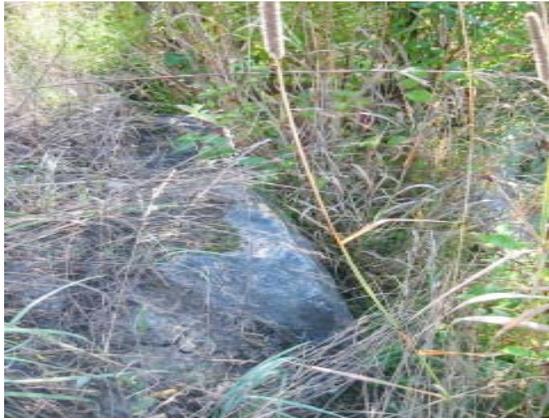
Durrell Creek Reach 2, Photo 3, 2007-08-08.
Facing downstream, standing on McKenzie Ave
(London Drugs is to the right). Banks are heavily
overgrown with invasive species.

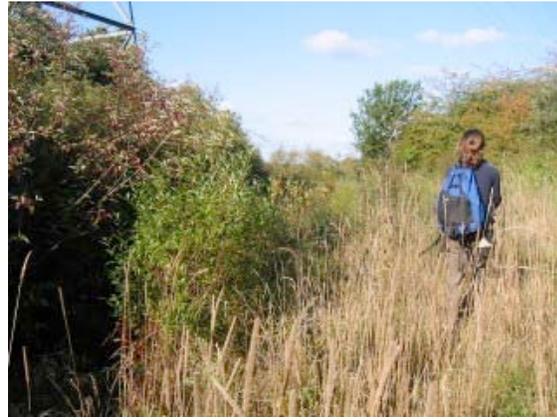
Durrell Creek Reach 2, Photo 4, 2007-09-18.
Looking upstream toward Wilkinson Road
Correctional Centre. Note presence of reed canary
grass and young willow.

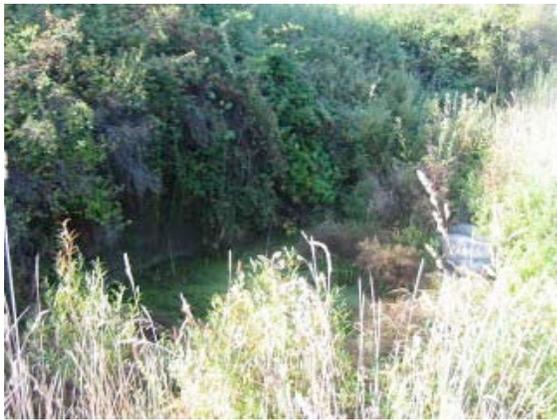
Durrell Creek Reach 2, Photo 5, 2007-09-18.
Small man-made pond adjacent to power tower.
Banks are oversteepened.

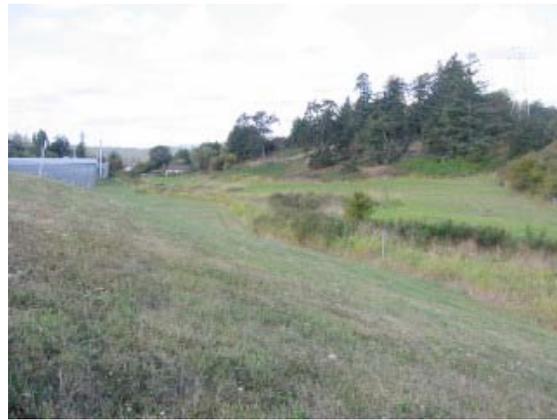
Durrell Creek Reach 2, Photo 6, 2007-09-18.
Looking upstream from Wilkinson Road
Correctional Centre. Mowing occurs near to the
edge of the channel.

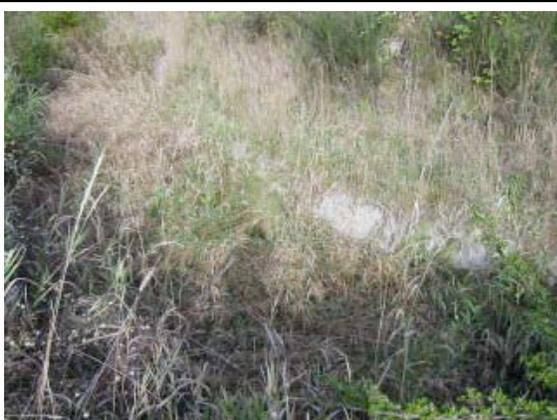
Durrell Creek Reach 2, Photo 7, 2007-09-18.
The channel through Wilkinson Road Correctional
Centre. Clay banks are steep and bare.

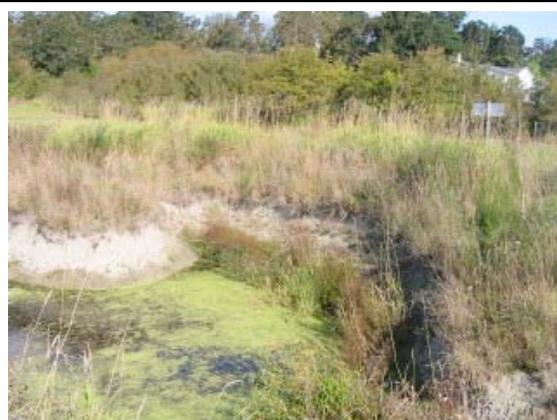
Durrell Creek Reach 2, Photo 8, 2007-09-18.
One of the man-made ponds within the correctional
centre property. Banks are vertical and bare.

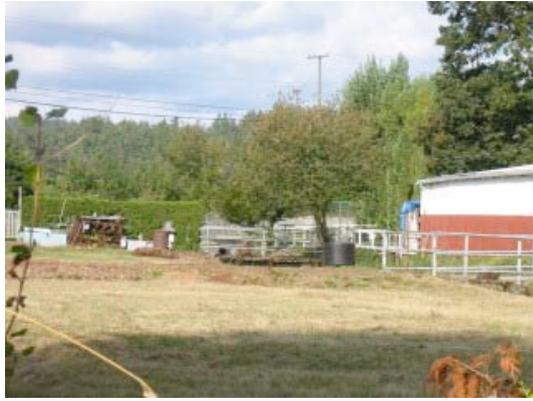
Durrell Creek Reach 3, Photo 1, 2007-09-18. Looking upstream from Wilkinson Road Correctional Centre. There is little vegetation present.

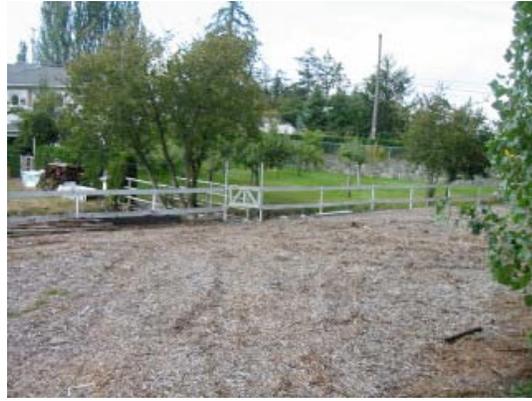
Durrell Creek Reach 3, Photo 2, 2007-09-18. Paddock area borders the left bank of the stream.

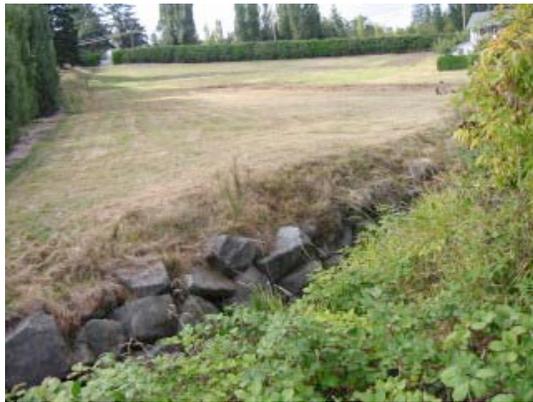
Durrell Creek Reach 3, Photo 3, 2007-09-18. Downstream end of reach 3. Banks are armoured with rock. No vegetation is present other than grass on the right bank.

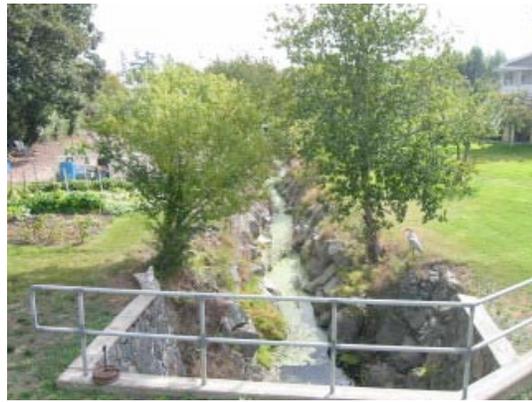
Durrell Creek Reach 3, Photo 4, 2007-09-18. Facing downstream from Interurban Road. Channel is armoured and there is little vegetation.

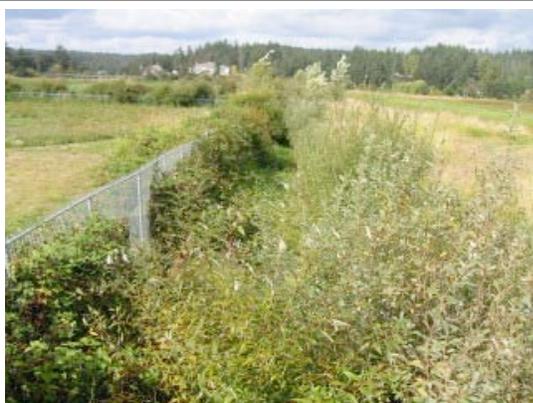
Durrell Creek Reach 4, Photo 1, 2007-09-18. Facing upstream from Interurban Road. Channel located in the middle of agricultural fields.

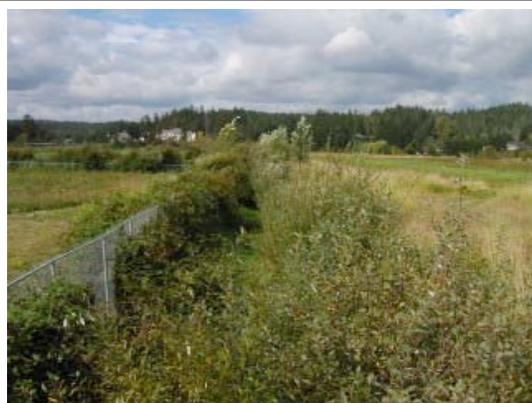
Durrell Creek Reach 4, Photo 2, 2007-09-18. Looking upstream. Channel is heavily vegetated.

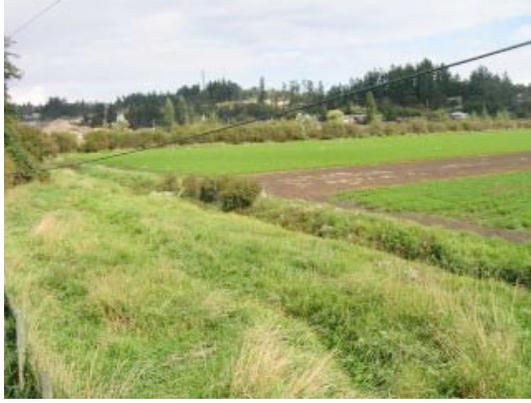
Durrell Creek Reach 4, Photo 3, 2007-09-18.
Facing downstream, from green trestle bridge.
The channel is located within the line of
vegetation in the background.

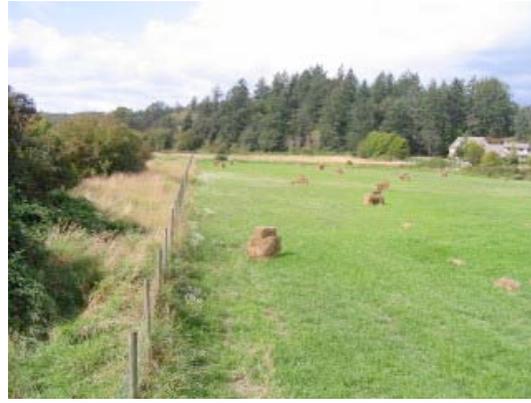
Durrell Creek Reach 4, Photo 4, 2007-09-18.
Facing upstream from the green trestle.

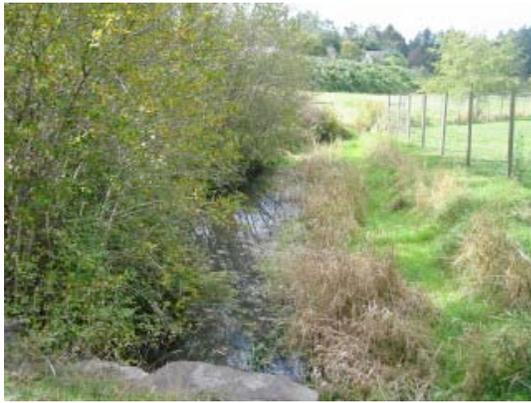
Durrell Creek Reach 4, Photo 5, 2007-09-18.
Facing upstream of Granville Avenue. Small,
terraced floodplain at left bank. Horse and cow
paddocks line both banks.

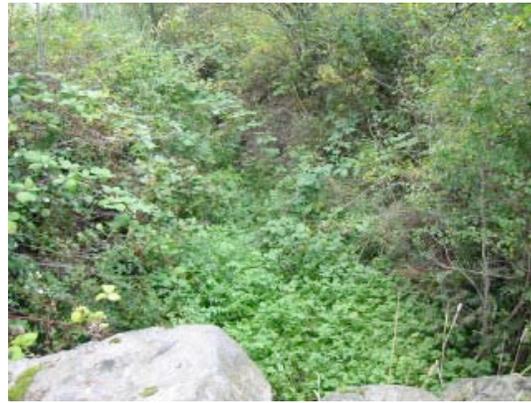
Durrell Creek Reach 4, Photo 6, 2007-09-18.
Looking downstream from Granville Avenue.
Flow is low and vegetation is encroaching upon
the channel.
