Lyall Harbour – Boot Cove Water System

2018 Annual Report

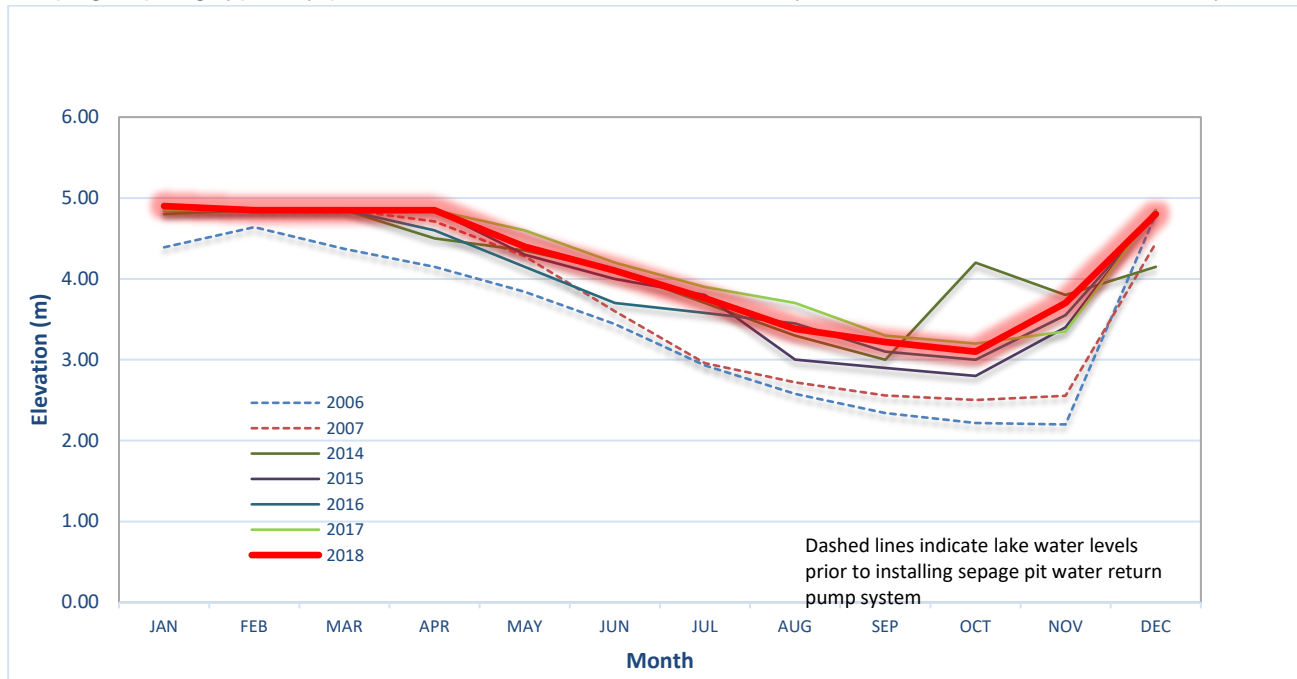
Figure 2: Lyall Harbour/Boot Cove - Money Lake Monthly Water Level

Referring to Figure 2 below, Money Lake surface water supply monthly water levels are highlighted for 2018. Water supply levels for the year are within historical limits. It is important to note that water supply levels in Money Lake, prior to 2008, were historically lower during the summer period. An upgrade to mitigate the low water levels involved the installation of a groundwater seepage spring recirculation pumping system. Excess water from the seepage spring is pumped back to Money Lake in order to keep the Lake as full as possible. The groundwater seepage spring water level is not monitored; however the seepage spring weekly flow rate is monitored to confirm production rate. The seepage spring typically provides 100% of the winter water system demand for the community.
